RIVERSIDE TERRACE CONDO.
Elevator Survey & Report
April 17, 2025

Prepared by
Carey & Associates, Inc.

Riverside Terrace Condominium
Elevator Survey & Report
April 17, 2024

Prepared for:
Riverside Terrace Condominium Association, Inc.
615 N. Riverside Drive
Pompano Beach, FL 33062

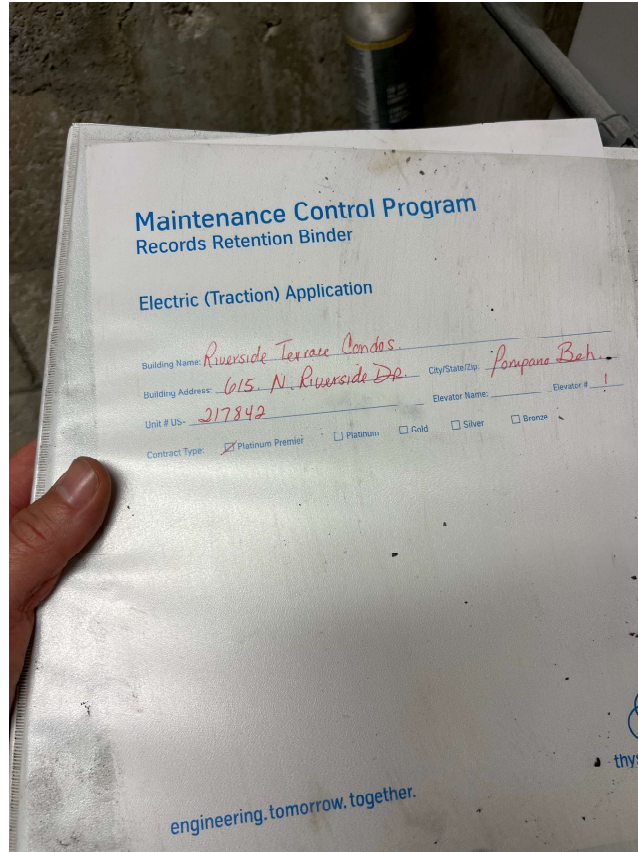
Maintenance check chart indicates only one service visit in 2023.

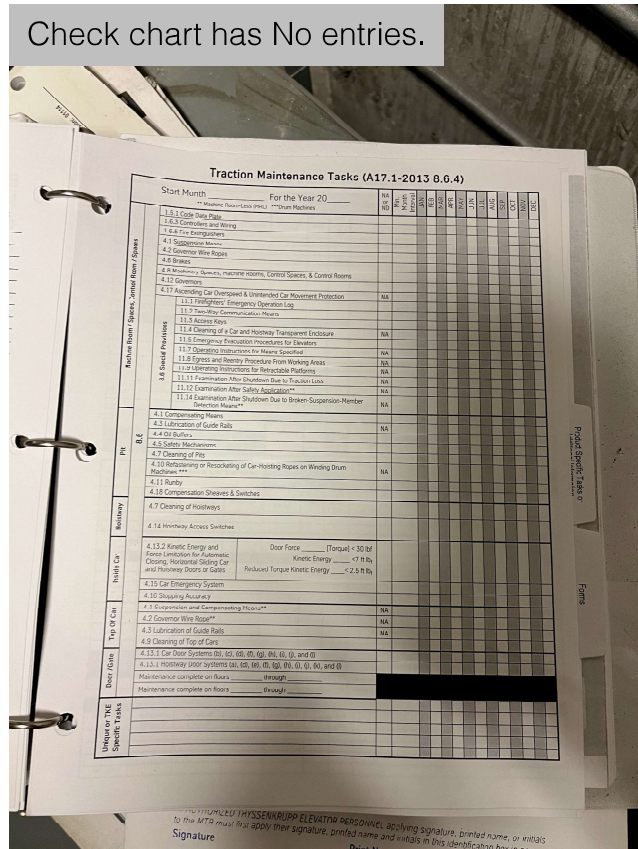
Check chart has No entries.

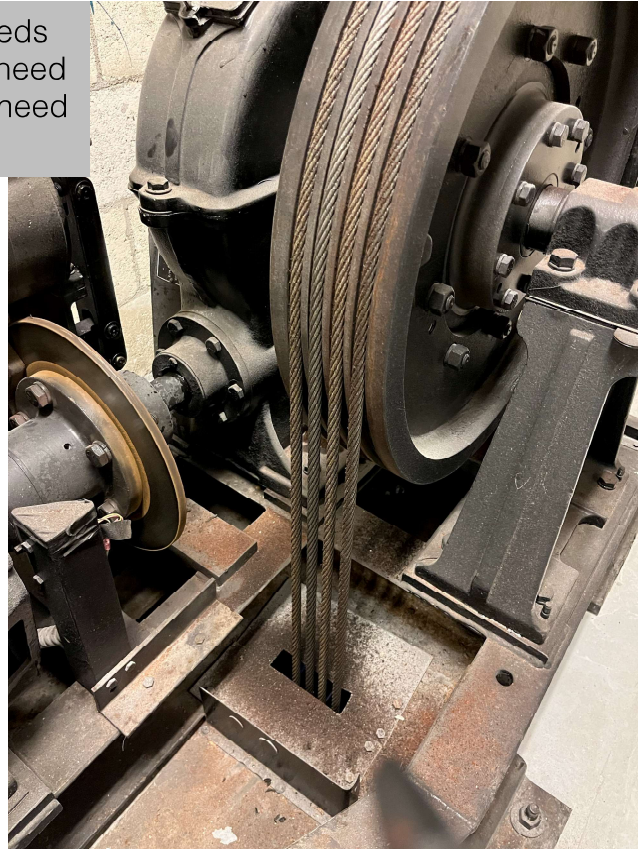
MOTOR ROOM EQUIPMENT
Controller: Clean controller to remove dirt and dust.
Machine: Clean and paint the machine.
Drive Sheave: Appears to have uneven groove wear at this time. Cables need maintenance
Hoist Motor: Appears to be in fair condition at this time
Brake: Ok
Brake Switch: Ok
Hoist Cables: Have some rusting that needs attention. Also, the tensioning needs to be equalized.
Governor: Is in need of cleaning and lubrication.
Governor Cables: Ok
Generator: NA
Main Fuse Disconnect: Appears Ok, needs source location info.
Cab Light Disconnect: Appears Ok, needs source location info.
GFI Electric Outlet: Ok
Smoke Detector: Ok
Machine Room Lighting: Ok
Machine Room Door & Signage: Ok
Machine Room Access: Ok
Machine Room Air Conditioning: New
Hoistway Smoke Hole: None
Notes: 1. Required documents/logs are not properly utilized. Missing entries...

The elevator machine needs cleaning. The hoist ropes need cleaning and the grooves need to be cleaned up.

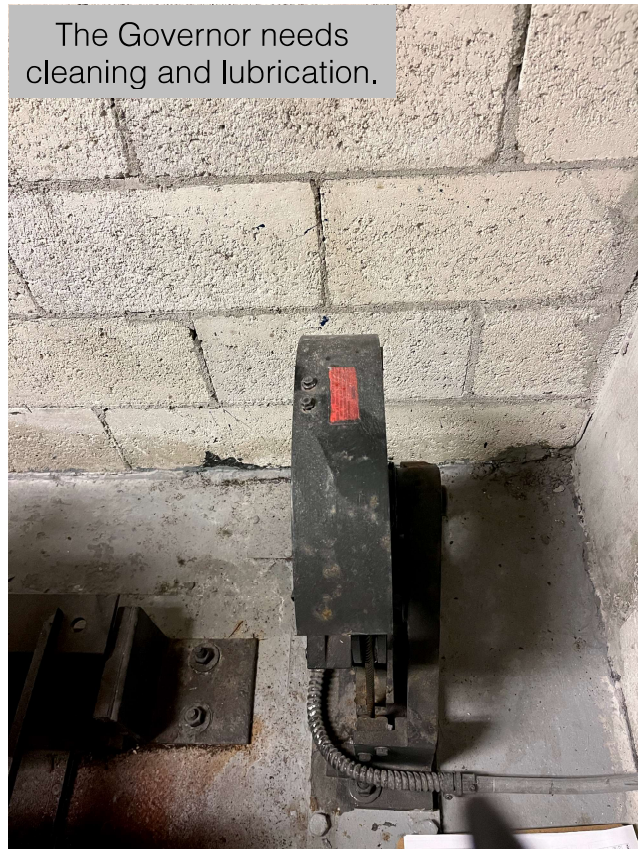
The Governor needs cleaning and lubrication.

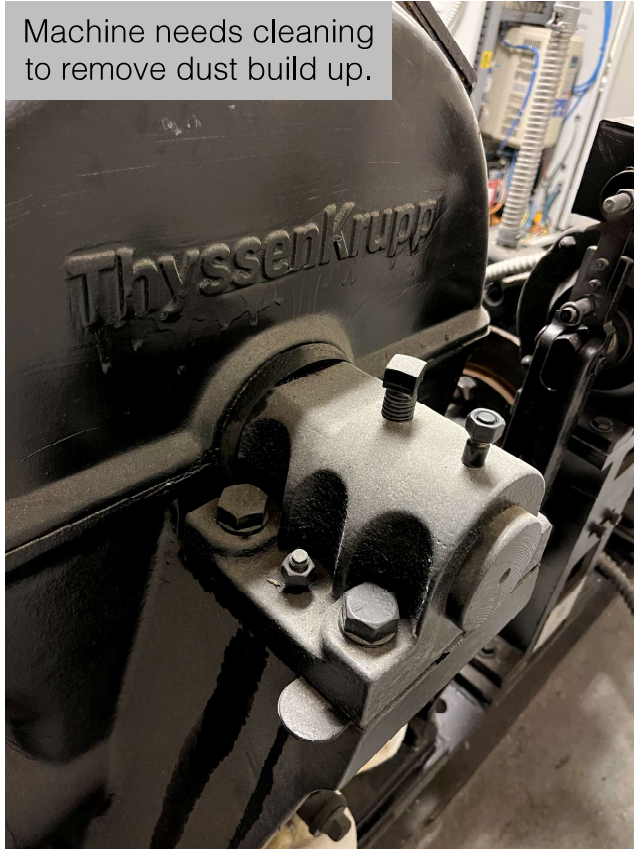
Machine needs cleaning to remove dust build up.

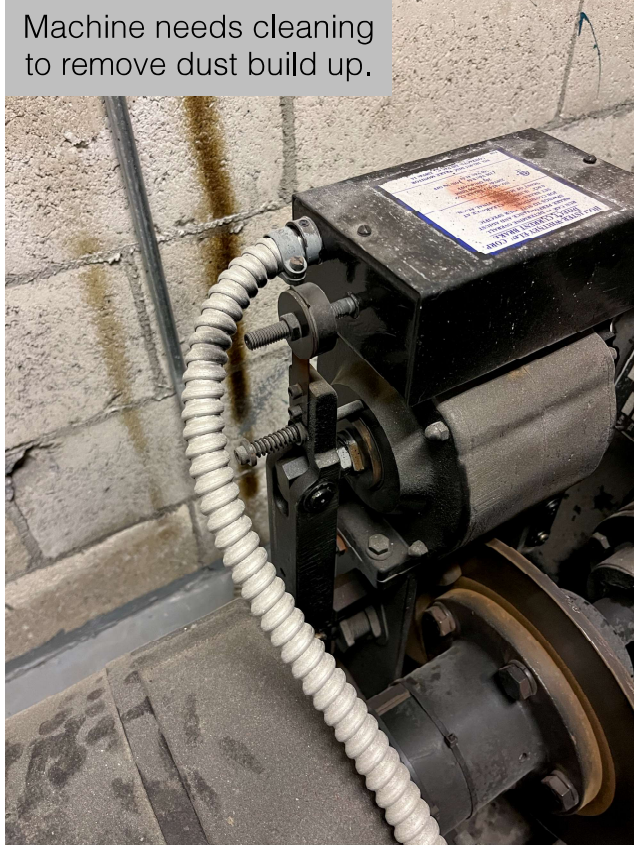
Machine needs cleaning to remove dust build up.

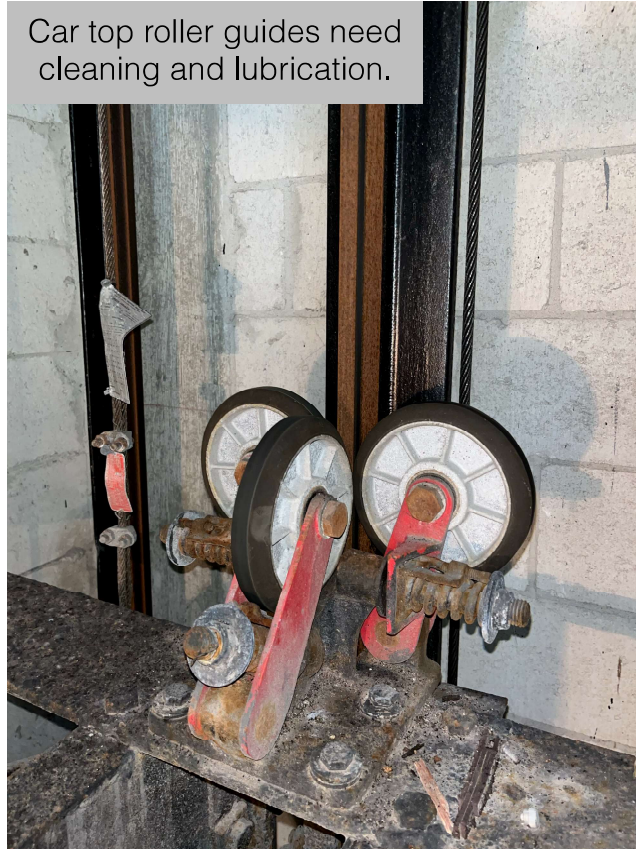
Car Guides: Excessive rusting evident. Clean and lubricate.

Car top roller guides need cleaning and lubrication.

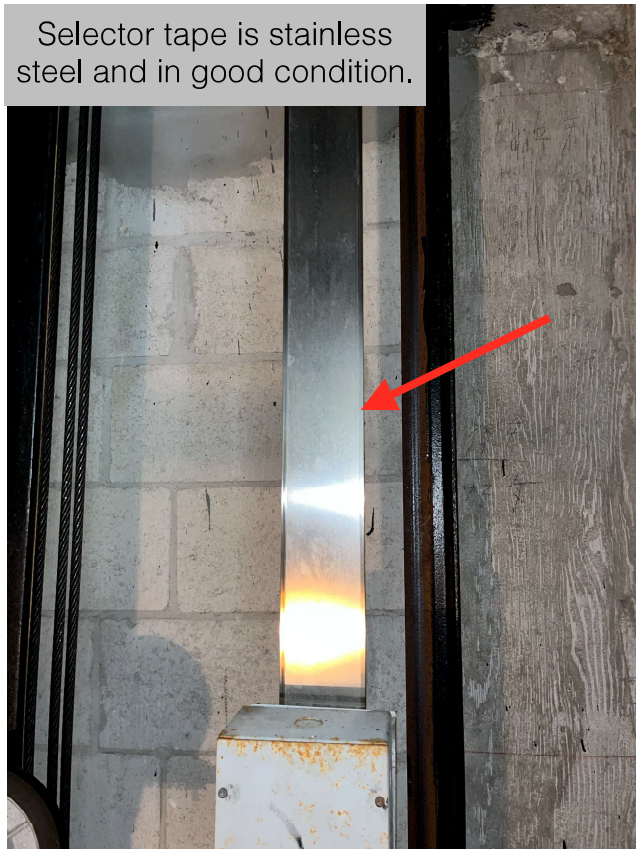
Selector tape is stainless steel and in good condition.

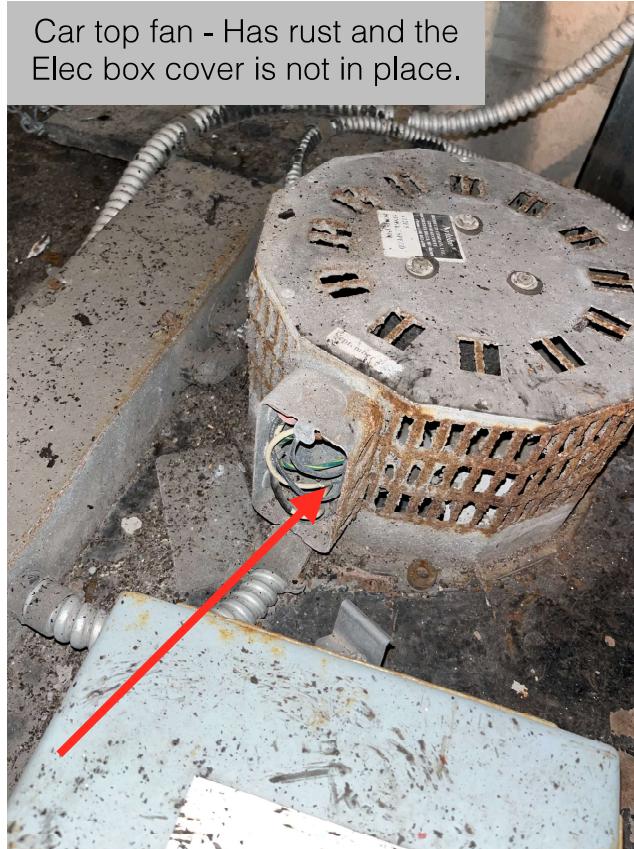
Car Top Fan: In place. Has some rusting. Electrical box is missing cover.

Car top fan - Has rust and the Elec box cover is not in place.

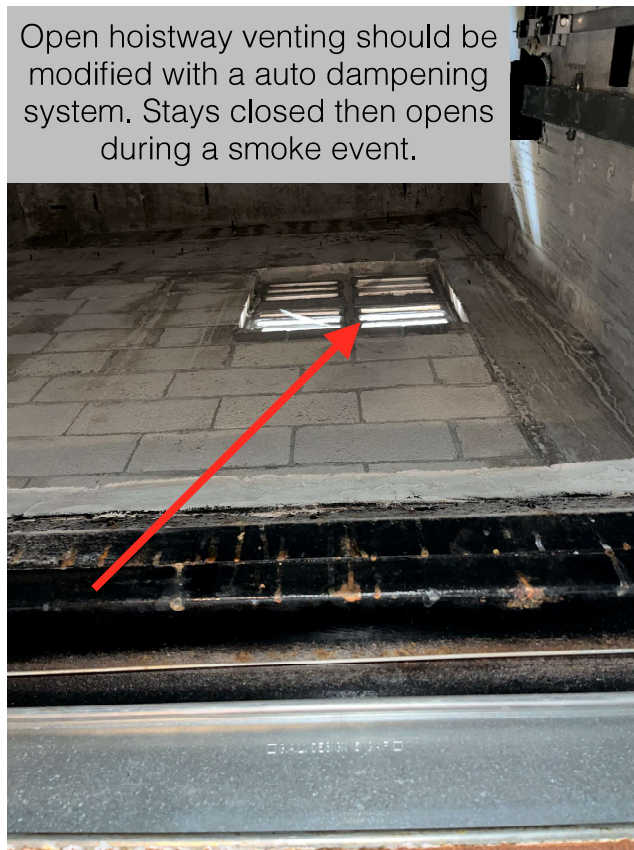
Open hoistway venting should be modified with a auto dampening system. Stays closed then opens during a smoke event.

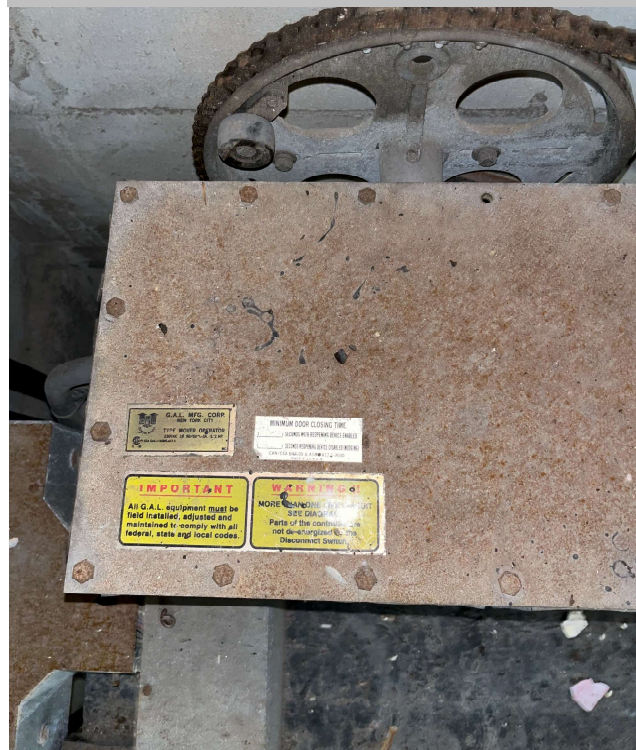
Door Operators: Front - Newer MOVFR - Clean up and lubricate.

This is a GAL water resistant door operator. It needs cleaning and lubrication.

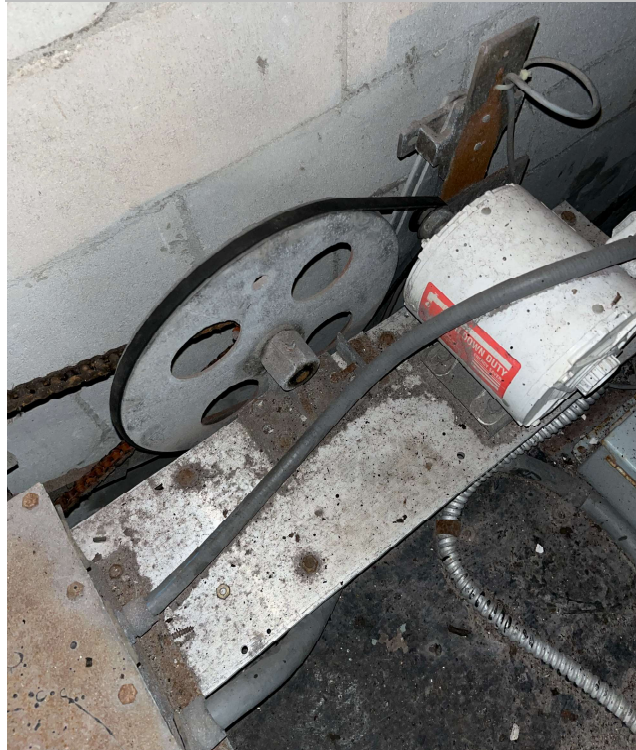
This is a GAL water resistant door operator. It needs cleaning and lubrication.

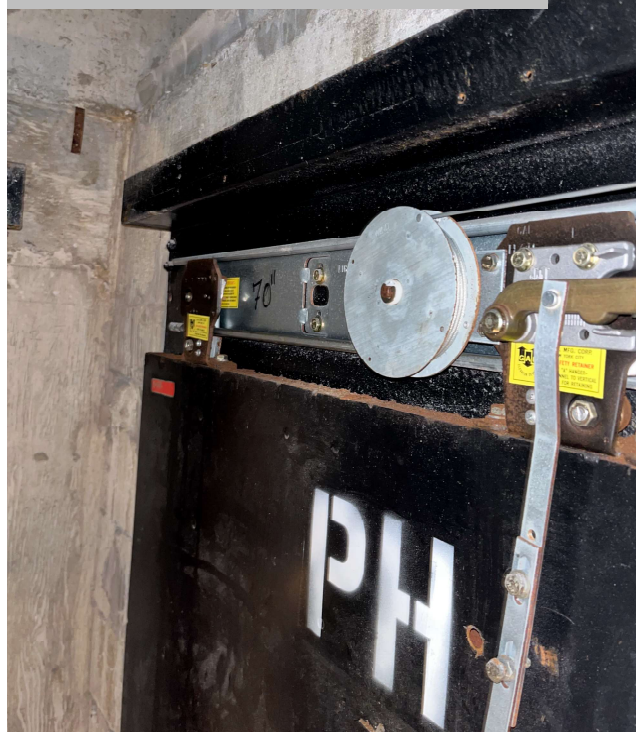
Hoistway door track and hardware needs cleaning and lubrication.

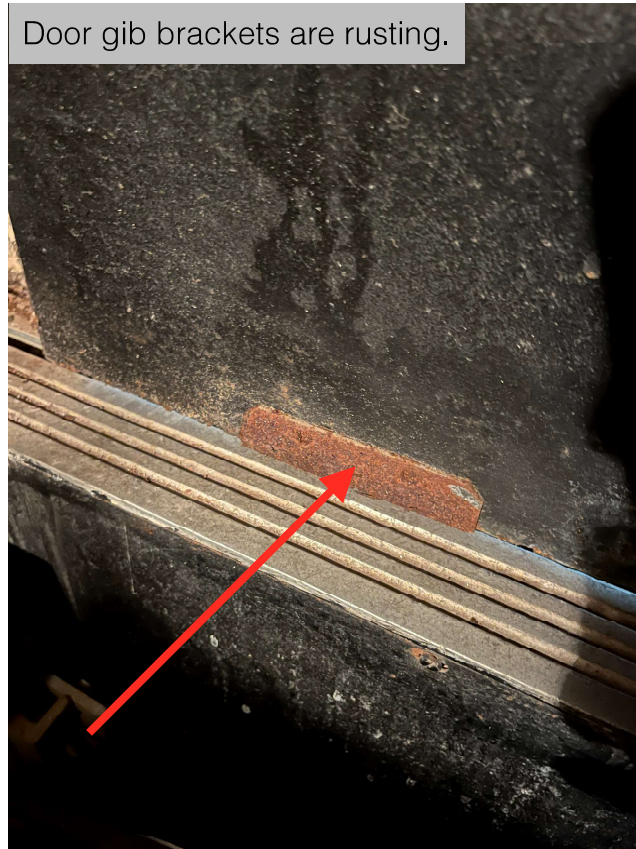
Door Gibs: Gibs are rusty.

Door gib brackets are rusting.

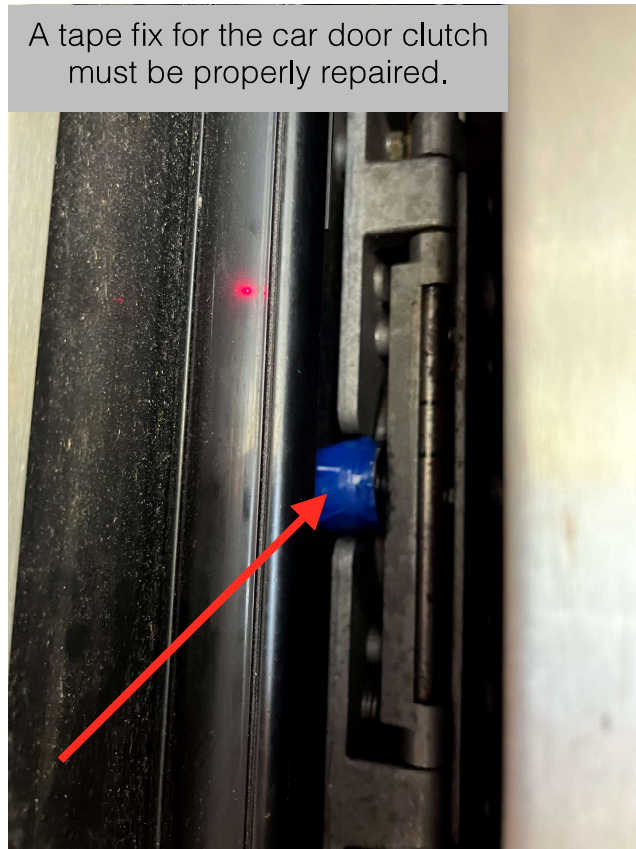
Car Door Clutch: Front - Replace missing nylon cam retracting roller. (A tape repair is unacceptable)

A tape fix for the car door clutch must be properly repaired.

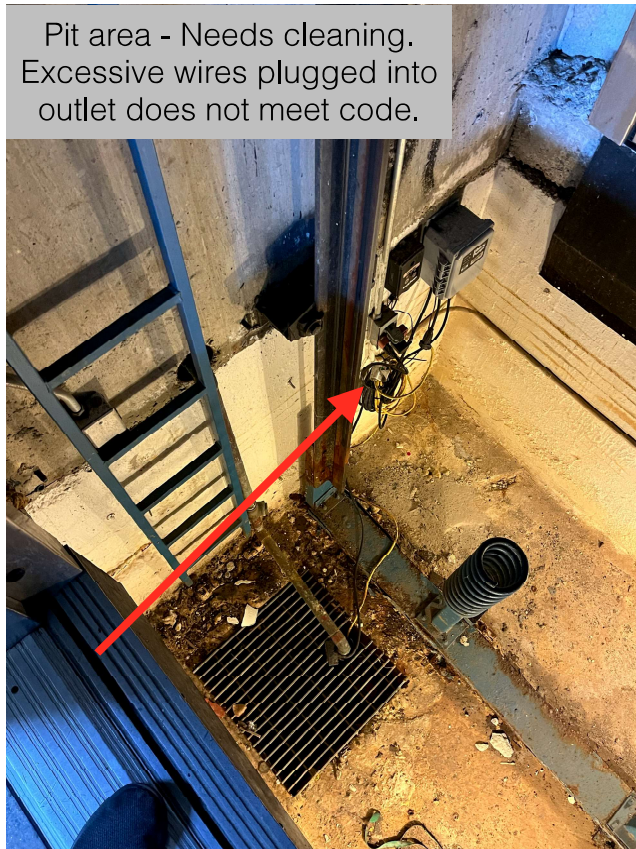
Pit area - Needs cleaning.
Excessive wires plugged into
outlet does not meet code.

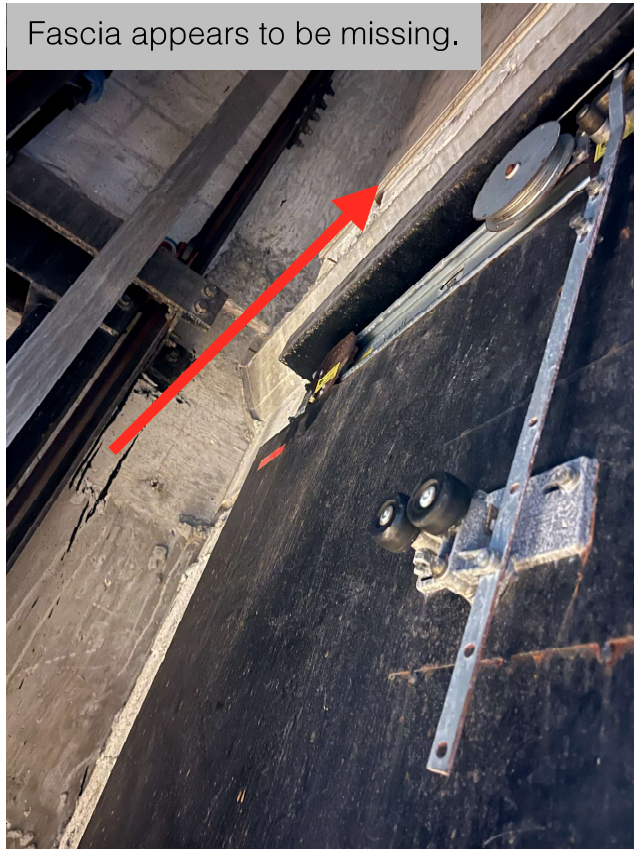
Fascia appears to be missing.

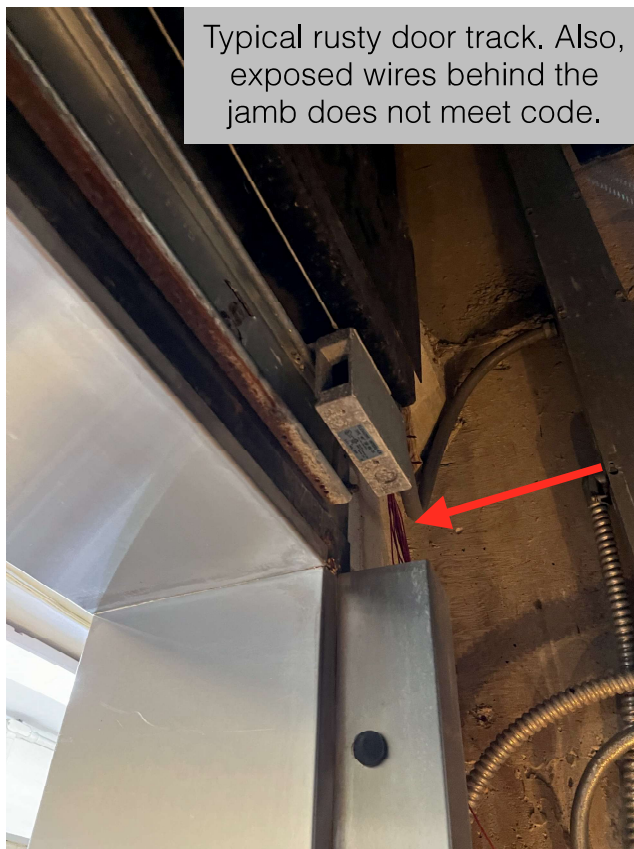
Typical rusty door track. Also, exposed wires behind the jamb does not meet code.

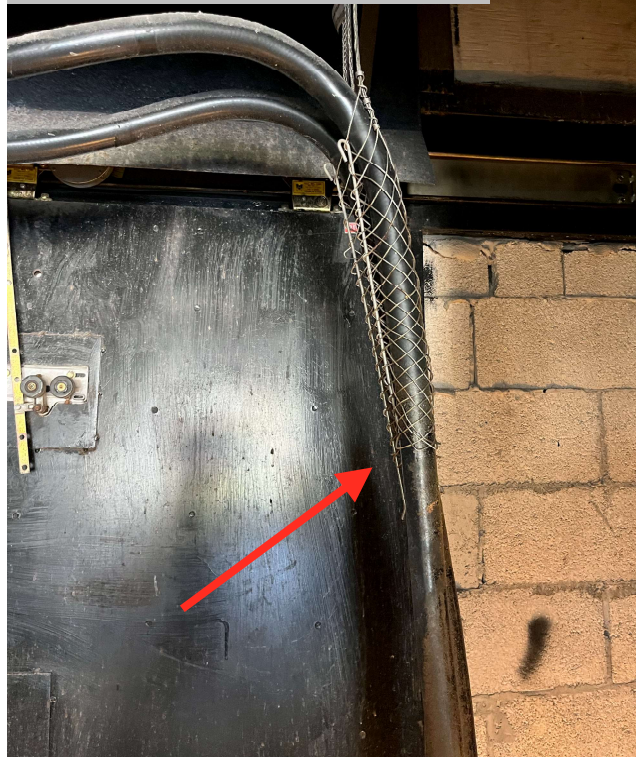
Counter Weights: Counter weights are dirty and need to be cleaned up.
CWT. Guides: Roller noise evident. Replace rollers as necessary.
Compensation Chains: NA
Traveling Cable: Appears ok at this time. No splits or worn spots evident. Tape Kellum grip.
Hoistway Ledges or Projections: NA

Kellum grip needs tape around bottom per manufacture.

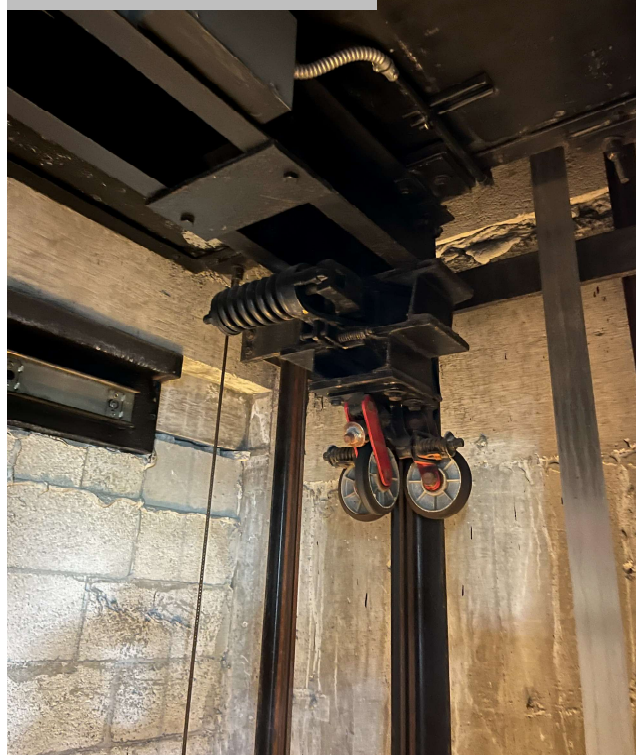
Car safeties appear to be in good condition.
