## Riverside Terrace Condominium

### 40 Year Electrical Recertification SITE INVESTIGATION

**Inspection Commenced**

**September, 2021**

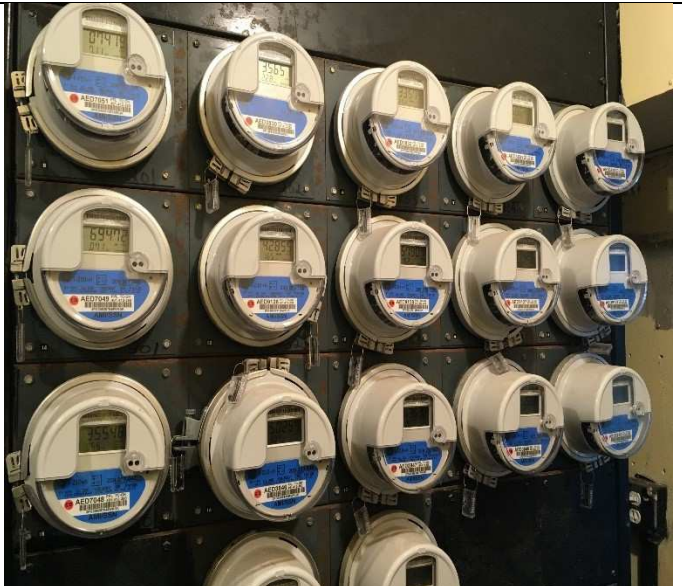
**Photo 1**

Gutters were observed. There was nothing stored in this room. Meters and breakers were marked in sharpie and should be relabeled with a label maker.

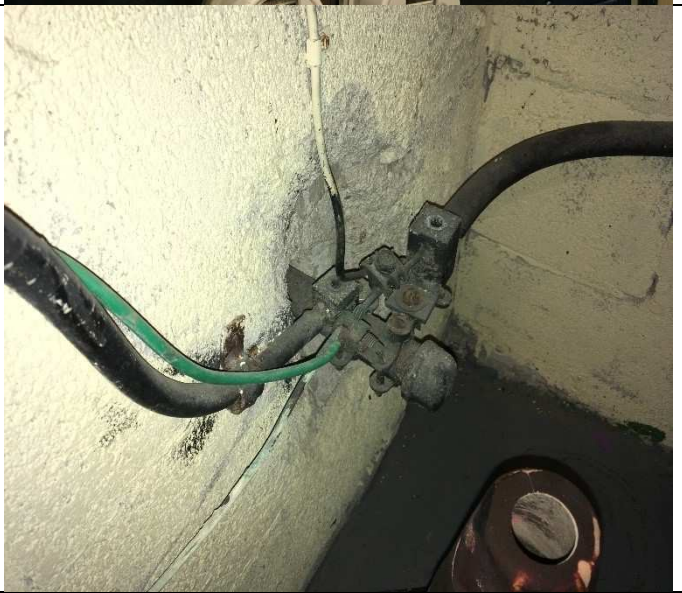
**Photo 2**

Grounding was observed.

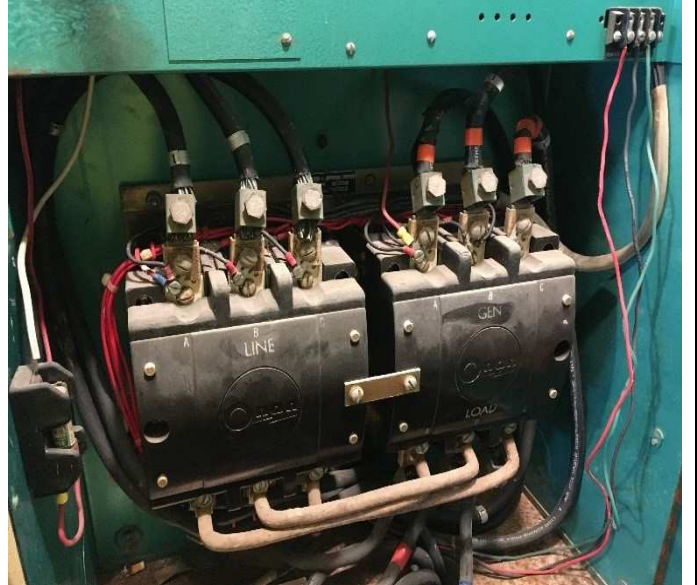
**Photo 3**

The generator switch panel connections were observed.

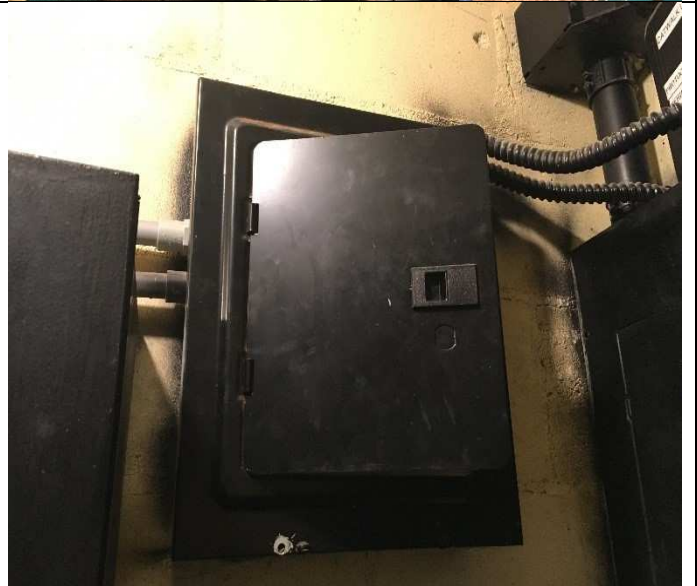
**Photo 4**

The panels were not labeled and should be labeled based on the original electrical drawing's schematic.

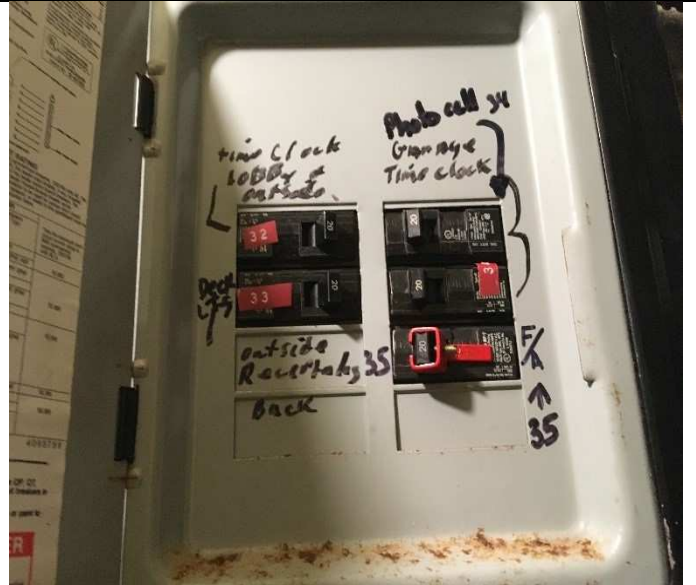
**Photo 5**

Panels were not labeled on the exterior and the interior was poorly labeled with a sharpie. This needs to be relabeled on a separate sheet.

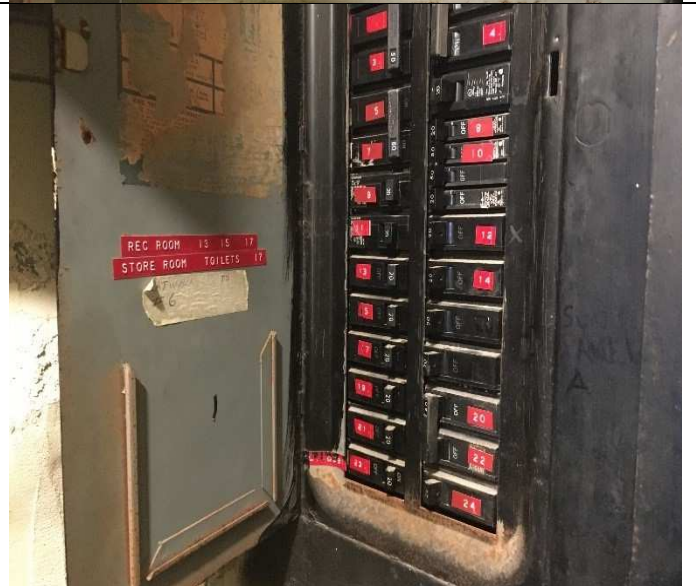
**Photo 6**

Panels were not labeled on the exterior and the interior was poorly labeled with a sharpie. This needs to be relabeled on a separate sheet.

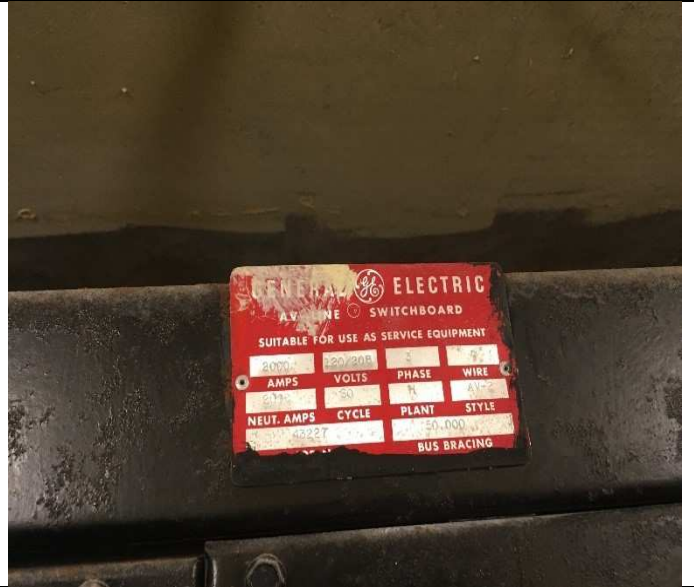
**Photo 7**

The Main service was inspected to and marked 2000 AMPS, 120/208 Volts, 3 Phase, 4 Wire.

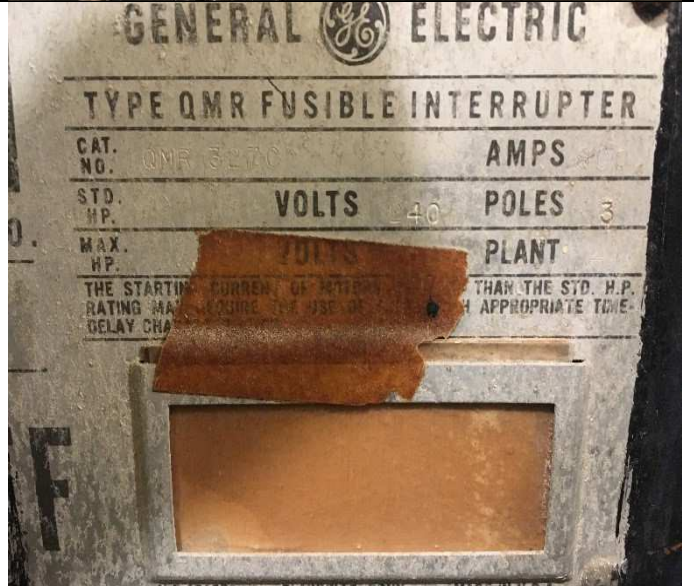
**Photo 8**

Fuses were observed to have 800 AMPS, 240 Volts, 3 Poles

600 AMPS, 240 Volts, 3 Poles

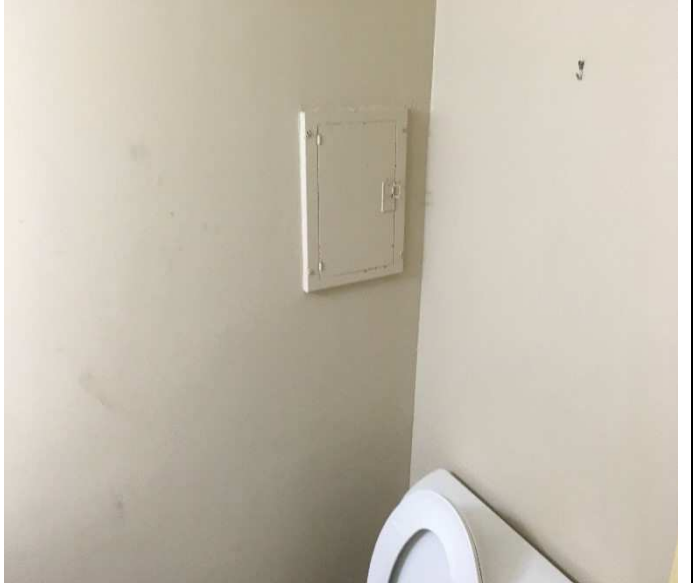
**Photo 9**  
**Location:** 1<sup>st</sup> Floor Recreation Bathroom  
**Comments:**  
The panel for the recreation room was found in the men's restroom. It was not labeled.

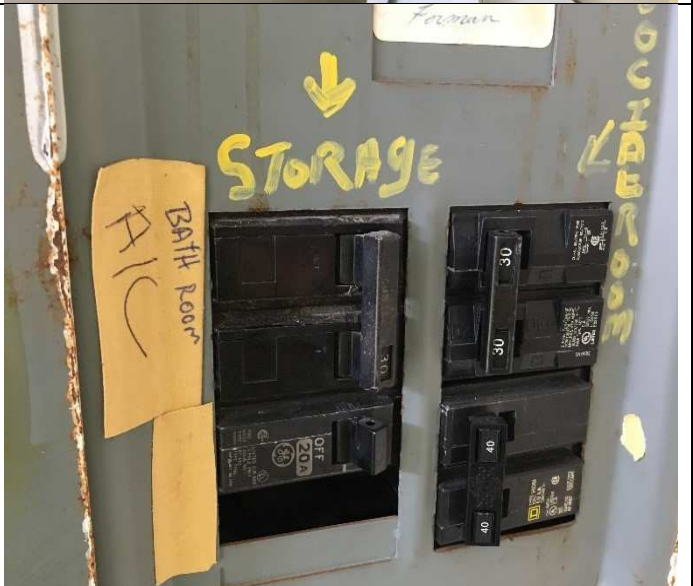
**Photo 10**  
**Location:** 1<sup>st</sup> Floor Recreation Bathroom  
**Comments:**  
The panel in the men's restroom needs to be relabeled and have a switch cover installed.

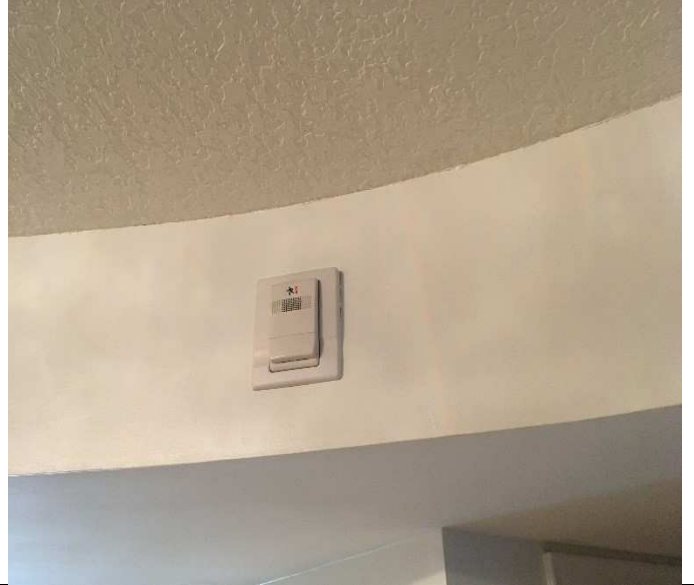
**Photo 11**

Building fire alarm system were observed in each unit visited.

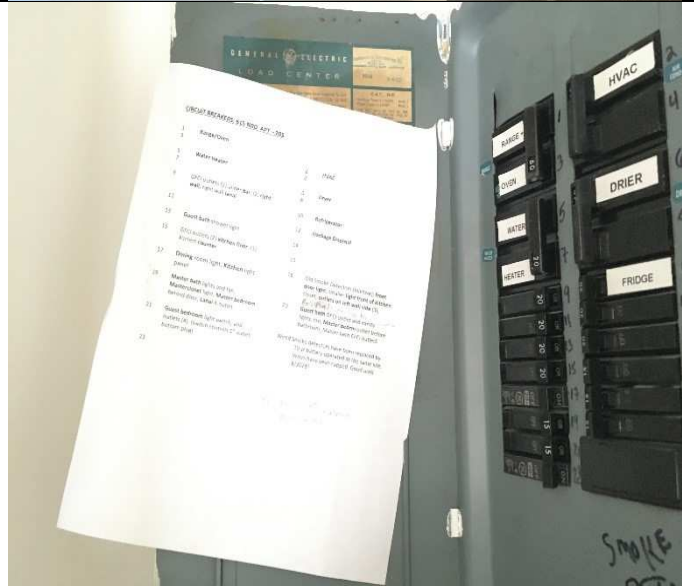
**Photo 12**

The breaker panel needs to have the label properly secured.

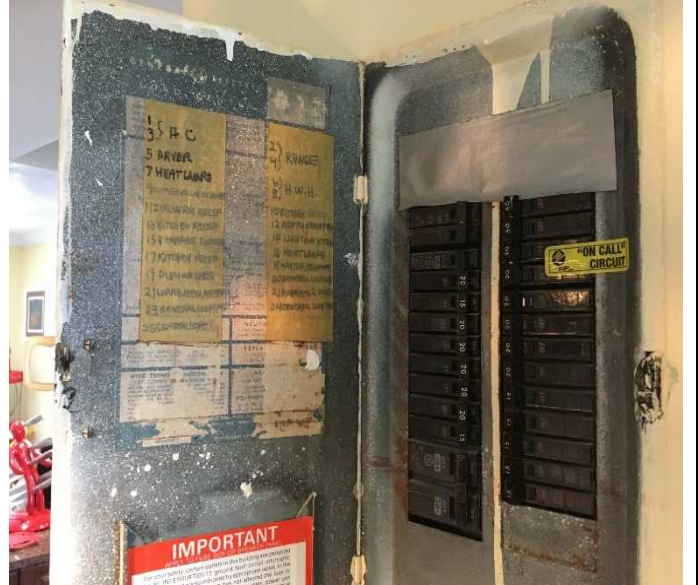
**Photo 13**

The breaker needs to receive proper switch covers and remove the tape.

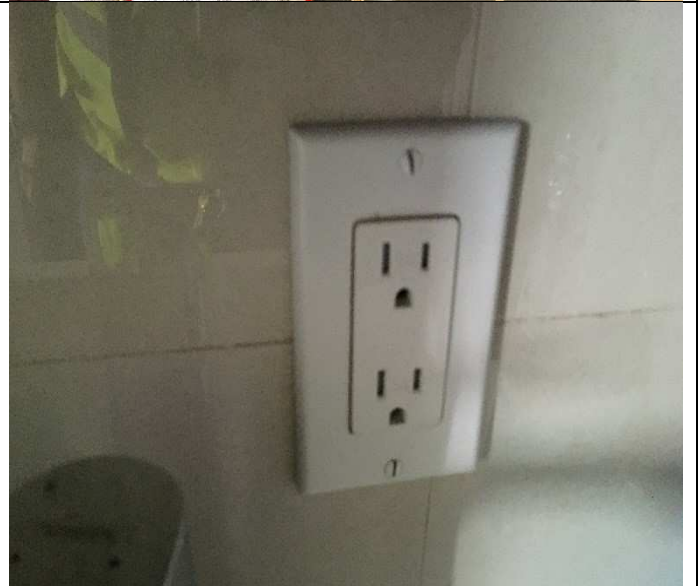
**Photo 14**

The unit did not have a GFI in the kitchen.

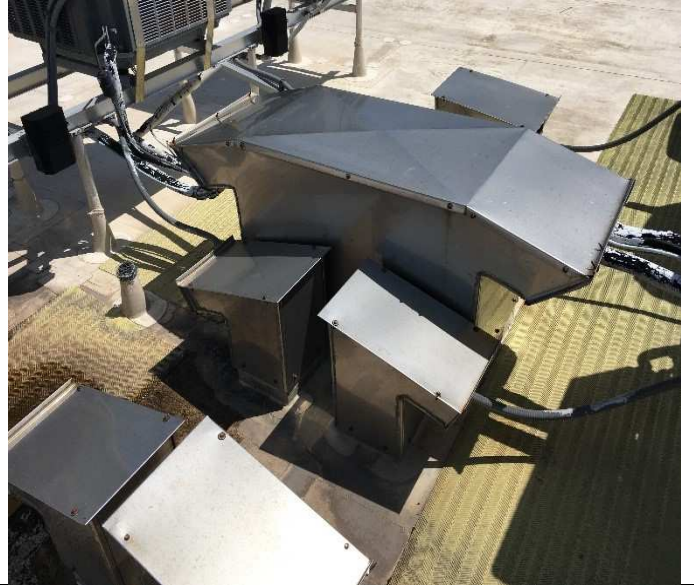
**Photo 15**

The roofing conduits were observed and properly supported.

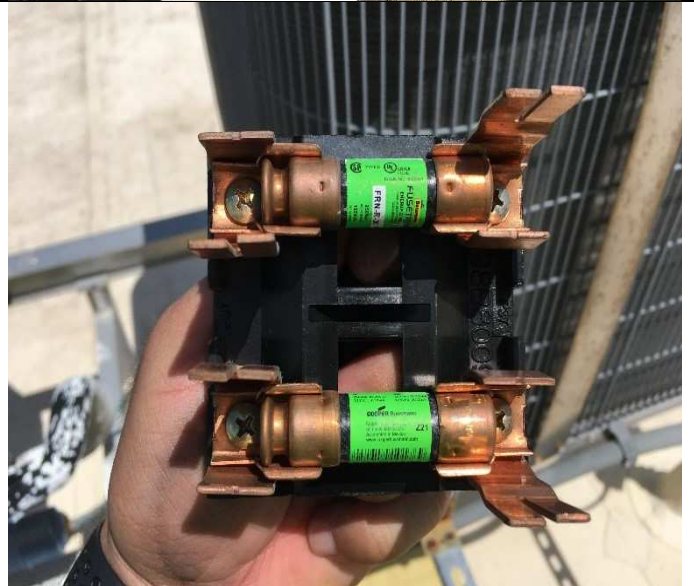
**Photo 16**

The fuses were observed at A/C units.

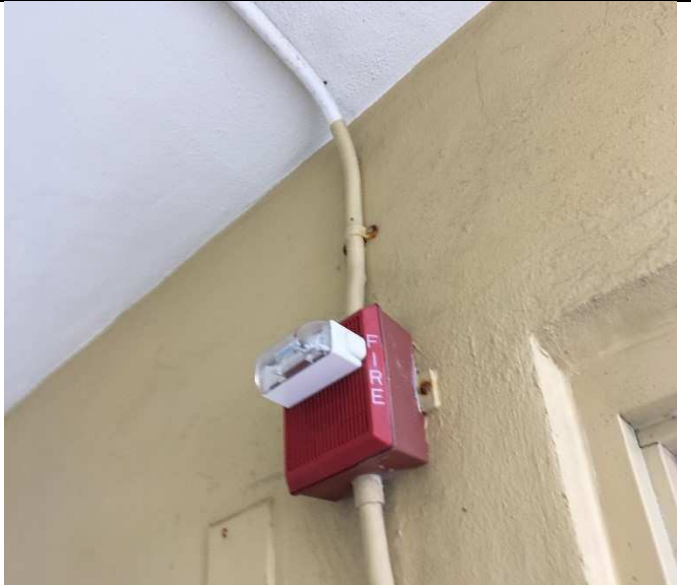
**Photo 17**  
**Location:** Emergency Lighting  
**Comments:**  
The fire alarm system was observed.

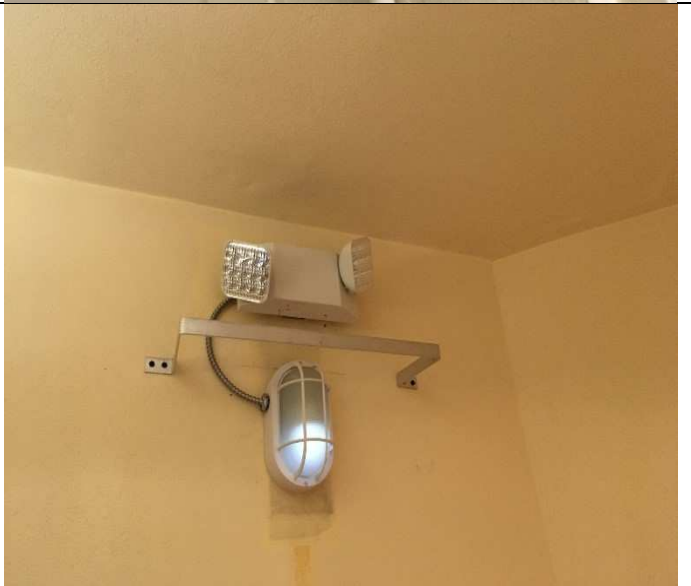
**Photo 18**  
**Location:** Building Egress Illumination  
**Comments:**  
Some stairwell lights needed to be replaced in both stairwells. Emergency lights were seen on every third floor tested before replacing.

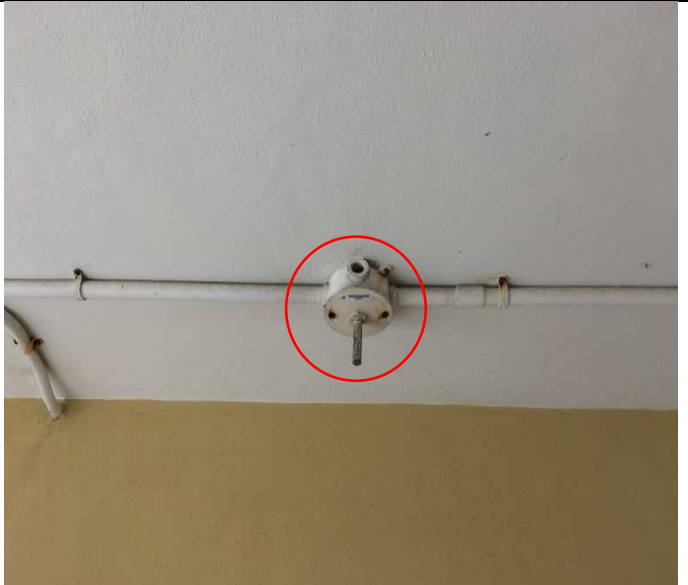
**Photo 19**

Conduit openings in the junction box need to be capped.

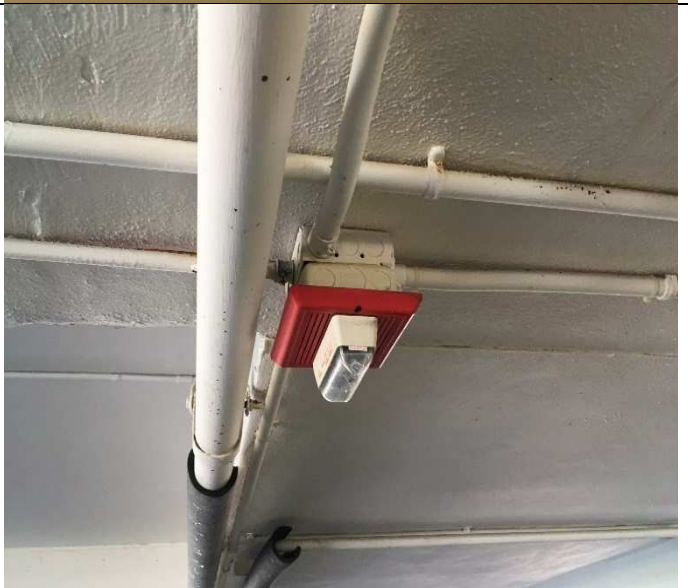
**Photo 20**

Fire alarms was observed at the covered parking area.

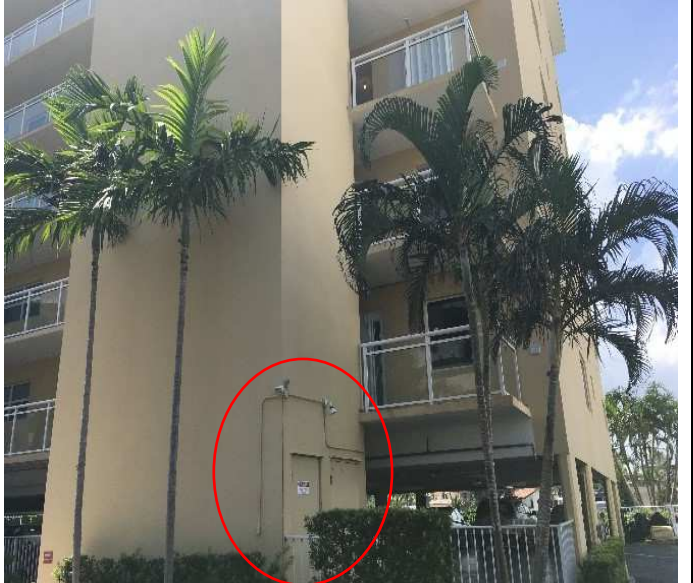
**Photo 21**

Exterior lights were observed at stairwell exits.

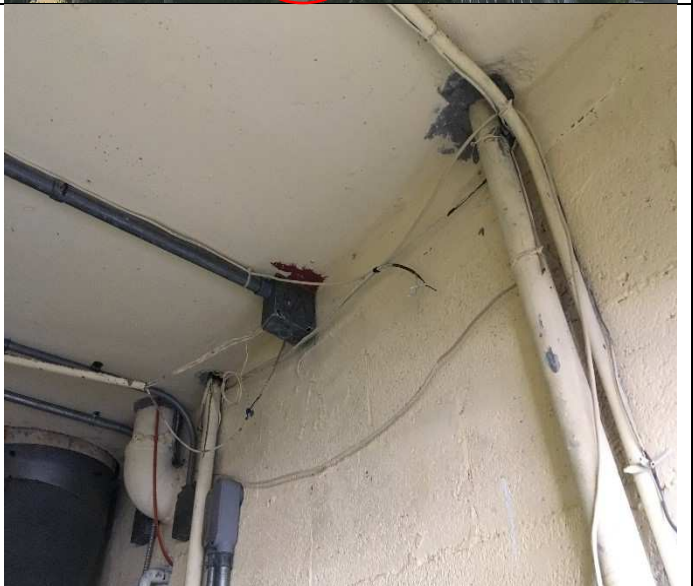
**Photo 22**

Electrical wiring were not properly supported.

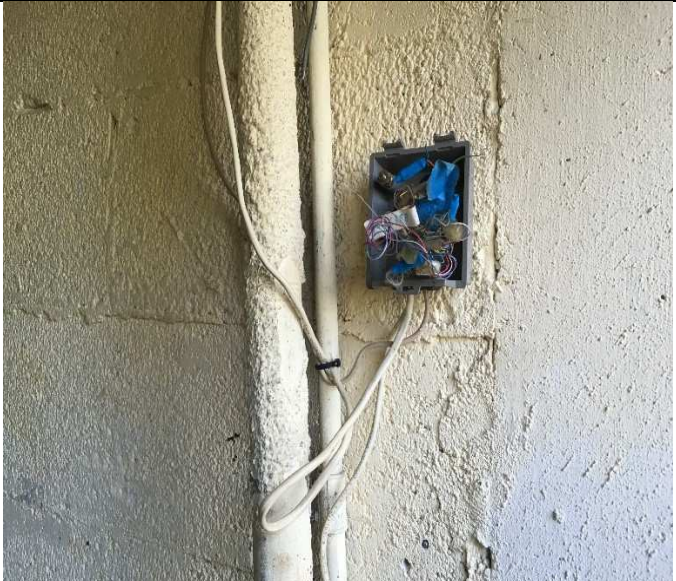
<p><b>Photo 23</b></p> <p><b>Location:</b> Trash Chute Room</p> <p><b>Comments:</b></p> <p>Wiring needs to be properly capped off and a cover needs to be installed at this box.</p>

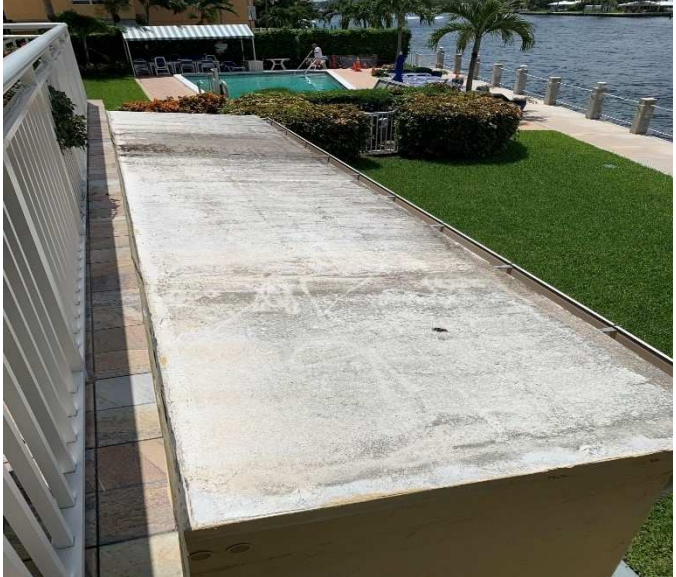
<p><b>Photo 24</b></p> <p><b>Location:</b> Generator Room</p> <p><b>Comments:</b></p> <p>TRC was unable to gain access to the generator room.</p>
