# **Riverside Terrace Condominium**

## **40 Year Structural Recertification**

**Project No. 21FTL323**

**September 10, 2021**

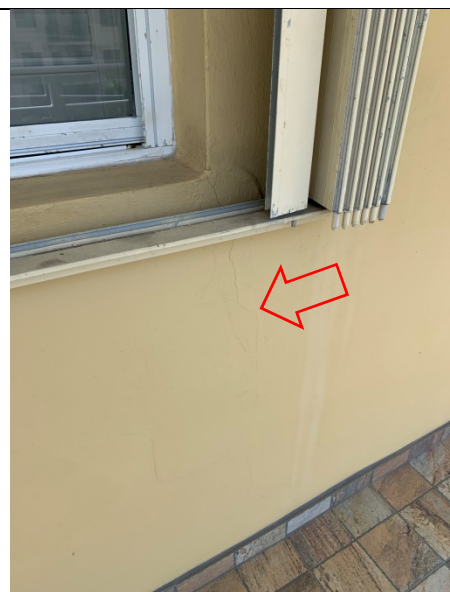
**Photo 1.**  
**Location: Exterior Elevation**  
**Comments:**  
Observed hairline crack in stucco finish.

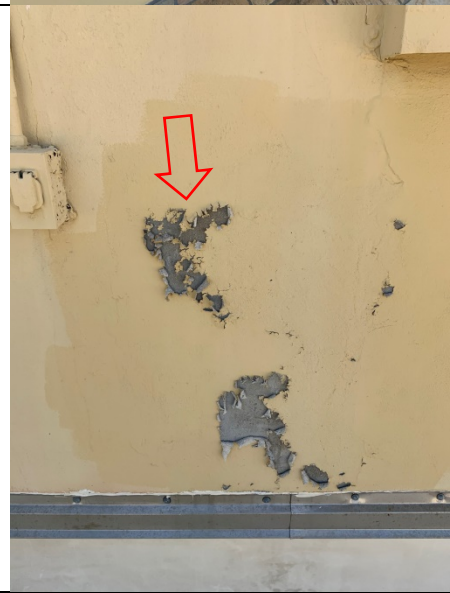
**Photo 2.**  
**Location: Exterior Elevation**  
**Comments:**  
Observed stucco finish deterioration at elevator machine room on roof.

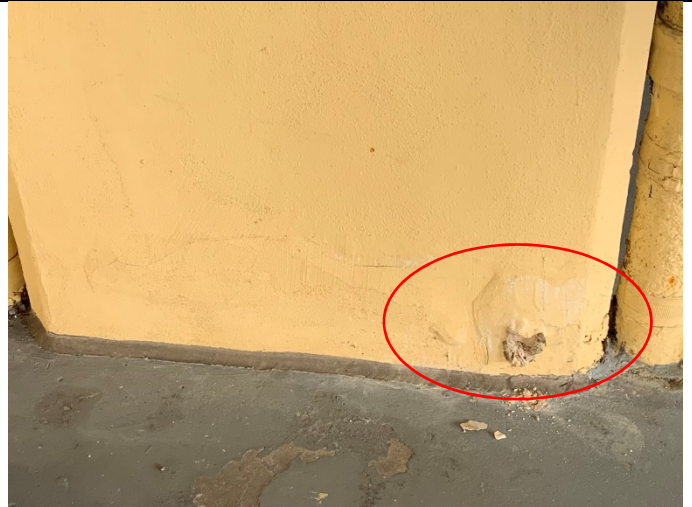
**Photo 3.**

Observed blister in paint underneath at garage column near FPL vault.

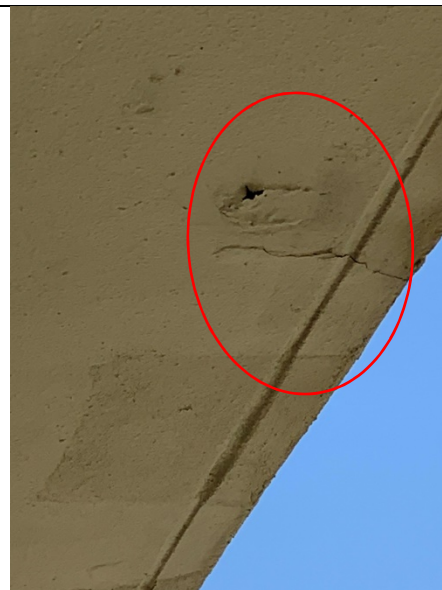
**Photo 4.**

Observed overhead stucco cracking and delamination.

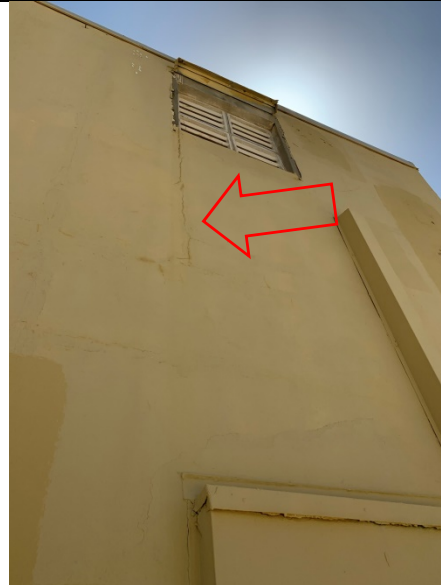
**Photo 5.**

Observed crack and sign of water intrusion in horizontal caulking joint.

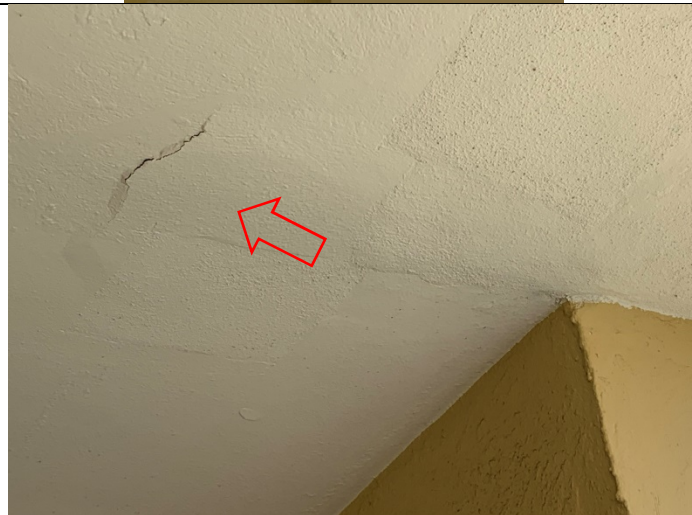
**Photo 6.**

Observed overhead stucco delamination.

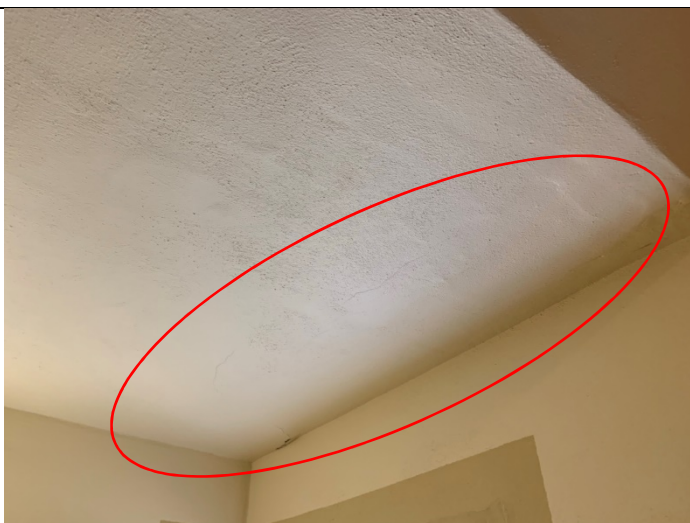
**Photo 7.**

Observed overhead crack in stucco finish and delamination in south stairwell at the 2<sup>nd</sup> floor.

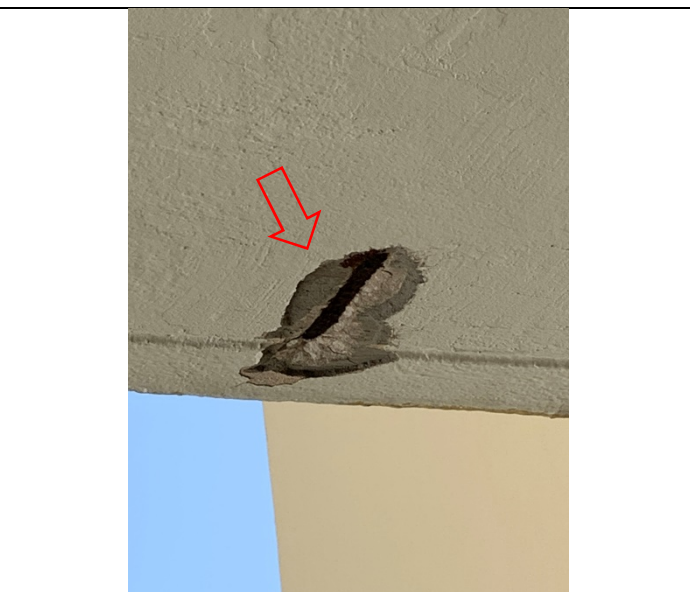
**Photo 8.**

Observed concrete spalling/cracking with exposed rebar at the underside of the 7<sup>th</sup> level slab.

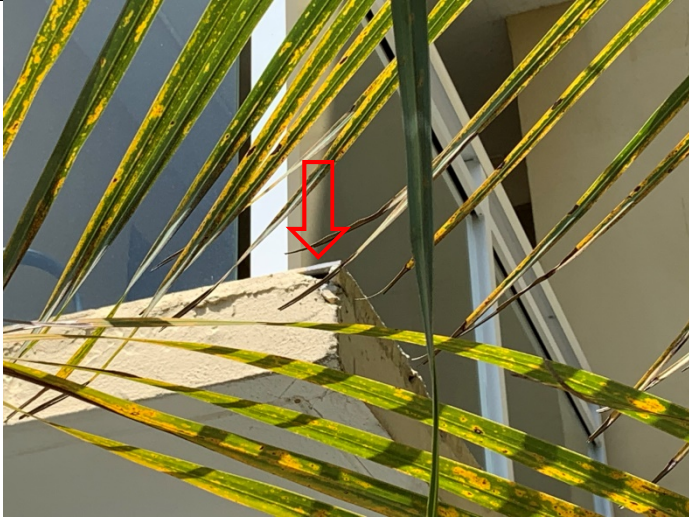
<p><b>Photo 9.</b></p> <p><b>Location: Planter</b></p> <p><b>Comments:</b></p> <p>Observed concrete spalling at south corner of the 2<sup>nd</sup> floor exterior walkway.</p>

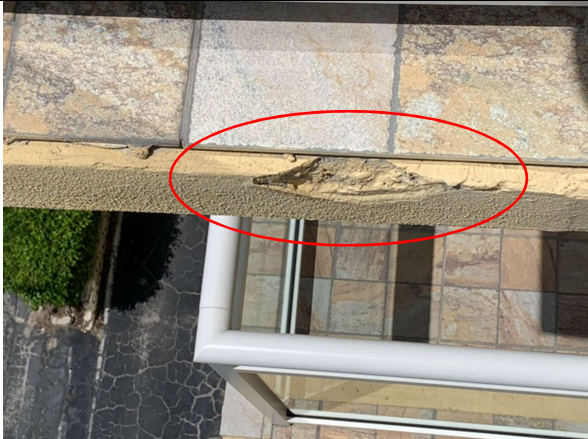
<p><b>Photo 10.</b></p> <p><b>Location: Walkway Slab</b></p> <p><b>Comments:</b></p> <p>Observed some concrete spall at the edge of the exterior walkway slab.</p>

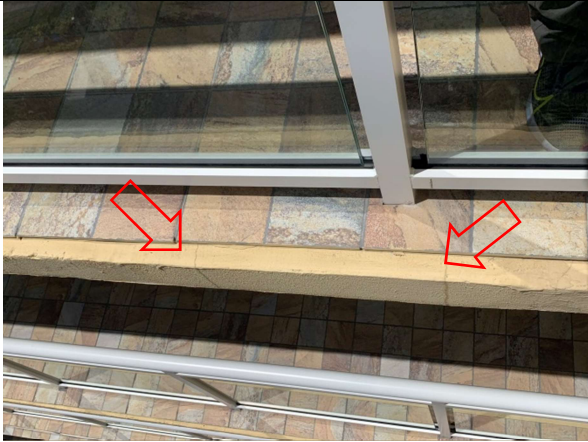
<p><b>Photo 11.</b></p> <p><b>Location: Walkway Slab</b></p> <p><b>Comments:</b></p> <p>Observed vertical cracks in exterior walkway slab edges.</p>

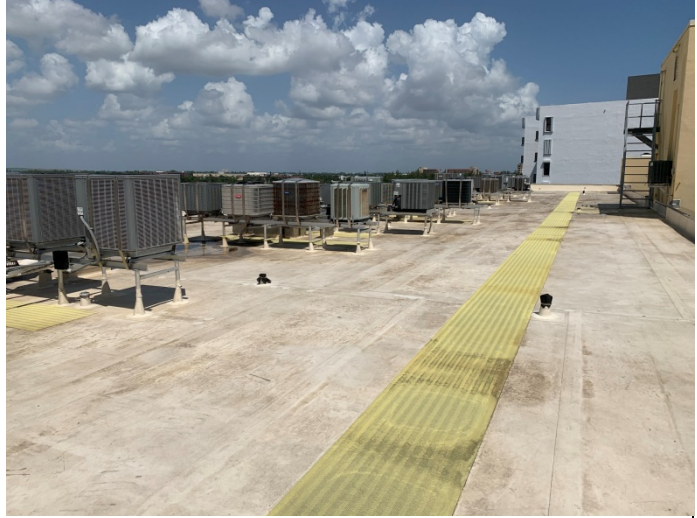
**Photo 12.**

Observed flat TPO roofing system in fair condition.

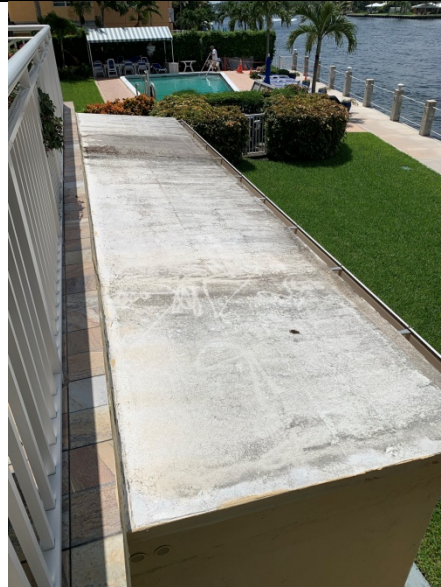
**Photo 13.**

Observed lower modified bitumen roof over pool restrooms.

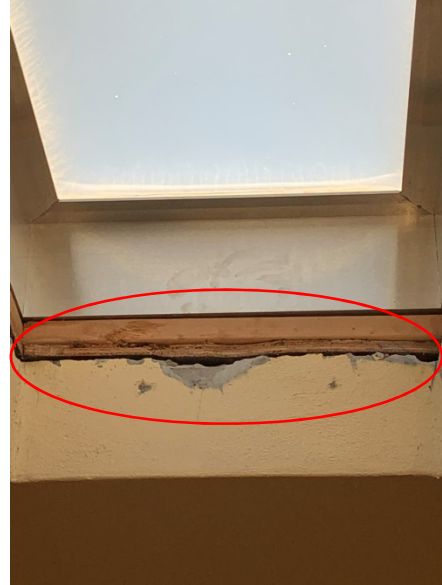
**Photo 14.**

Observed concrete spalling at stair tower skylights near roof access.

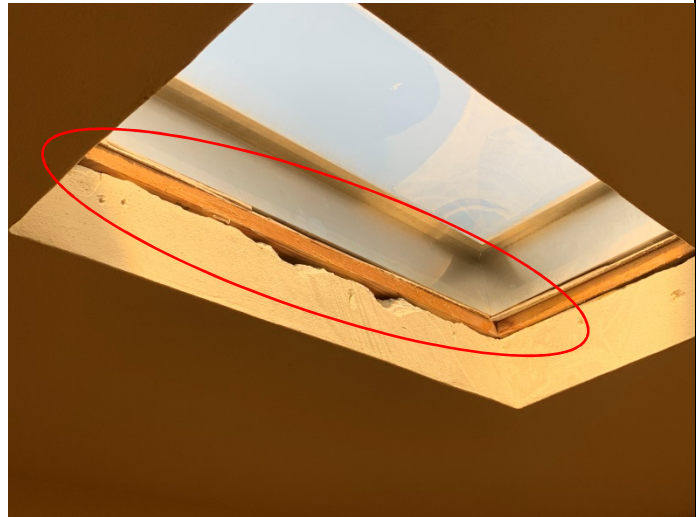
**Photo 15.**

Observed concrete spalling at stair tower skylights near roof access.

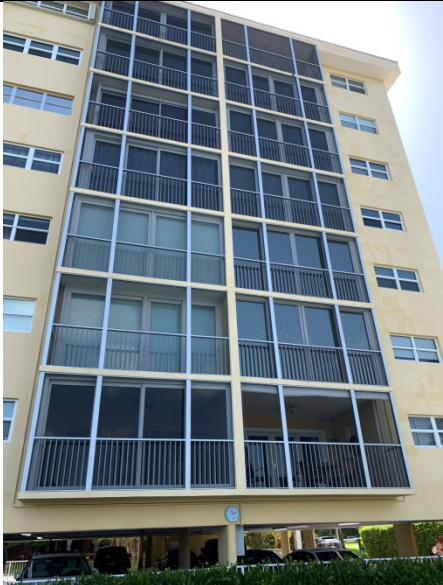
<p><b>Photo 16.</b></p> <p><b>Location: Windows</b></p> <p><b>Comments:</b></p> <p>Observed double hung windows and sliding glass doors in good condition.</p>

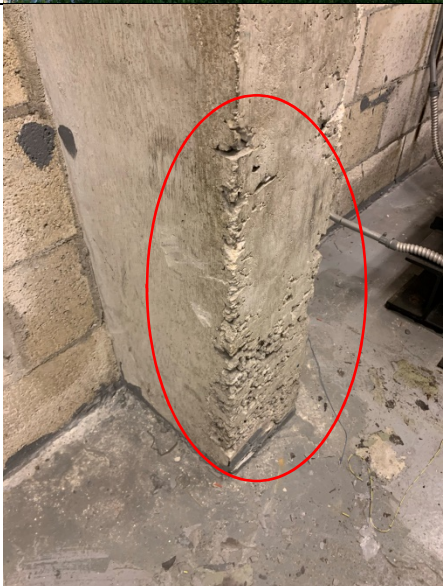
A photograph showing the exterior of a multi-story residential or commercial building. The building has a light-colored facade and features a grid of balconies with glass railings. The windows are double-hung, and some ground-floor units have sliding glass doors. The sky is clear and blue.
<p><b>Photo 17.</b></p> <p><b>Location: Elevator Machine Room</b></p> <p><b>Comments:</b></p> <p>Observed concrete honeycombing in elevator machine room column.</p>

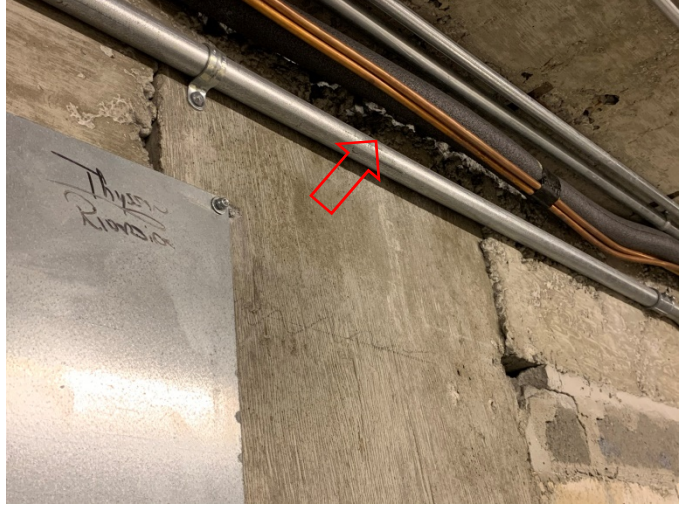
**Photo 18.**

Observed concrete honeycombing in elevator machine room tie beam.

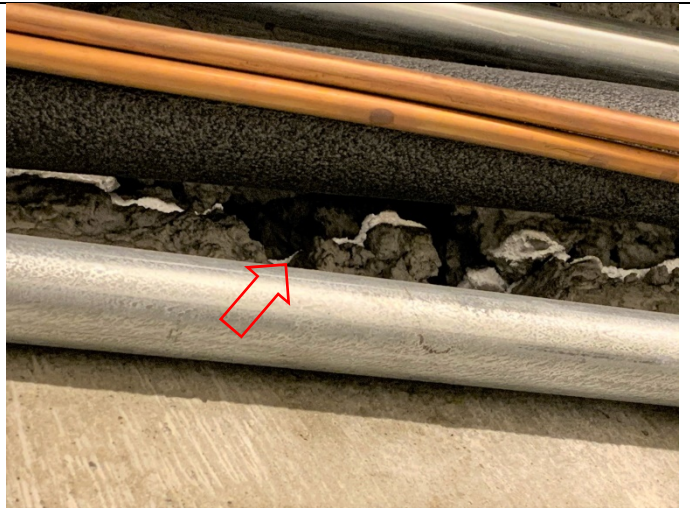
**Photo 19.**

Observed concrete honeycombing in elevator machine room tie beam.

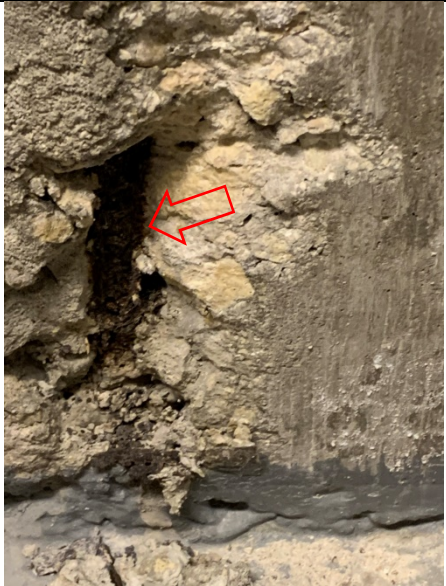
<p><b>Photo 20.</b></p> <p><b>Location: Elevator Machine Room</b></p> <p><b>Comments:</b></p> <p>Observed concrete honeycombing in elevator machine room with exposed rebar.</p>

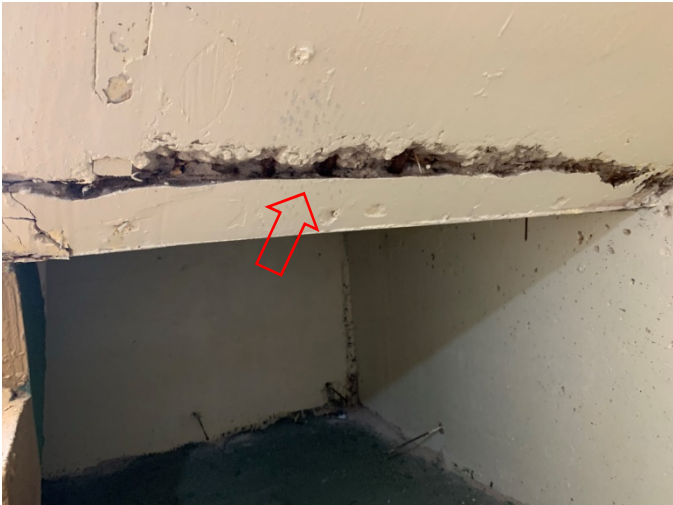
<p><b>Photo 21.</b></p> <p><b>Location: Pump Room</b></p> <p><b>Comments:</b></p> <p>Observed concrete spalling with exposed rebar in the pump room.</p>

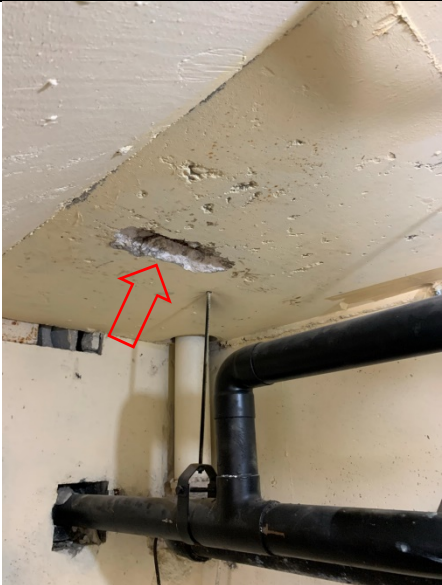
<p><b>Photo 22.</b></p> <p><b>Location: Pump Room</b></p> <p><b>Comments:</b></p> <p>Observed concrete spalling with exposed rebar in the pump room.</p>

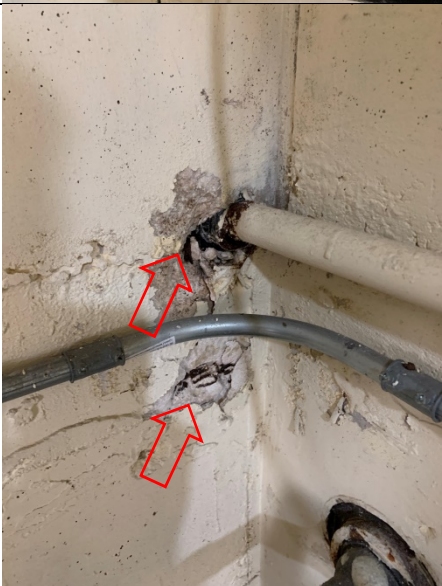
A photograph showing a section of a concrete ceiling in a pump room. There is a significant area of concrete spalling, with a red arrow pointing to the exposed rebar. Black pipes are visible in the foreground, and a white pipe runs vertically in the background.
<p><b>Photo 23.</b></p> <p><b>Location: Pump Room</b></p> <p><b>Comments:</b></p> <p>Observed concrete spalling with exposed rebar in the pump room.</p>

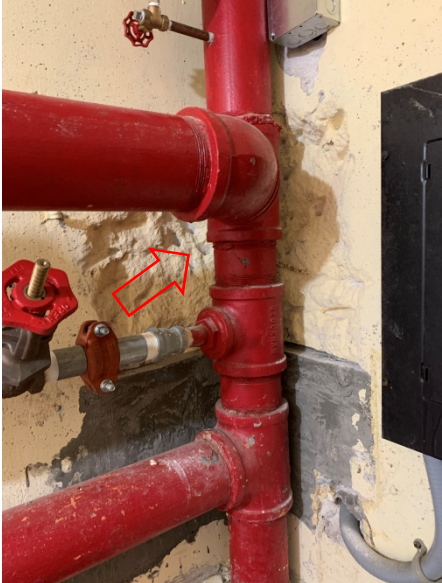
<p><b>Photo 24.</b></p> <p><b>Location: Fire Pump Room</b></p> <p><b>Comments:</b></p> <p>Observed concrete spalling with exposed rebar in the pump room.</p>

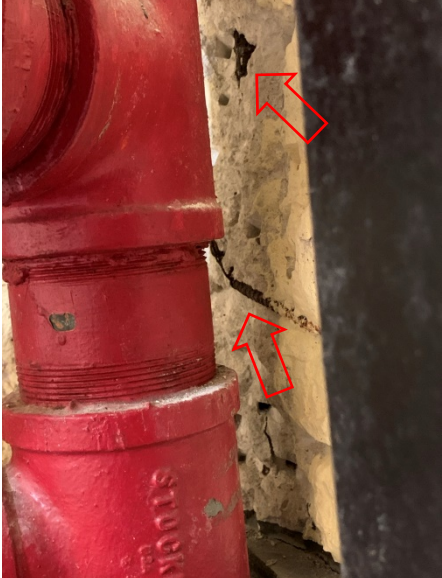
A photograph showing red fire pump pipes and valves against a wall. The wall has significant concrete spalling, with exposed rebar. A red arrow points to the damaged area.
<p><b>Photo 25.</b></p> <p><b>Location: Fire Pump Room</b></p> <p><b>Comments:</b></p> <p>Observed concrete spalling with exposed rebar in the pump room.</p>
