December 2<sup>nd</sup>, 2024

Re: Riverside Terrace Condominium  
Structural Integrity Reserve Study (SIRS)  
615 North Riverside Drive  
Pompano Beach, Florida 33062  
UES Project No: 6011.2300167.0000

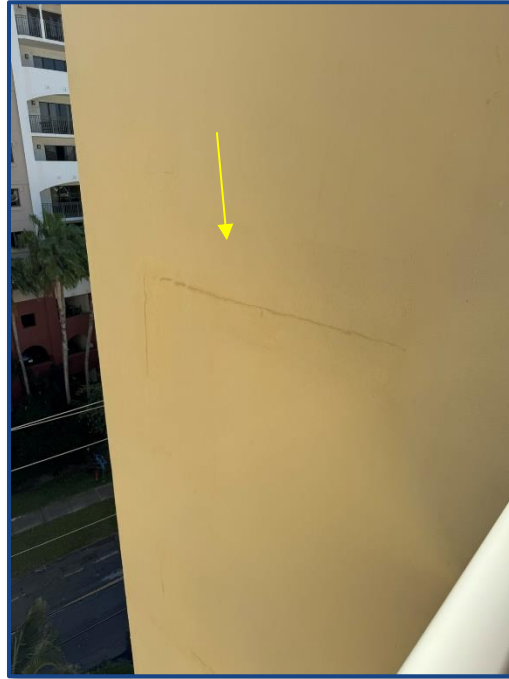
Photograph No. 23: Wall cracking observed at South stair tower 7<sup>th</sup> floor.

- UES recommends the repair of all spalled and cracked areas observed at the walkways, parking garages, and unit balconies. UES recommends the retention of a licensed engineer to prepare specifications/drawings for the repairs required in all areas. Once permits are obtained, a licensed engineer shall be responsible for ensuring that all repairs are done as per the permitted specifications/drawings.
- UES recommends the repair of all damaged roof systems per manufacturer's recommendations. Recoating of the fibered aluminum coating system is to be performed at cracked sections of the roof as required.

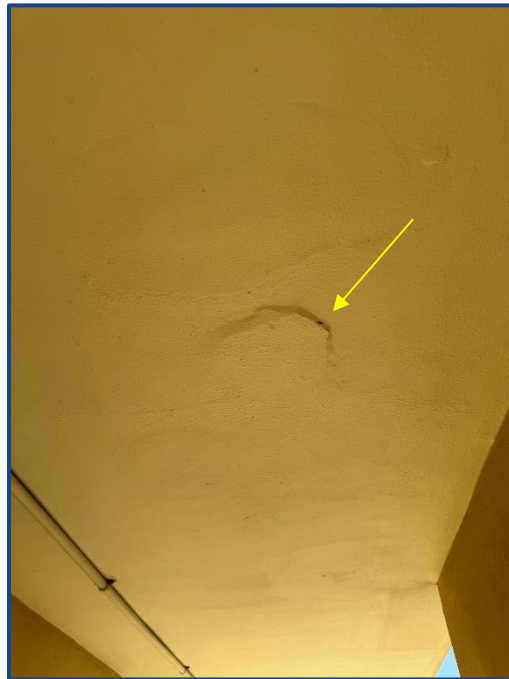
Photograph No. 24: Overhead spalling observed near unit 701.

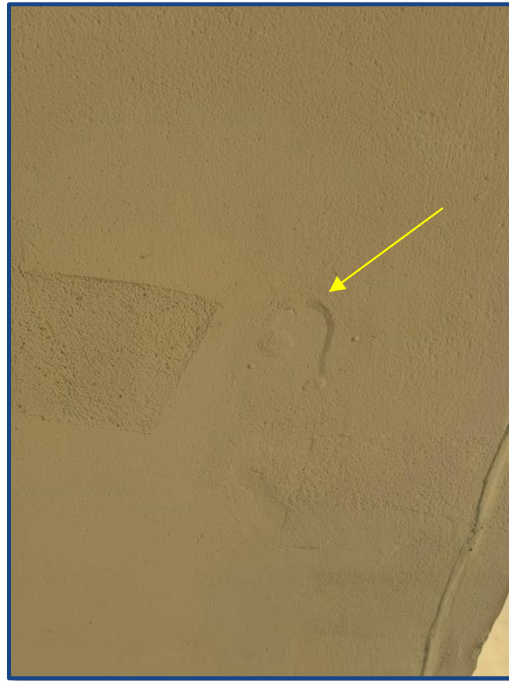
Photograph No. 25: Overhead cracking observed near unit 705.

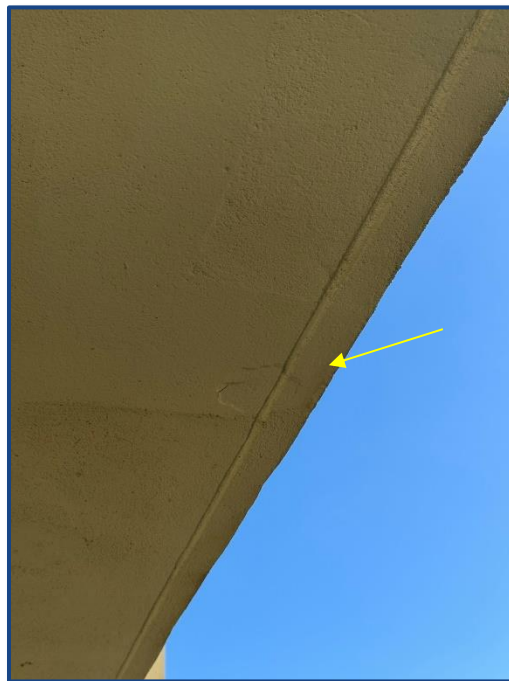
Photograph No. 26: Overhead cracking observed near unit 604.

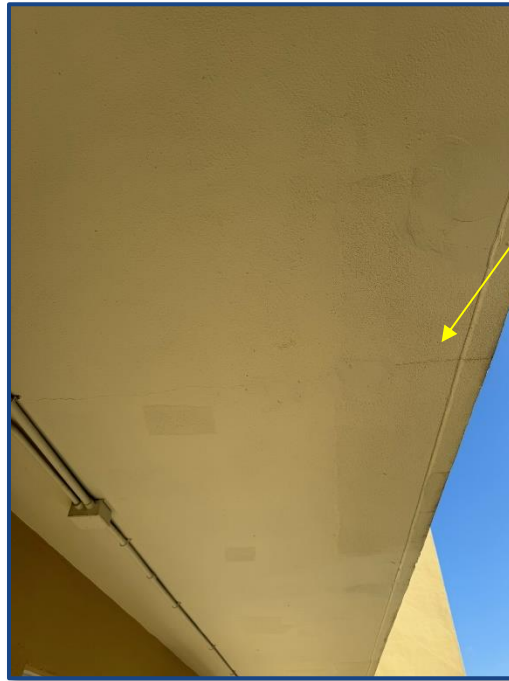
Photograph No. 27: Overhead cracking observed near unit 502.

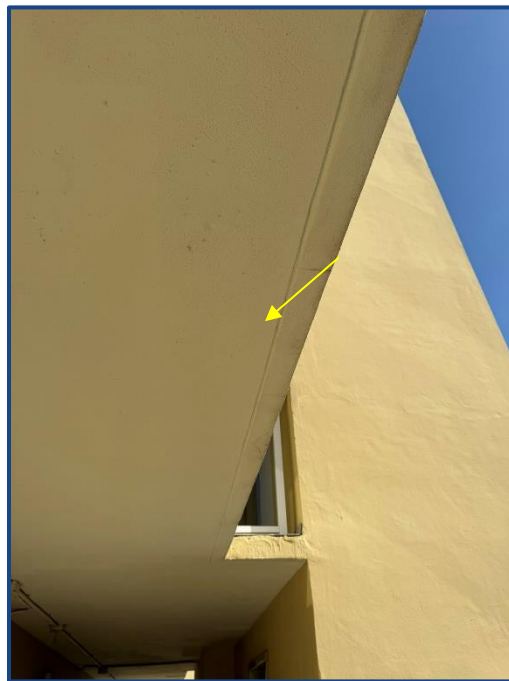
Photograph No. 28: Overhead cracking observed near unit 403.

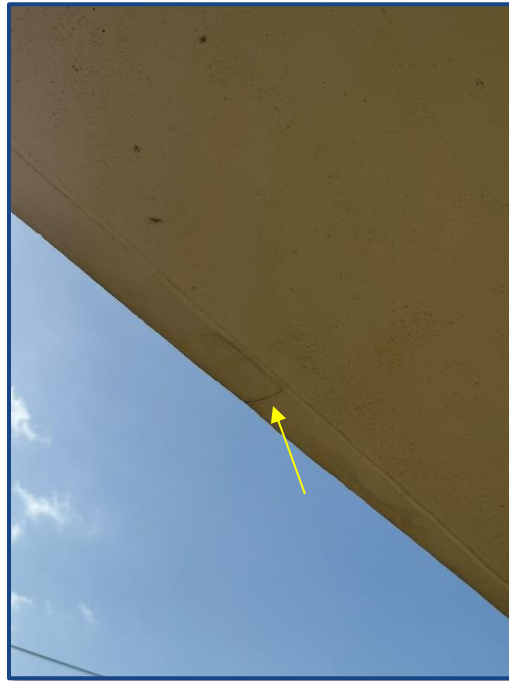
Photograph No. 29: Overhead cracking observed near unit 401.

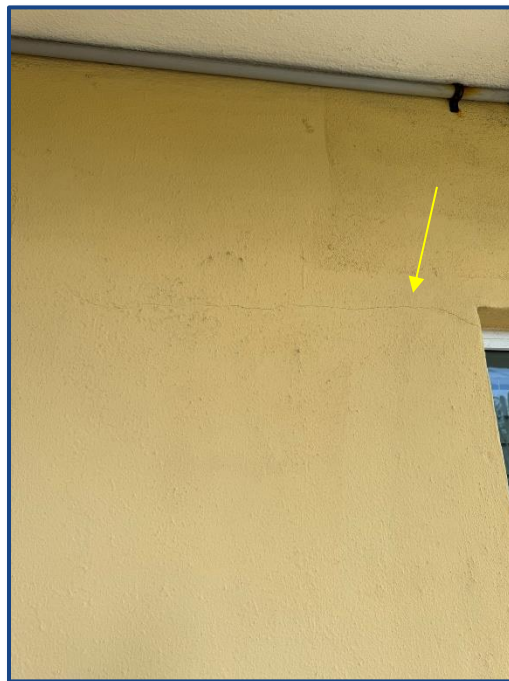
Photograph No. 30: Wall cracking observed near unit 206.

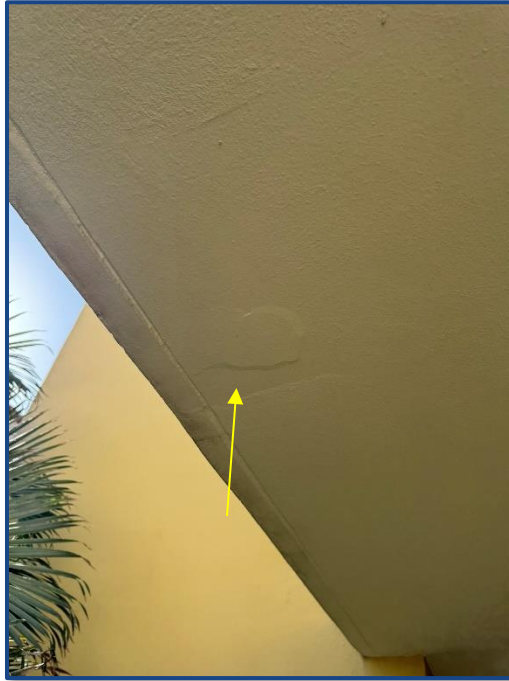
Photograph No. 31: Overhead spalling observed near unit 202.

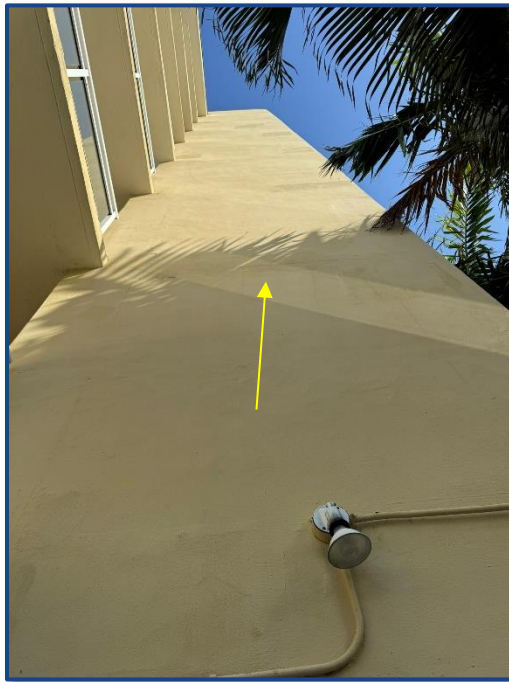
Photograph No. 32: Wall cracking observed at South stairs 2<sup>nd</sup> floor.

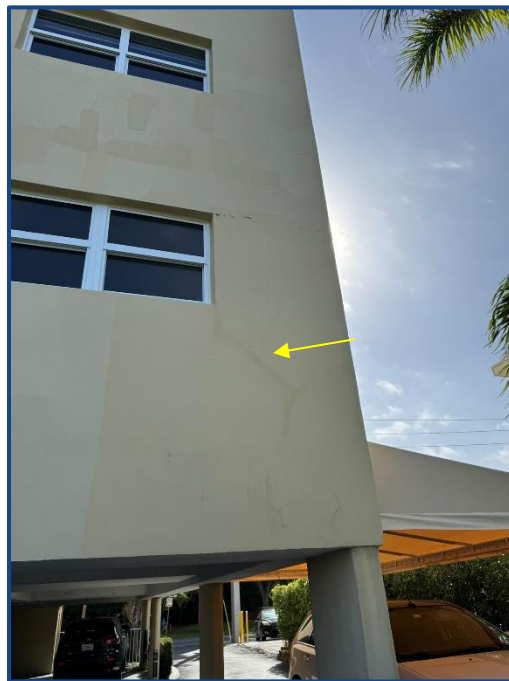
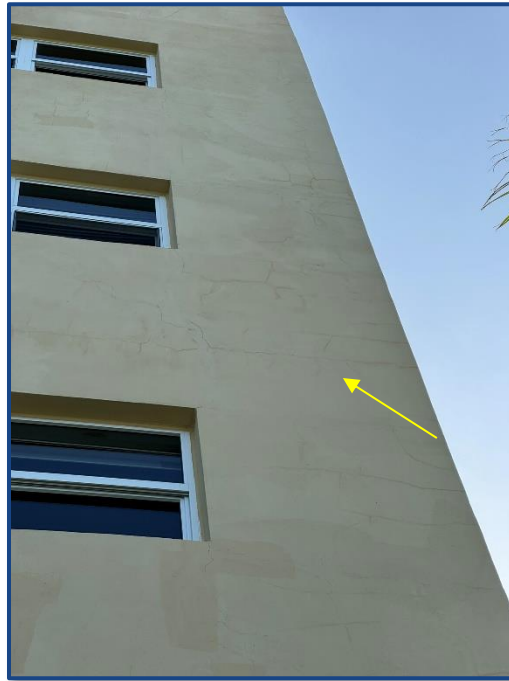
Photograph No. 40: Wall cracking observed at X01 window riser.

Photograph No. 41: Wall cracking observed at X01 window riser.

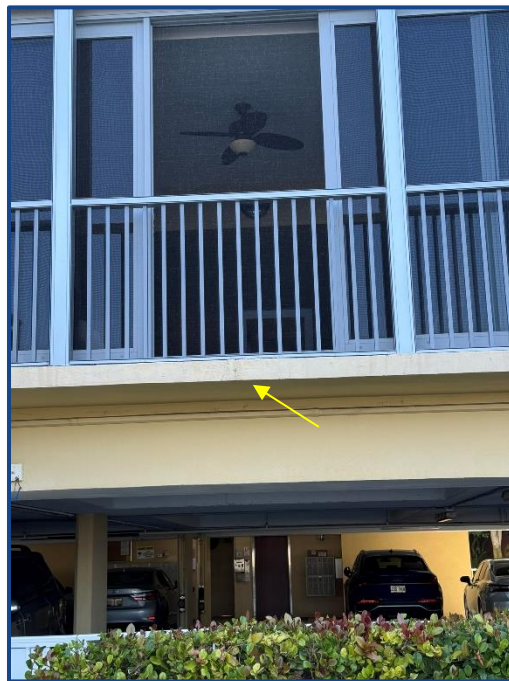
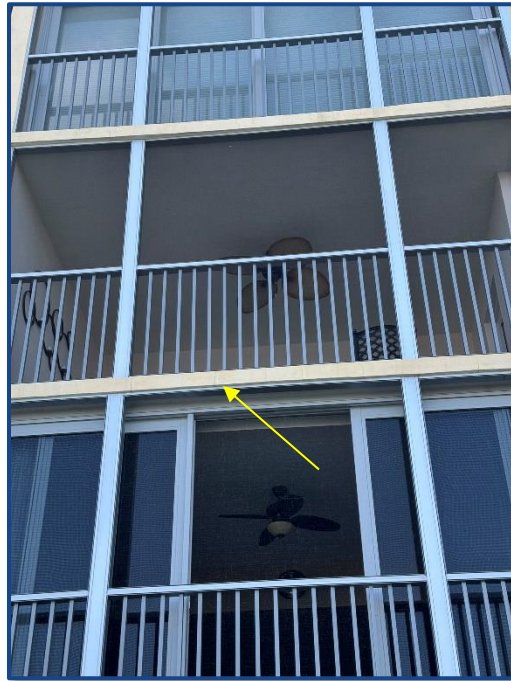
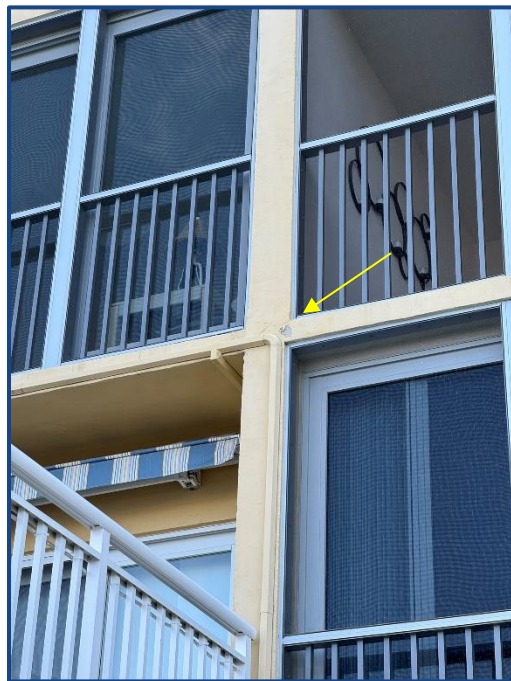
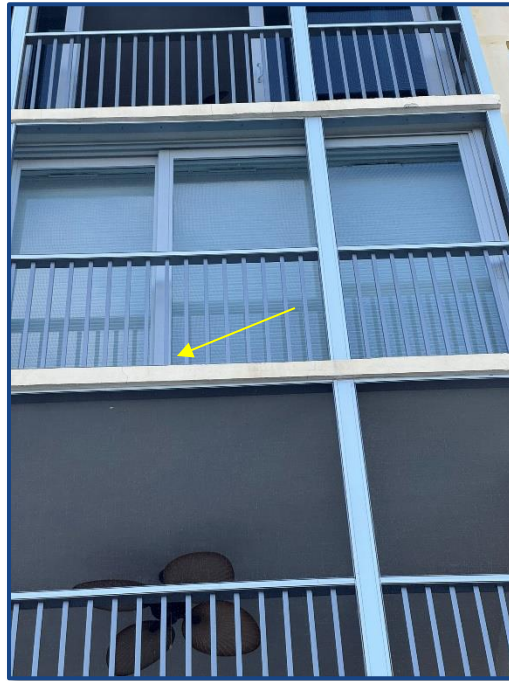
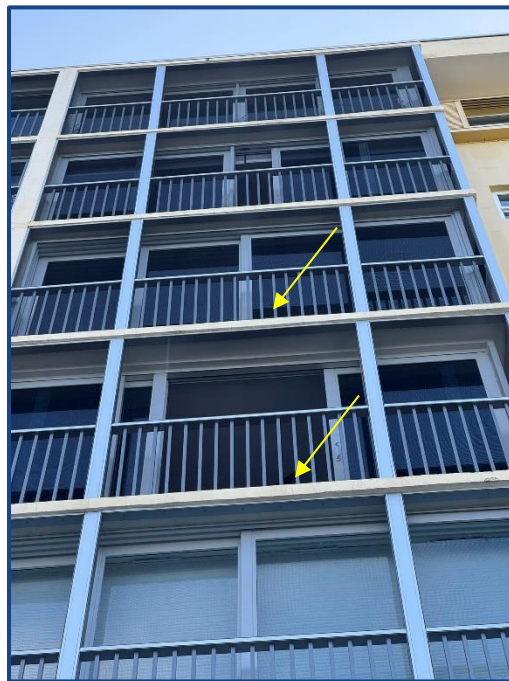
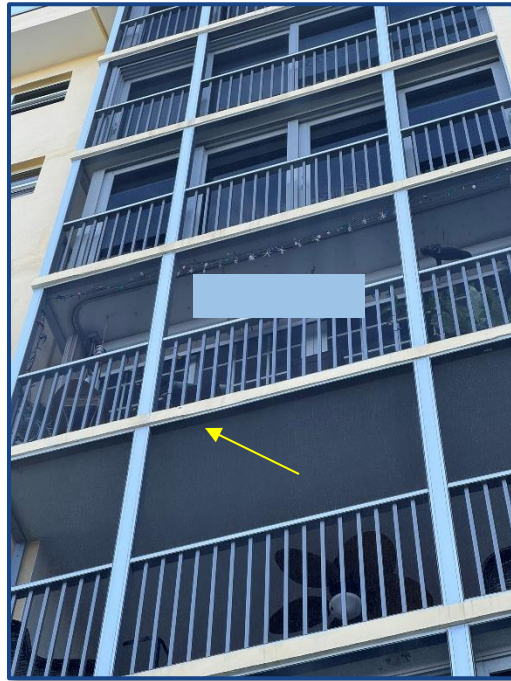
Photograph No. 42: Edge cracking observed at X03/X04 riser.

Photograph No. 43: Edge cracking observed at X03/X04 riser.

Photograph No. 44: Edge cracking observed at X03/X04 riser.

Photograph No. 45: Edge cracking observed at X03/X04 riser.

Photograph No. 46: Edge cracking observed at X03/X04 riser.

Photograph No. 47: Edge cracking observed at X03/X04 riser.

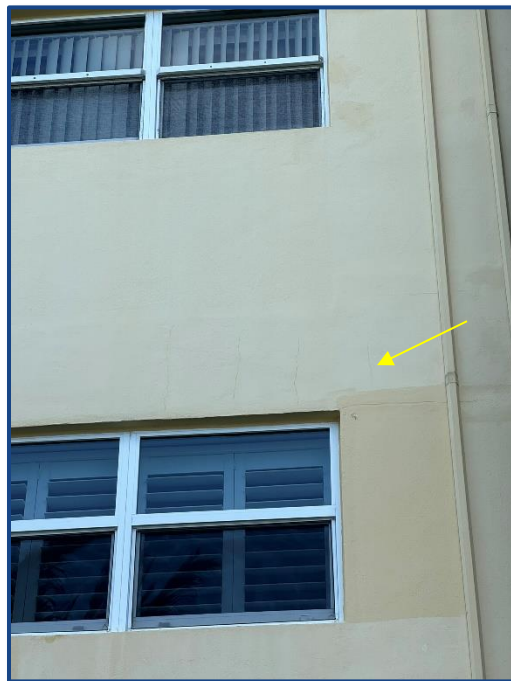
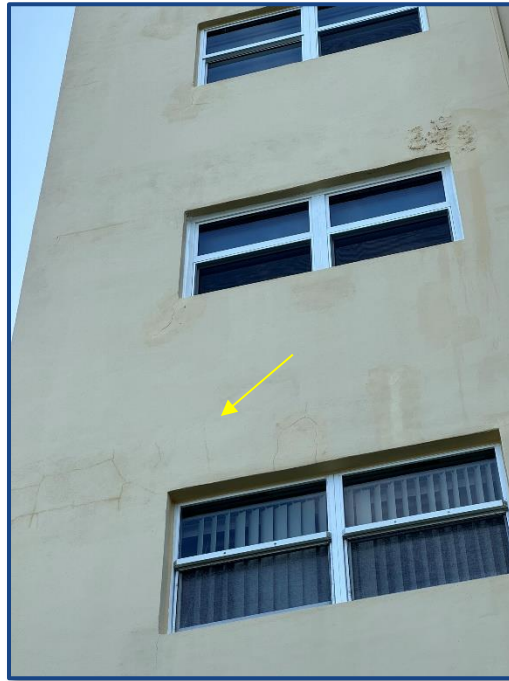
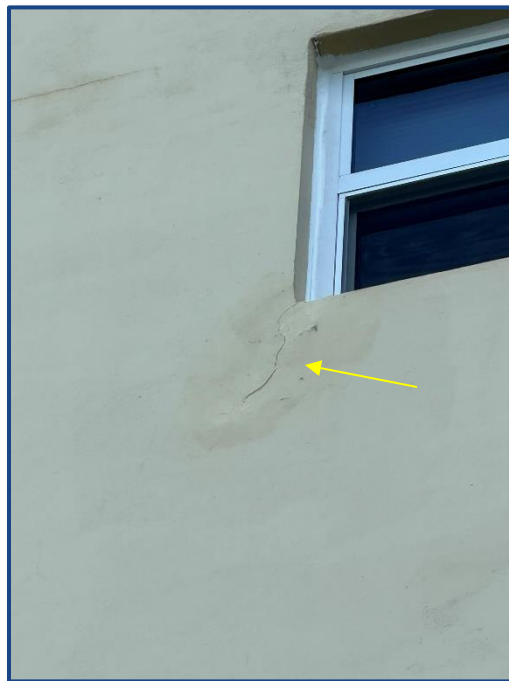
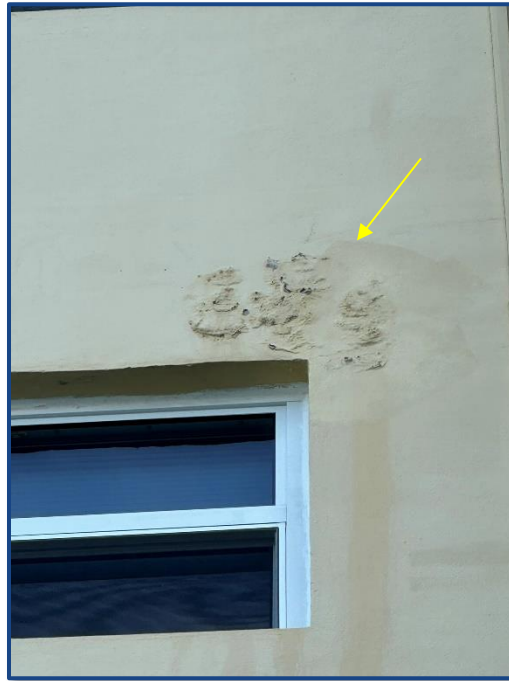
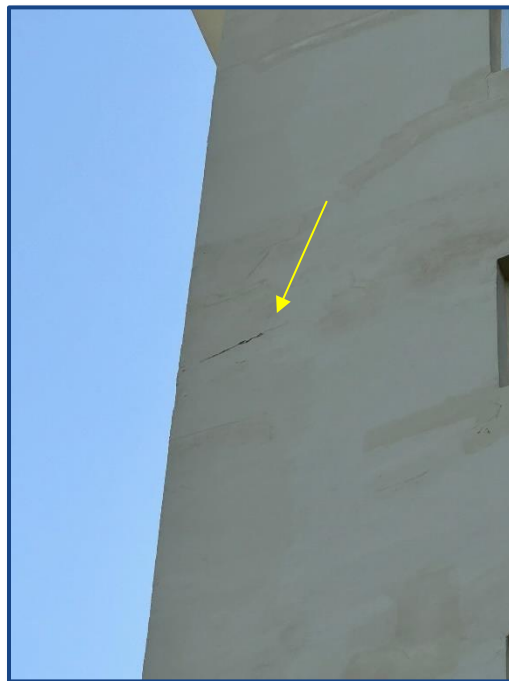
Photograph No. 48: Wall cracking observed at X05/X06 riser.

Photograph No. 49: Wall cracking observed at X05/X06 riser.

Photograph No. 50: Wall cracking observed at X05/X06 riser.

Photograph No. 51: Wall cracking observed at X05/X06 riser.

Photograph No. 52: Wall cracking observed at X05/X06 riser.

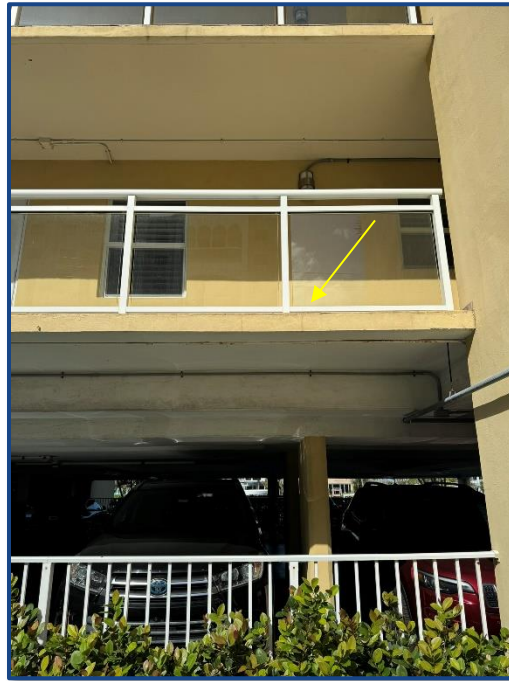
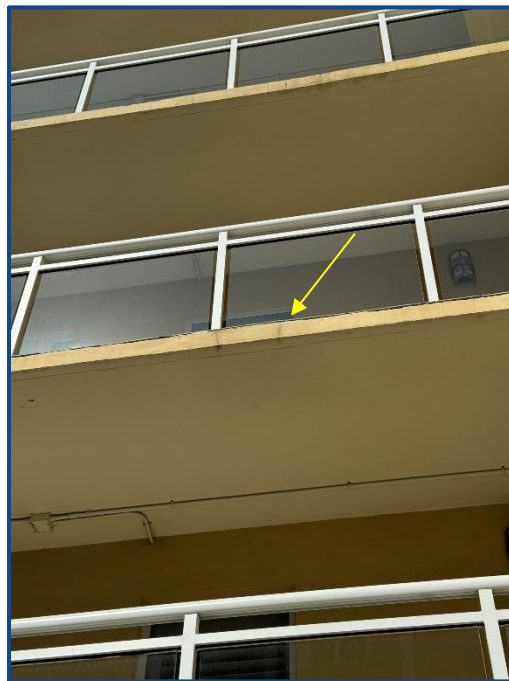
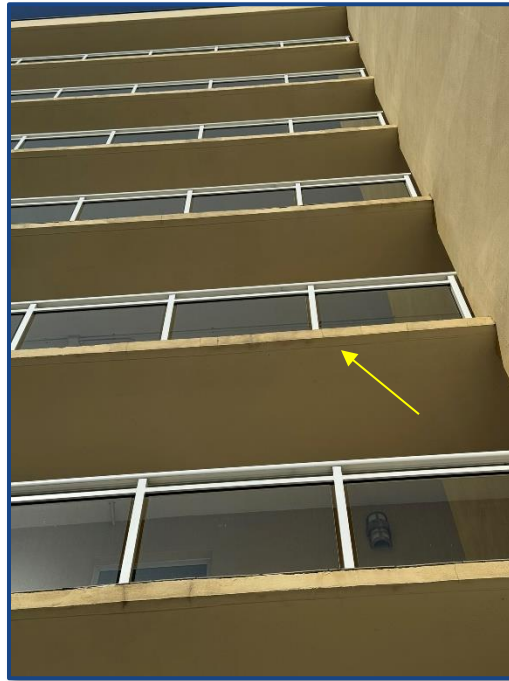
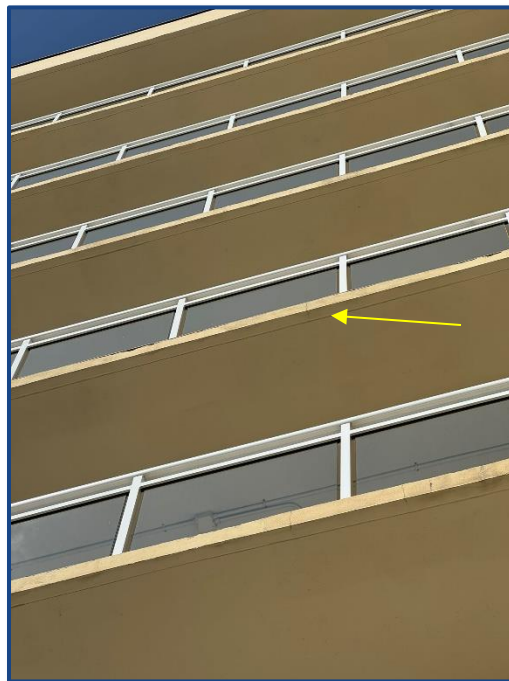
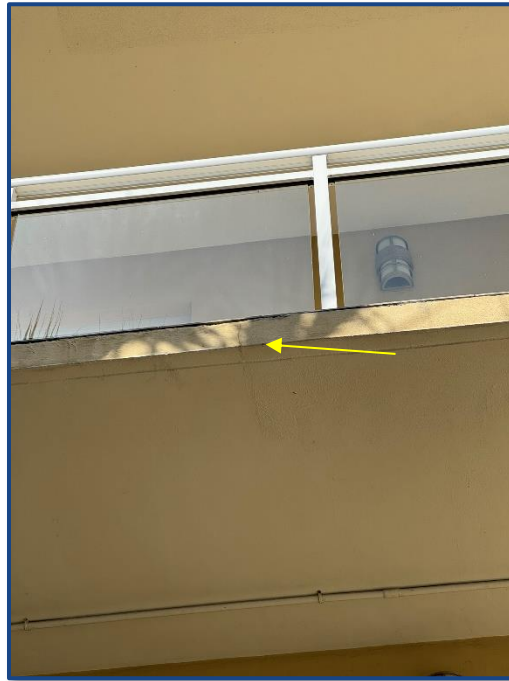
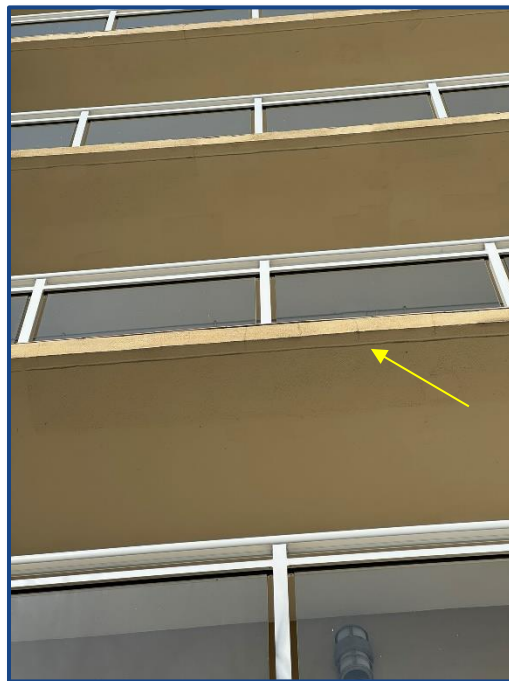
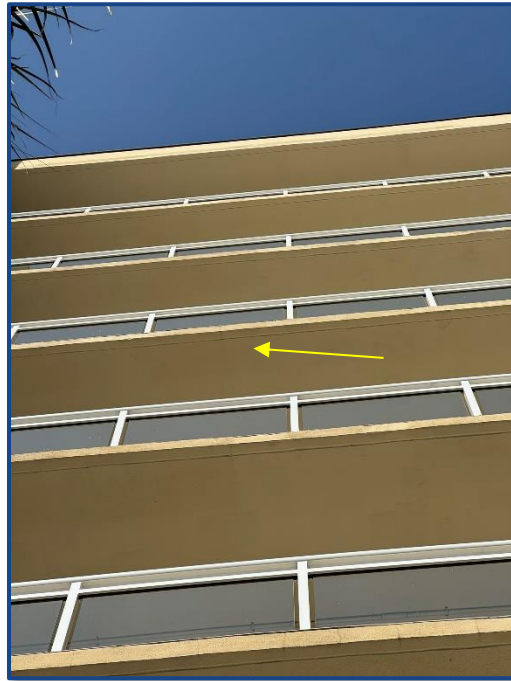
Photograph No. 53: Edge cracking observed near riser X05 catwalk side.

Photograph No. 54: Edge cracking observed near riser X05 catwalk side.

Photograph No. 55: Edge cracking observed near riser X05 catwalk side.

Photograph No. 56: Edge cracking observed near riser X05 catwalk side.

Photograph No. 57: Edge cracking observed near riser X05 catwalk side.

Photograph No. 58: Edge cracking observed near riser X05 catwalk side.

Photograph No. 59: Edge cracking observed near riser X05 catwalk side.

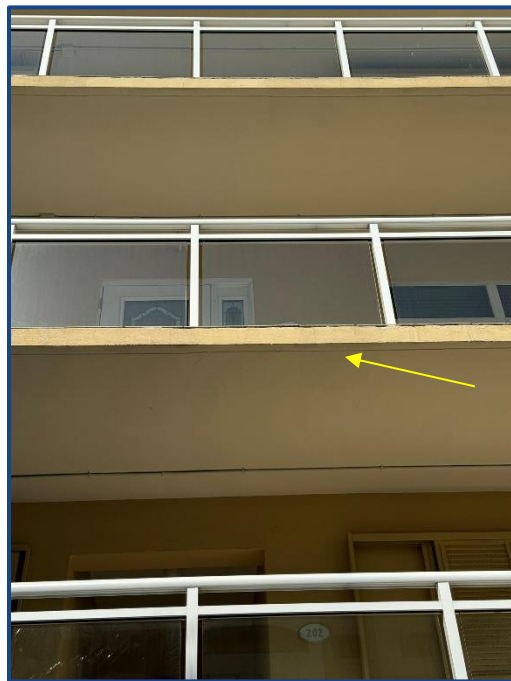
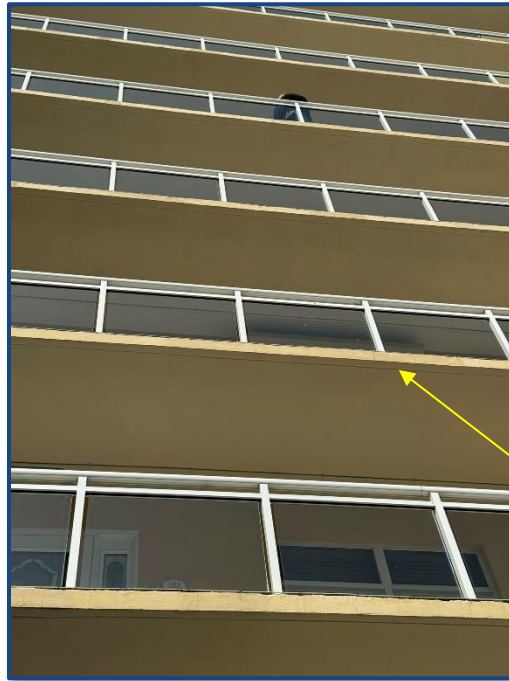
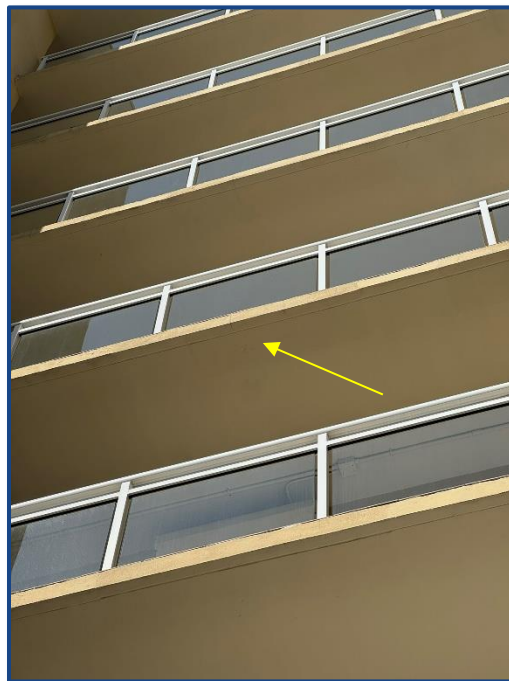
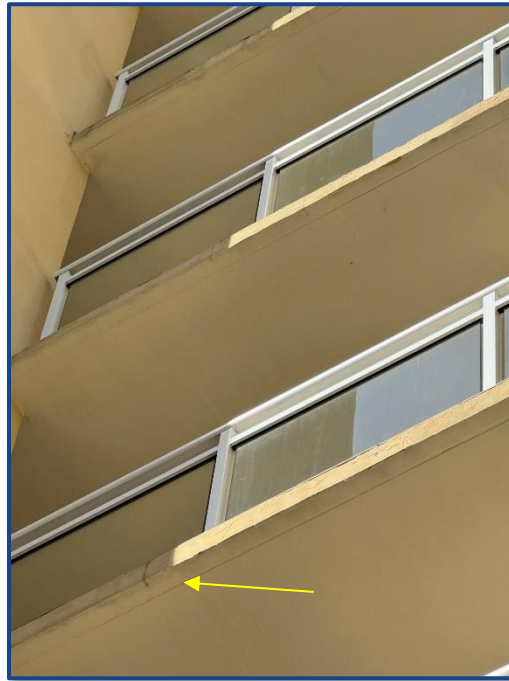
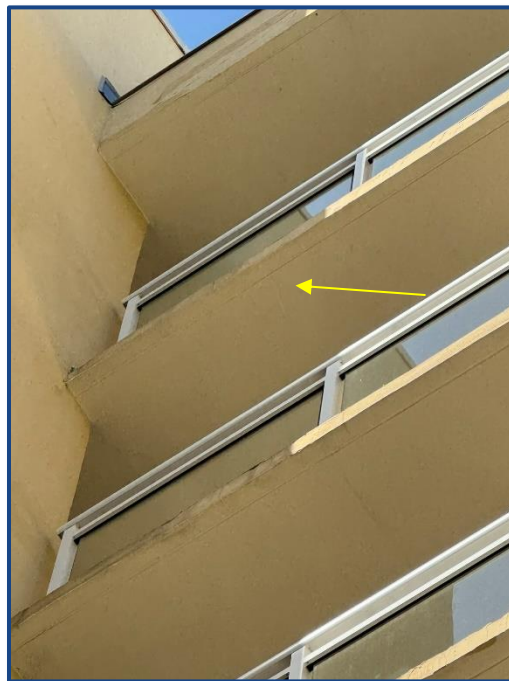
Photograph No. 60: Edge cracking observed near riser X02 catwalk side.

Photograph No. 61: Edge cracking observed near riser X02 catwalk side.

Photograph No. 62: Edge cracking observed near riser X02 catwalk side.

Photograph No. 63: Edge cracking observed near riser X02 catwalk side.

Photograph No. 64: Edge cracking observed near riser X02 catwalk side.

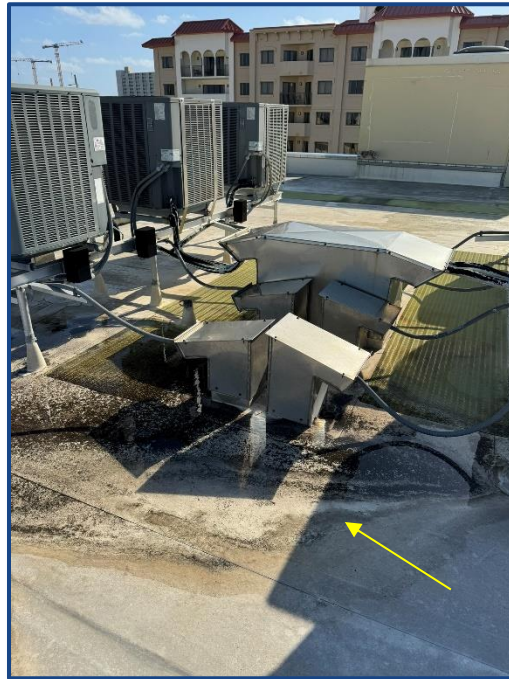
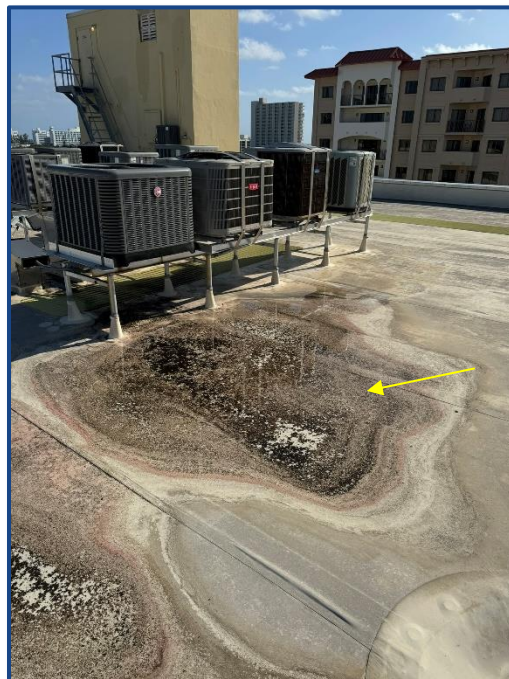
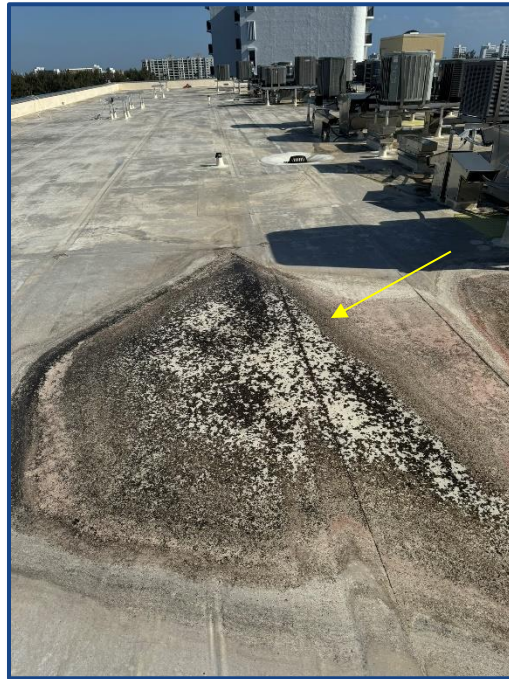
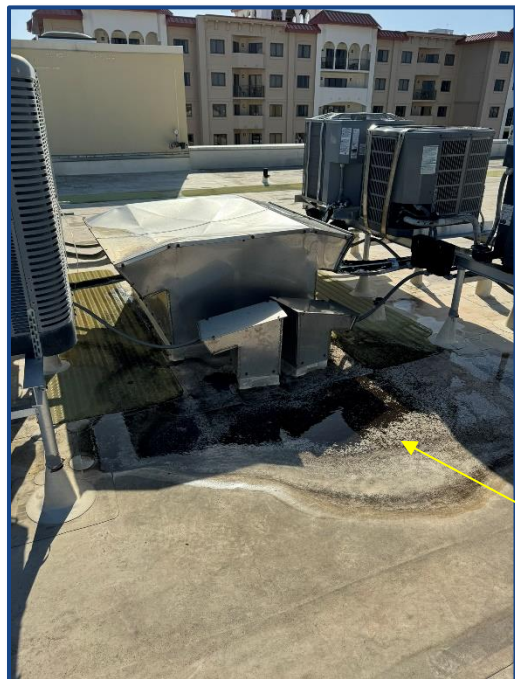
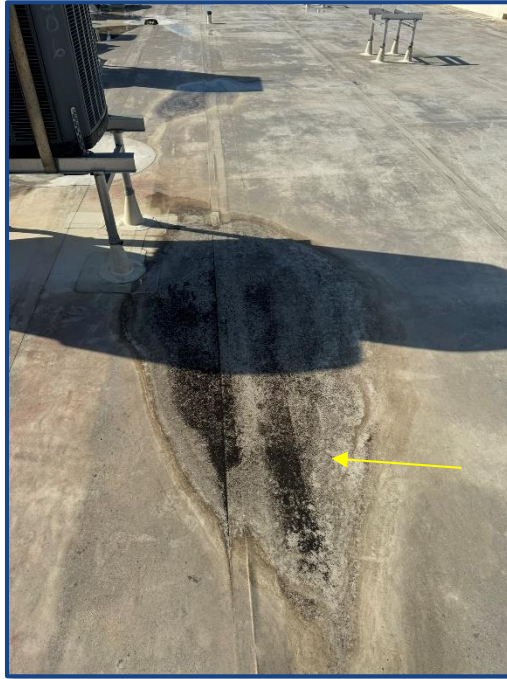
The building's roof is a flat roof consisting of post-tensioned concrete slabs covered with a TPO roofing system. At the time of inspection, the roof is in fair condition with debris buildup from water accumulation observed at several areas. Roof maintenance is performed annually as advised by the association and provided roofing contract. See Appendix B for photographs and locations.

Photograph No. 65: Debris buildup observed from water accumulation at building roof.

Photograph No. 66: Debris buildup observed from water accumulation at building roof.

Photograph No. 67: Debris buildup observed from water accumulation at building roof.

Photograph No. 68: Debris buildup observed from water accumulation at building roof.

Photograph No. 69: Debris buildup observed from water accumulation at building roof.
