**RE: Special Inspector Final Letter of Compliance
615 North Riverside Drive,
Pompano Beach, Florida 33062
Permit No. 22-00006488**

STRUCTURAL SAFETY INSPECTION REPORT FORM

Field Observation Report – Riverside Terrace Condominium

TRC Project No. 21FTL323

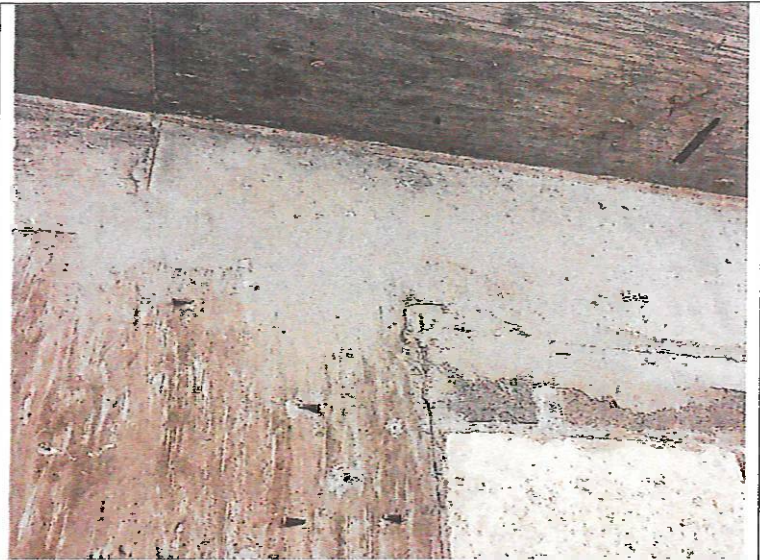
Photo No. 1

Location: Elevator Room

The contractor patched the remaining area in the elevator room.

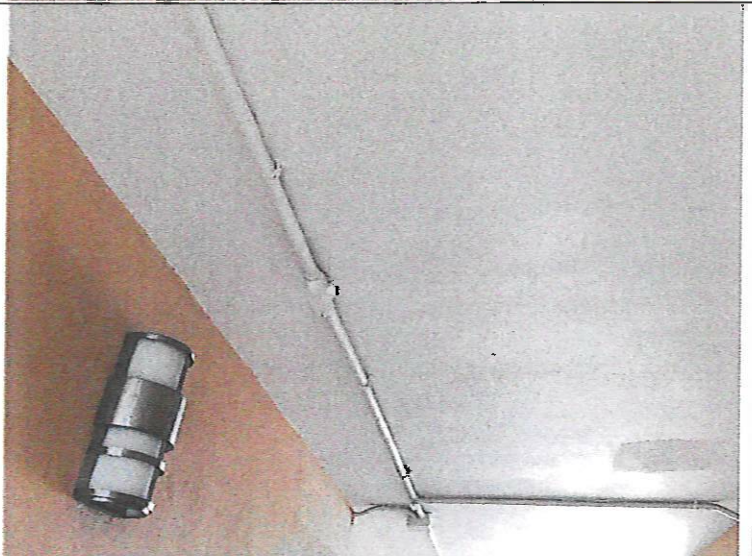
Photo No. 2

Location: Building Walkways

All building walkway repairs that were outstanding have been corrected and painted.

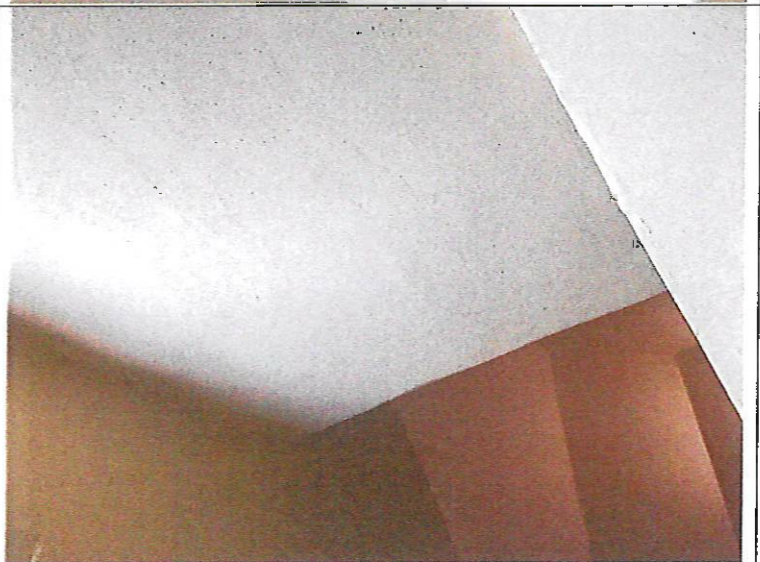
Photo No. 3

Location: Stair Case Repairs

Staircase repairs have been completed and painted.
