Field Observation Report – Riverside Terrace Condominium

TRC Project No. 21FTL323

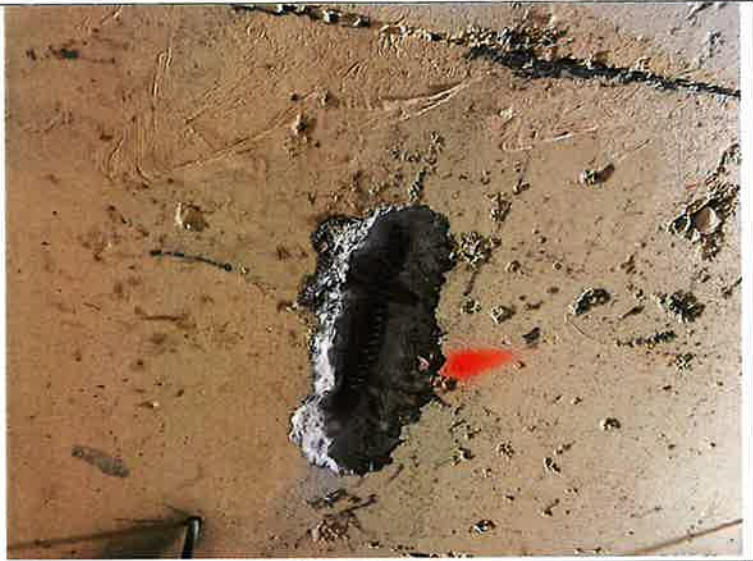
Photo No. 1

Location: Garage, Elevated Walkways and Stairwell

Areas were observed to be demolished without engineer approval. The contractor was instructed to not demolish an area unless the engineer has instructed the contractor to demolish that area.

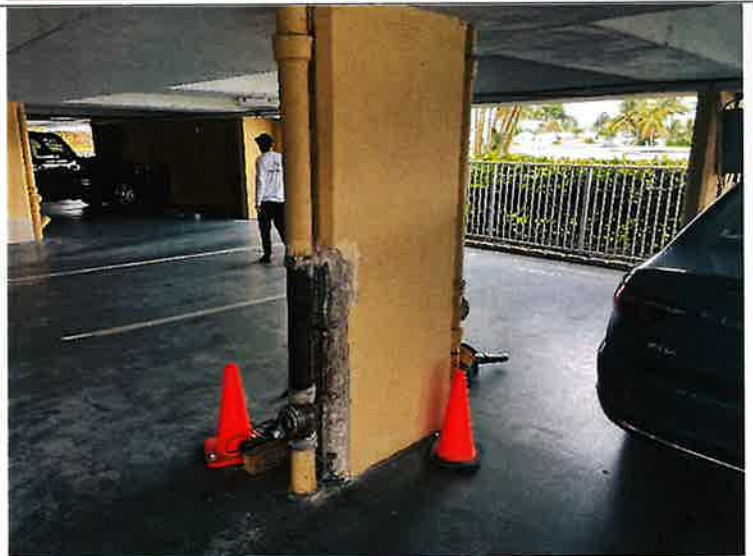
Photo No. 2

Location: Garage Column

A portion of the column was observed to be demolished. Cut stirrups were observed. The contractor was advised to wait for a detail from the engineer on a remedy for the damaged column stirrups before proceeding.

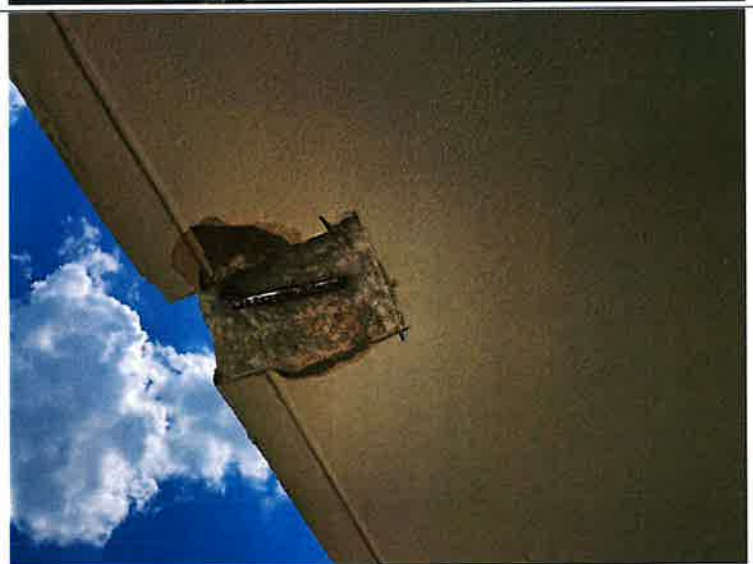
Photo No. 3

Location: Tower

Where repair areas were opened, some reinforcement appeared to be grinded too much. When advised to clean the reinforcement by the engineer, the contractor was advised to clean the reinforcement with a brush that does not produce this scratching.

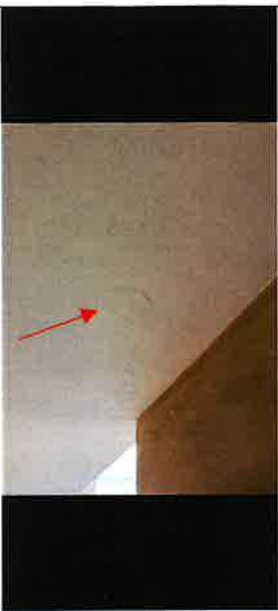
<p>Photo No. 4</p> <p>Location: Elevated Walkways</p> <p>Comments:</p> <p>Undemolished concrete deteriorations were observed. The contractor was instructed to wait for the next site visit for demolition instructions in areas where demolition instructions were not given.</p> <p>Re-inspection required: <input checked="" type="checkbox"/> yes <input type="checkbox"/> no</p>

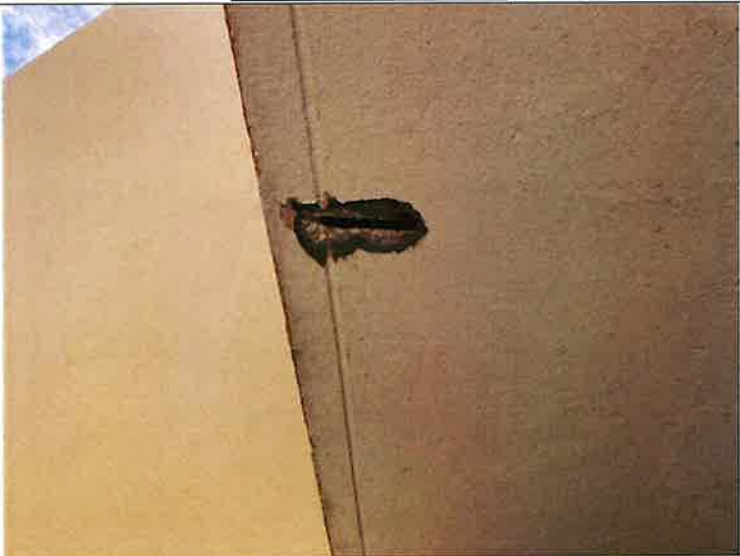
<p>Photo No. 5</p> <p>Location: Elevated Walkways</p> <p>Comments:</p> <p>Partially demolished repair areas were observed. The contractor was provided demolition instructions in pencil adjacent to these areas. The contractor was cautioned to take care in not damaging the walkway tile and embedded railing posts during demolition. The contractor was advised to not clean the reinforcement and to not coat with a corrosion inhibitor so that the engineer to review.</p> <p>Re-inspection required: <input checked="" type="checkbox"/> yes <input type="checkbox"/> no</p>

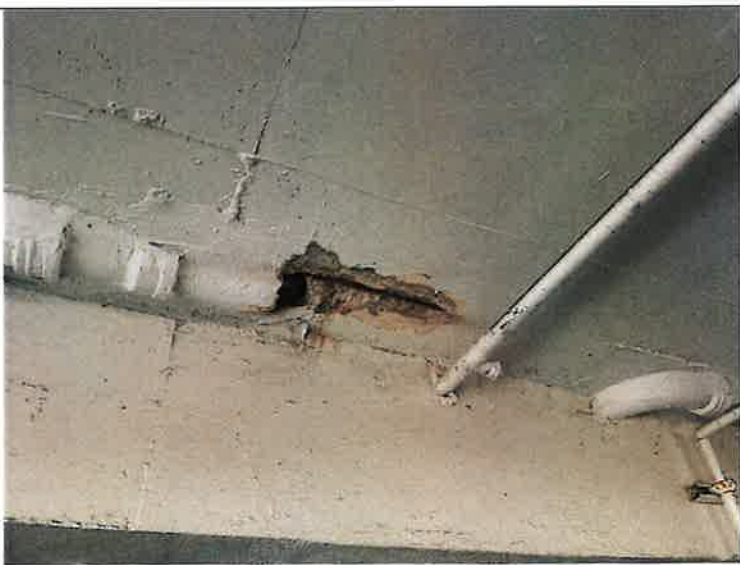
<p>Photo No. 6</p> <p>Location: Stairwell and Garage</p> <p>Comments:</p> <p>Partially demolished repair areas and concrete deterioration were observed. The contractor was instructed to wait until the next site visit for demolition instructions where demolition instructions were not given.</p> <p>Re-inspection required: <input checked="" type="checkbox"/> yes <input type="checkbox"/> no</p>

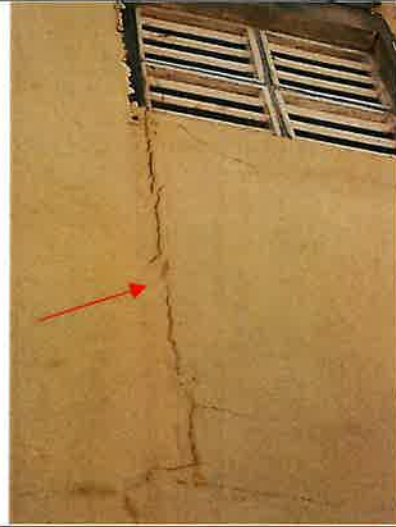
Photo No. 7

Location: Roof

Stucco deterioration was observed. The contractor was advised to demolish the stucco three inches to the left and right of this crack for the length of the crack.
