## Field Observation Report – Riverside Terrace Condominium

### TRC Project No. 21FTL323

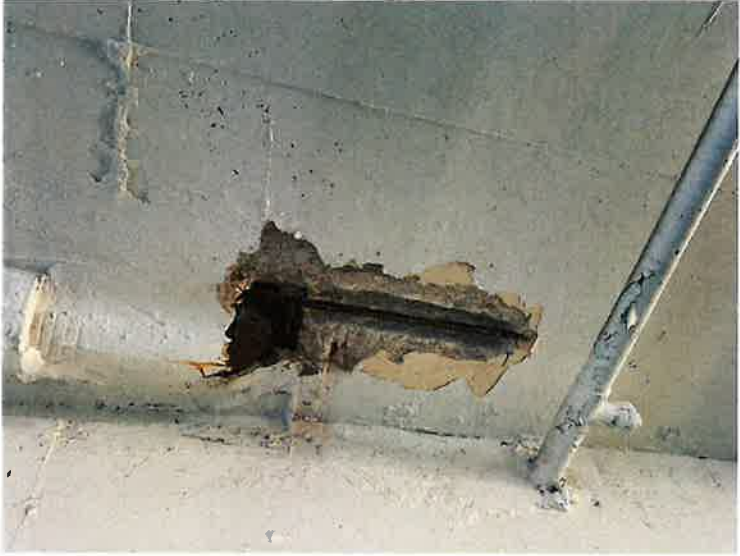
<p>Photo No. 1</p> <p>Location: Concrete Repair Areas – Slabs</p> <p>Comments:</p> <p>On areas where reinforcement was observed to be corroded at the extent of demolition, the contractor was advised to continue demolition on the concrete until at least 1 inch of clean reinforcement is found and await engineer review. The contractor shall not make the area full depth and/or greater than 4 square feet and/or more than 6 feet long without engineer approval. When demolishing the concrete to find clean reinforcement, the contractor shall not demolish into and/or above beams and/or columns and/or walls.</p> <p>Re-inspection required: <input checked="" type="checkbox"/> yes <input type="checkbox"/> no</p>

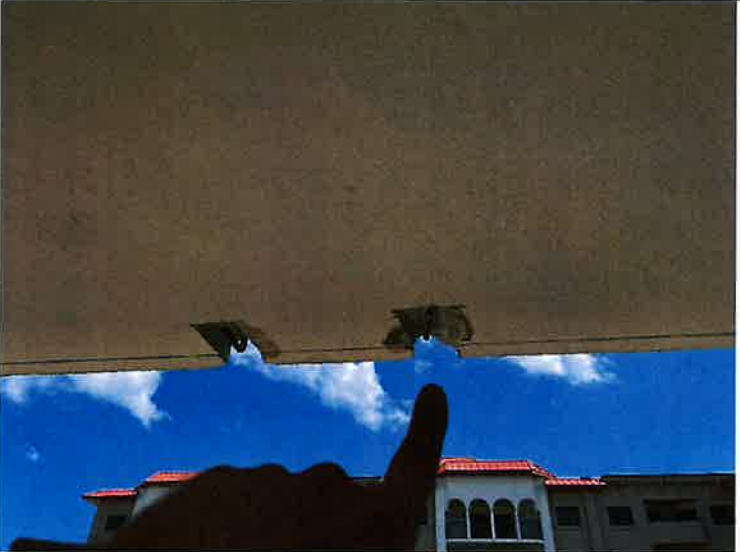
<p>Photo No. 2</p> <p>Location: Outside of Unit 702 – Elevated Walkway</p> <p>Comments:</p> <p>The area indicated in this photo is approved to clean and coat the reinforcement.</p> <p>Re-inspection required: <input checked="" type="checkbox"/> yes <input type="checkbox"/> no</p>

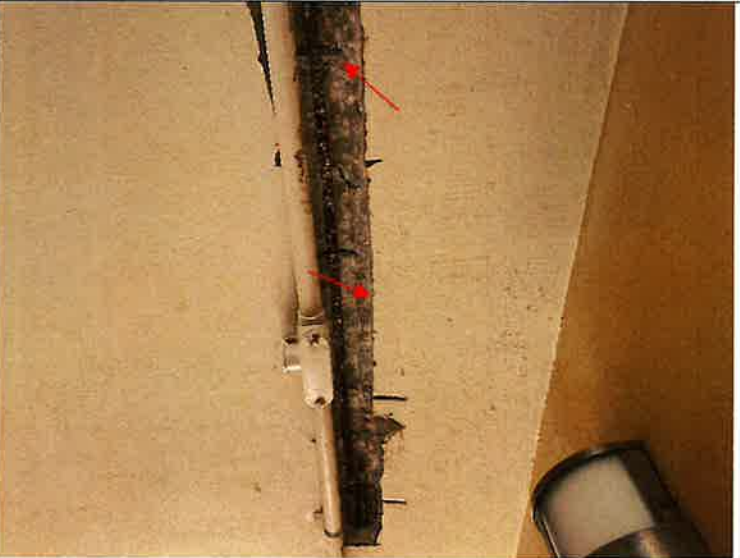
<p>Photo No. 3</p> <p>Location: Concrete Repair Areas</p> <p>Comments:</p> <p>The contractor was advised to expose partially exposed bars and roughen the sides of the areas per ICRI guidelines. Corroded reinforcement chairs shall be treated similarly to corroded reinforcement and shall not be cut without engineer approval. The contractor shall contact the engineer if a repair goes full depth.</p> <p>Re-inspection required: <input checked="" type="checkbox"/> yes <input type="checkbox"/> no</p>

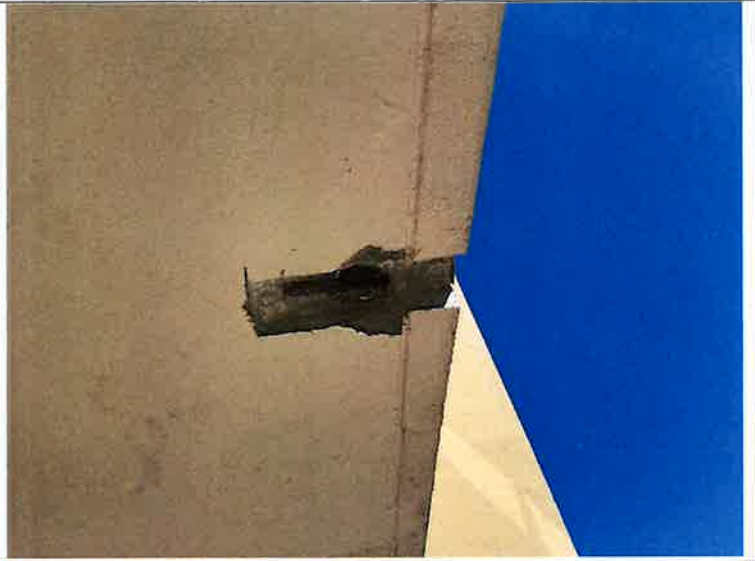
Photo No. 4

Location: Elevated Walkways

The contractor was advised to wait on demolition on areas where the hooks were corroded at the extent of demolition due to the potential of damage to the tile and railing. The engineer will review with the client on this.

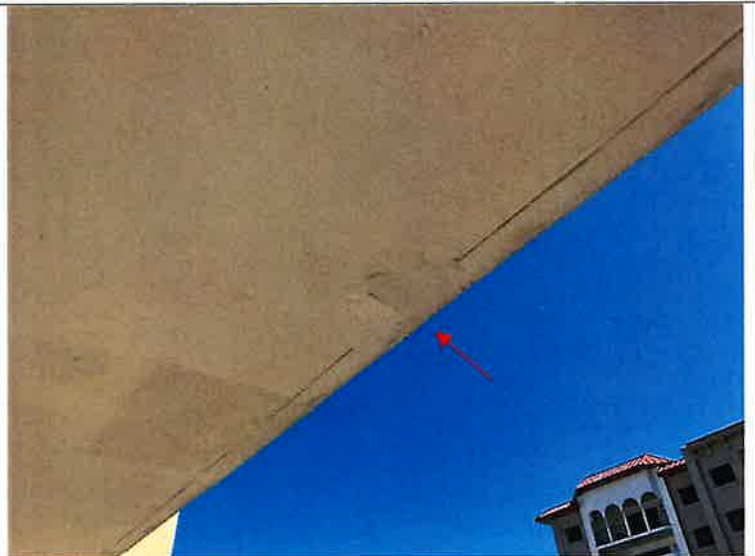
Photo No. 5

Location: Concrete and Stucco Repair Areas

Some additional areas, that have not been already opened, require repairs for the 40-year structural re-certification. The specific locations of these areas will be called out on the next site visit and shall not be demolished yet.

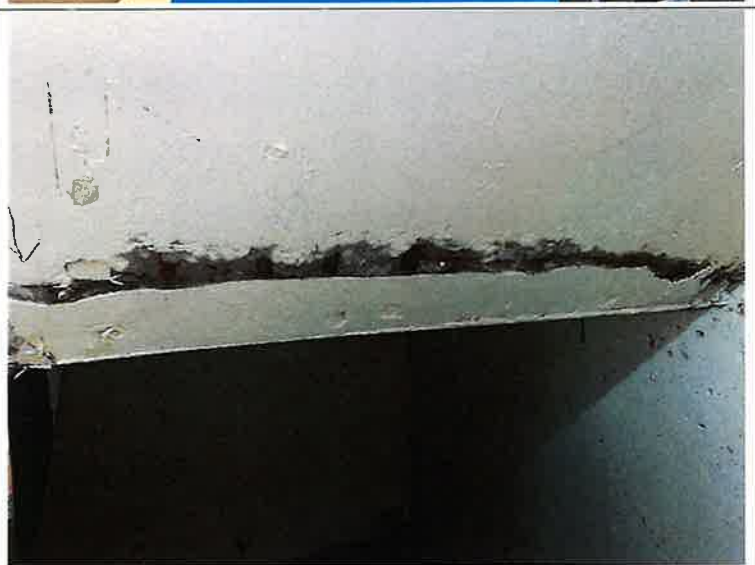
Photo No. 6

Location: Pump Rooms

The contractor was advised to not perform demolition under the stairs in the pump room and the walls in the pump rooms. Shoring is required per a Professional Engineer registered in the State of Florida.

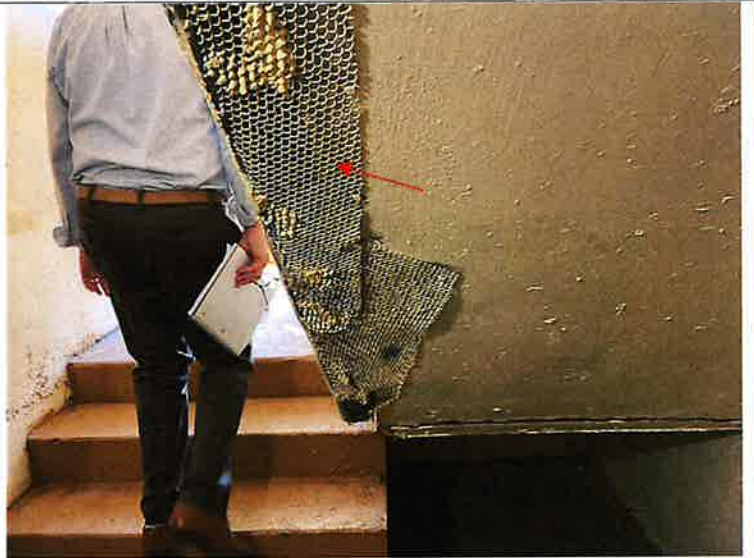
Photo No. 7

Location: Pump Room

The contractor was advised to remove the stucco lath indicated in this photo and allow the engineer to review.

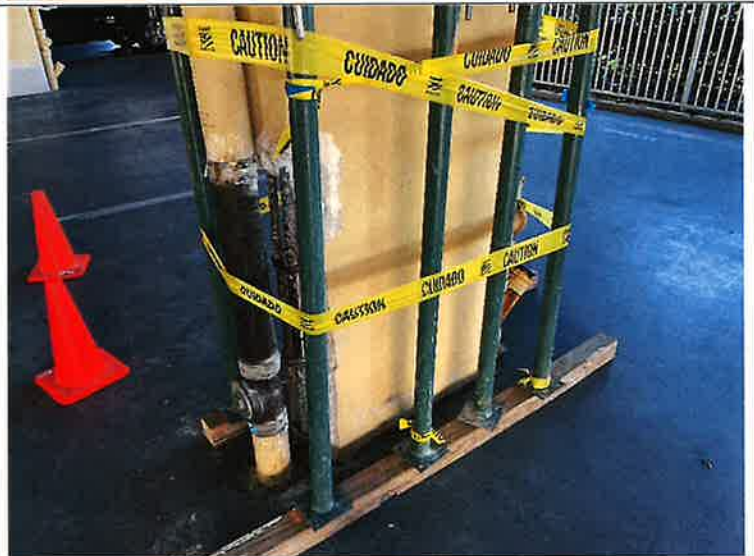
Photo No. 8

Location: Garage

The contractor was advised to allow the engineer to provide guidance on how to repair the column in the garage before performing any work on this column.

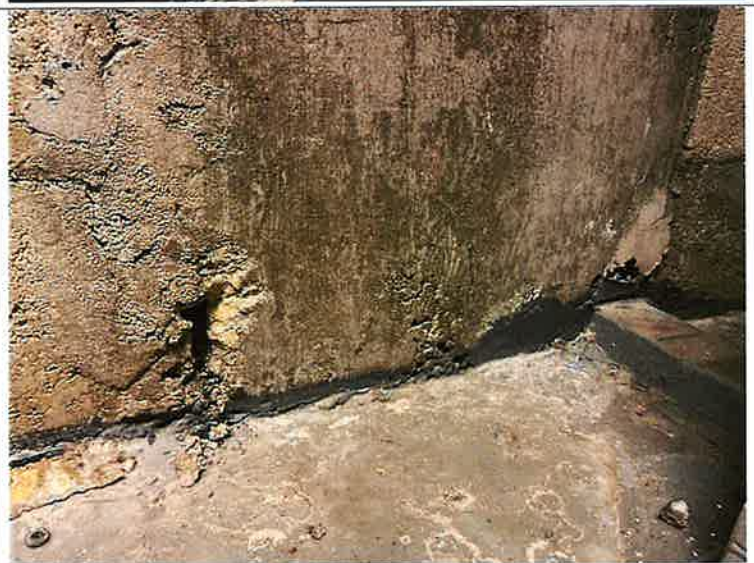
Photo No. 9

Location: Elevator Machine Room

Exposed reinforcement was observed in some areas.
