TRC Worldwide Engineering

Field Observation Report – Riverside Terrace Condominium

TRC Project No. 21FTL323

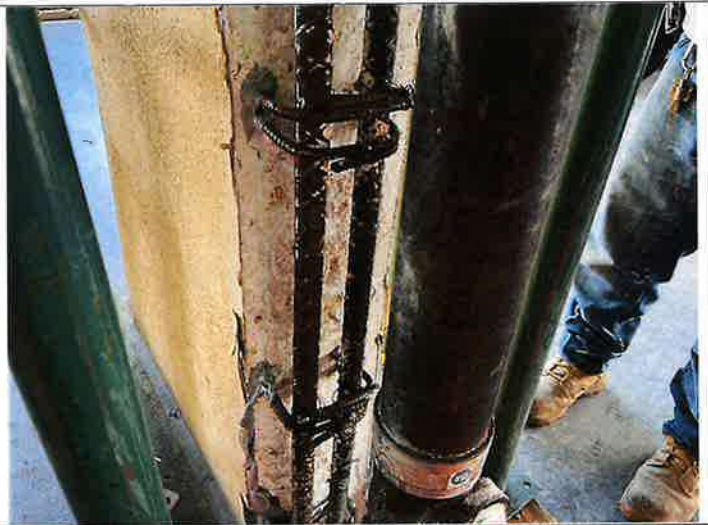
Photo No. 1

Location: Underside Parking Garage

The parking garage column was inspected. The contractor was directed to clean the rebar further. This was done during this site visit and was approved for coating and concrete pouring.

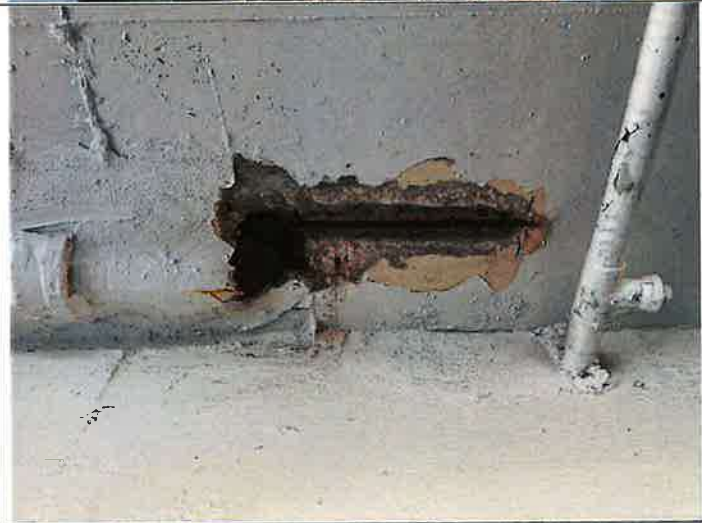
Photo No. 2

Location: Underside Parking Garage

The contractor was directed that this repair was able to be coated and poured.

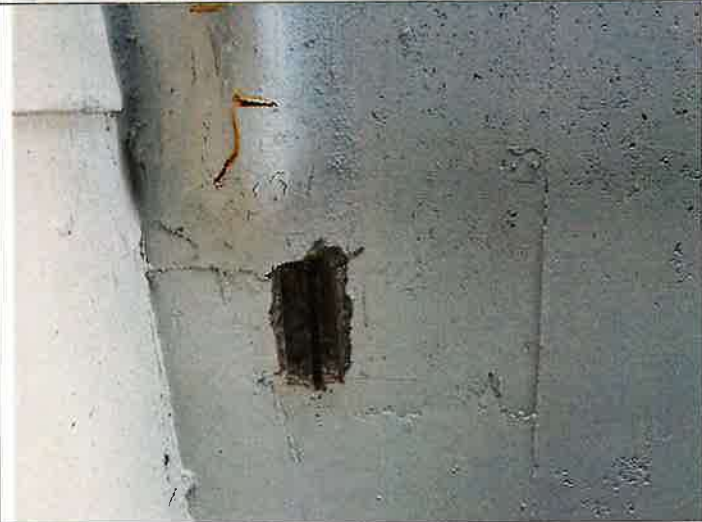
Photo No. 3

Location: Underside Parking Garage

The contractor was directed that this repair was able to be coated and poured.

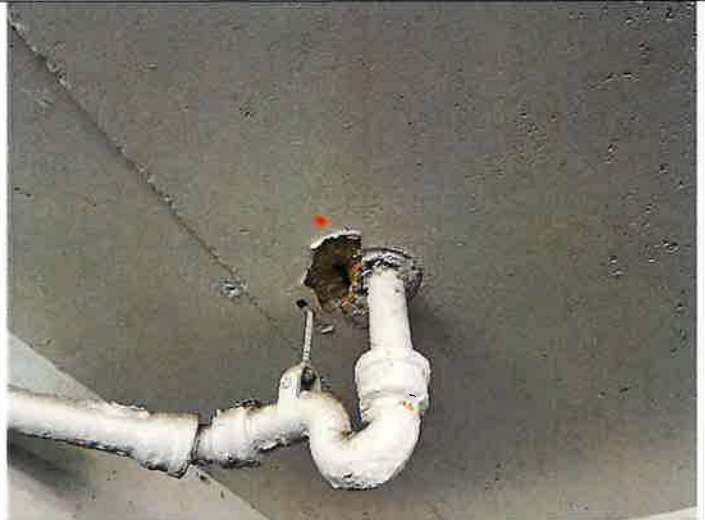
Photo No. 4

Location: Underside Parking Garage

New exposed rebar was observed and marked. The contractor was directed to follow ICRI guidelines and chase the rebar until there is no rust (within reason).

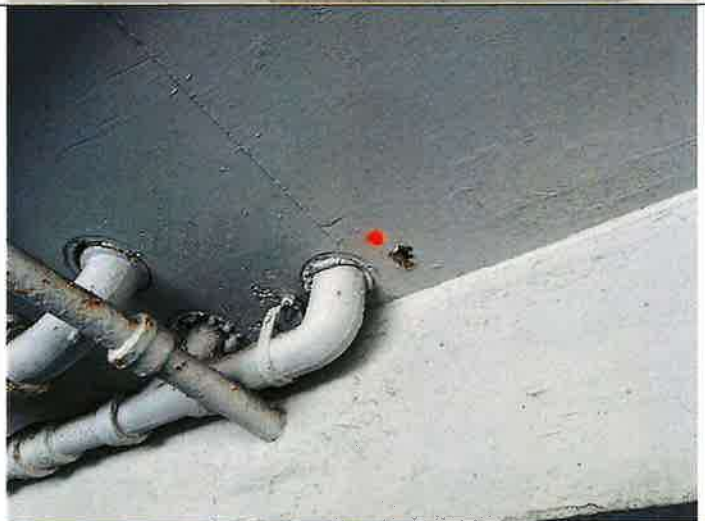
Photo No. 5

Location: Underside Parking Garage

New exposed rebar was observed and marked. The contractor was directed to follow ICRI guidelines and chase the rebar until there is no rust (within reason).

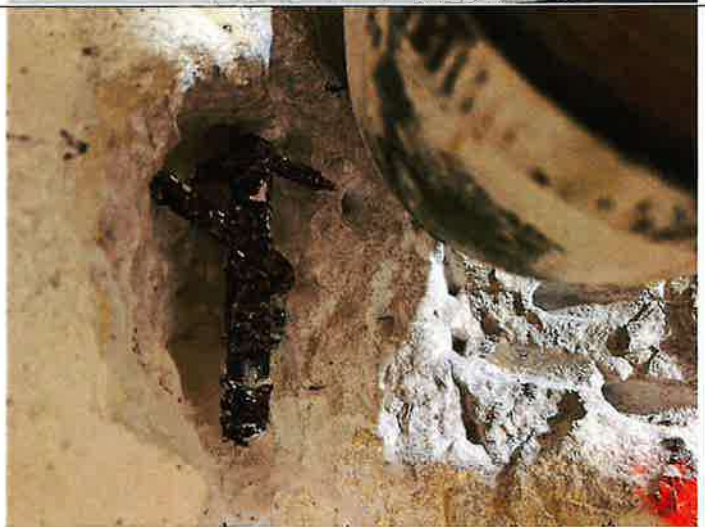
Photo No. 6

Location: Ground Floor South Staircase

The previously marked area was chipped out. This location needs to be cleaned further with a cupped wire brush.

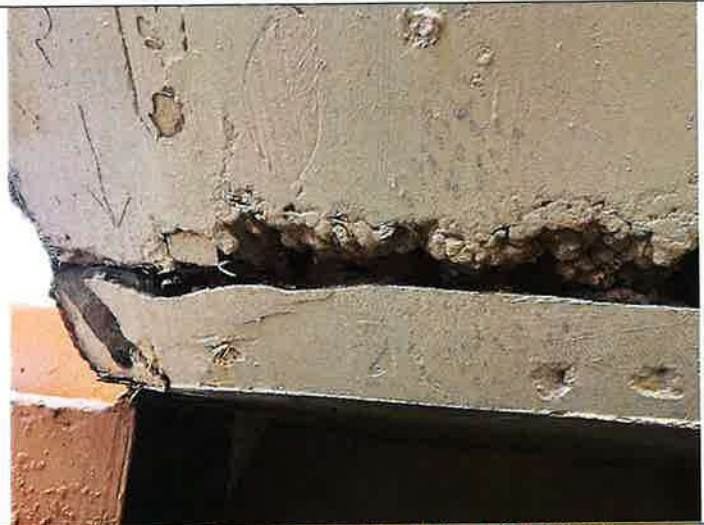
Photo No. 7

Location: Ground Floor South Staircase

The exposed rebar section needs to be shored properly, chipped and restored. This will occur at the end of the project.

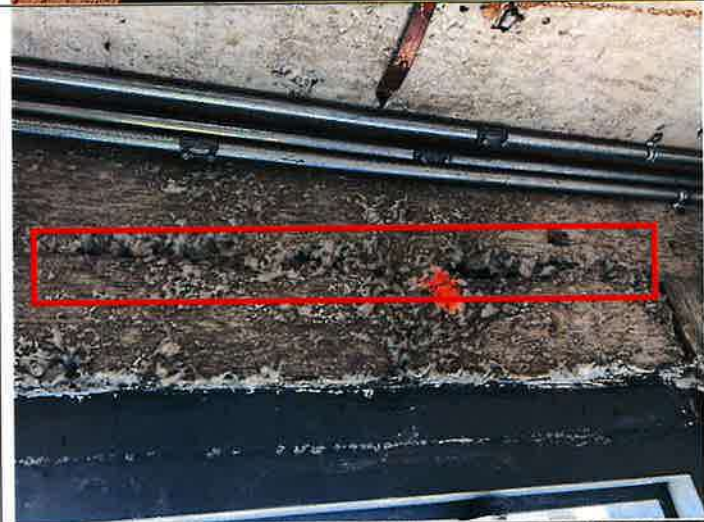
Photo No. 8

Location: Upper Roof Elevator Room

The exposed rebar needs to be chipped and patched as outlined by the red box.

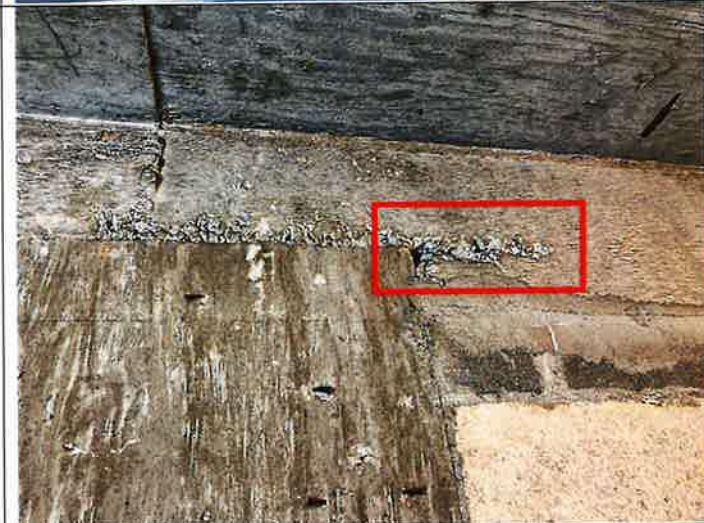
Photo No. 9

Location: Upper Roof Elevator Room

The squared location needs to be patched.

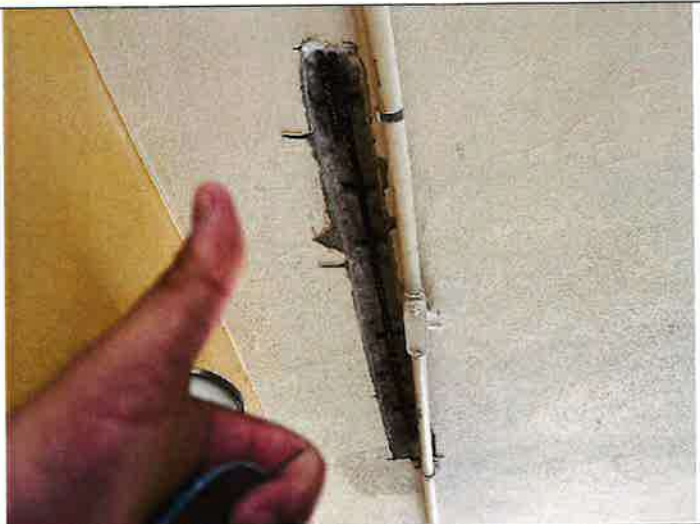
Photo No. 10

Location: Level 7 Walkway

The area was clean and able to be coated and patched.

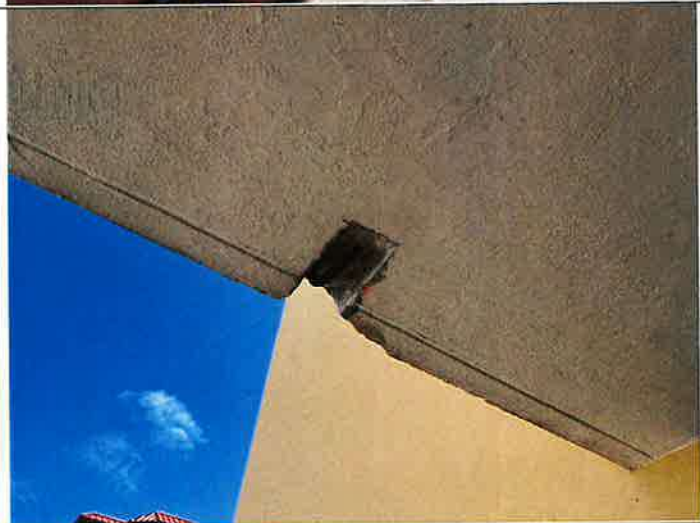
Photo No. 11

Location: Level 6 Walkway

The area was clean and able to be coated and patched.

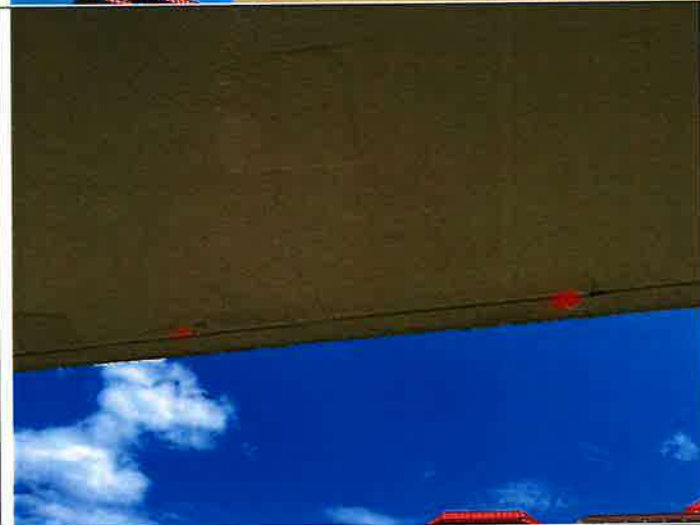
Photo No. 12

Location: Level 6 Walkway

New delaminated areas were observed and marked.
The contractor was directed to chip the stucco first
and sound the concrete once exposed.

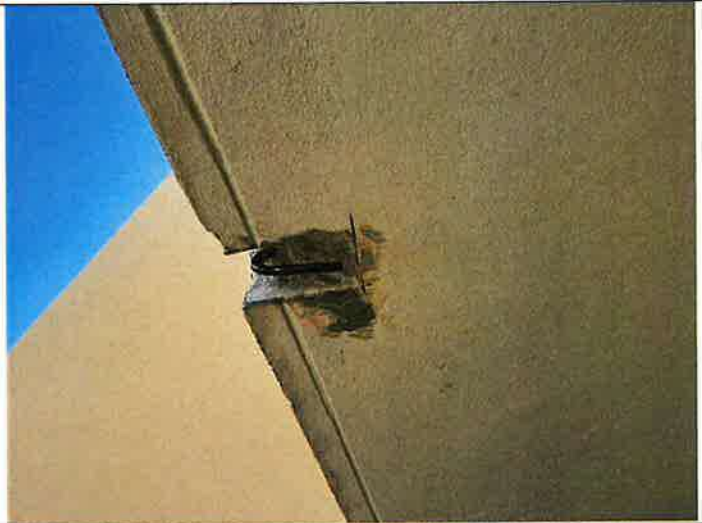
Photo No. 13

Location: Level 6 Walkway

The area was clean and able to be coated and patched.

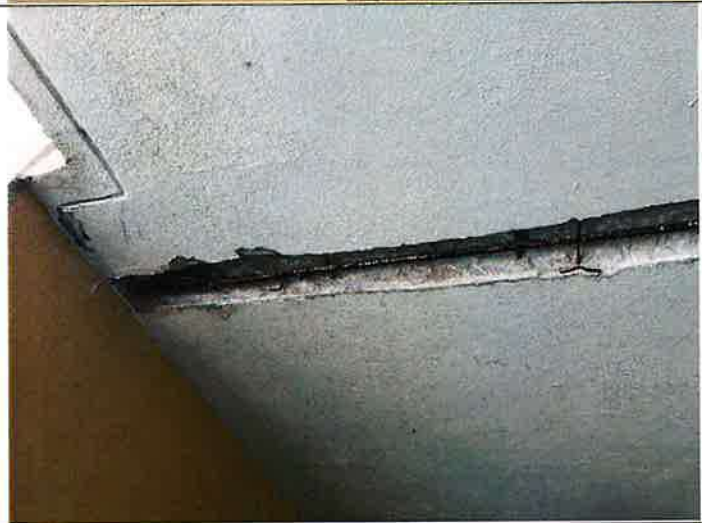
Photo No. 14

Location: Level 6 Walkway

This area was directed to be cleaned further and the existing chairs to be cut out. They contractor began working on this area before the inspection was completed.

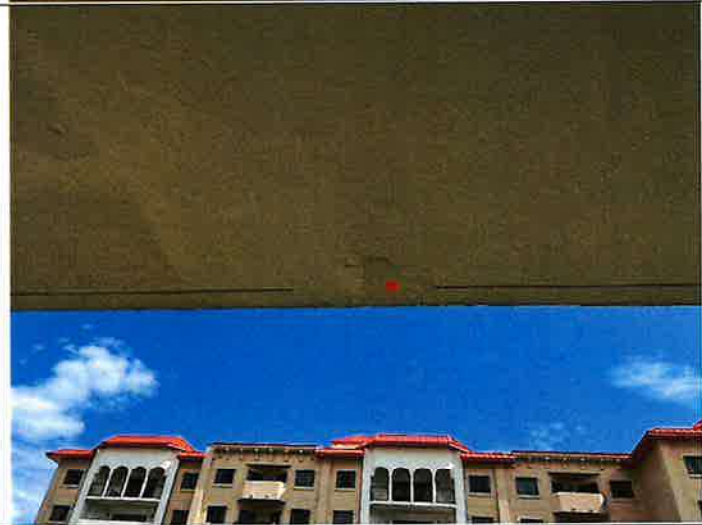
Photo No. 15

Location: Level 6 Walkway

New delaminated areas were observed and marked. The contractor was directed to chip the stucco first and sound the concrete once exposed.

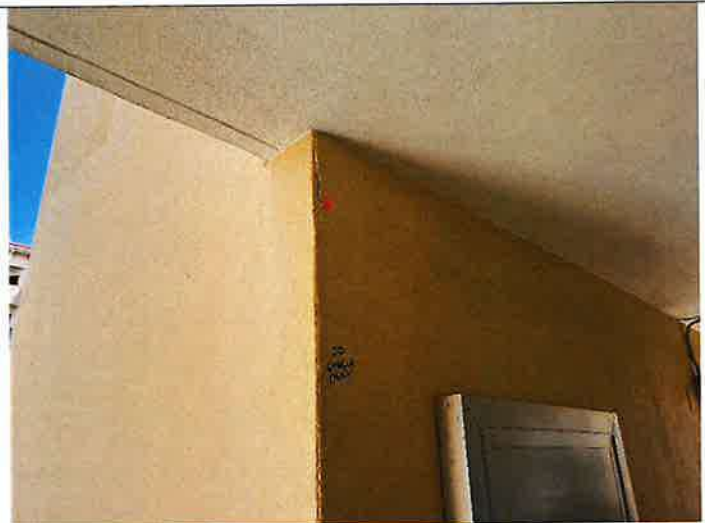
Photo No. 16

Location: Level 6 Walkway

New delaminated areas were observed and marked.
The contractor was directed to chip the stucco first
and sound the concrete once exposed.

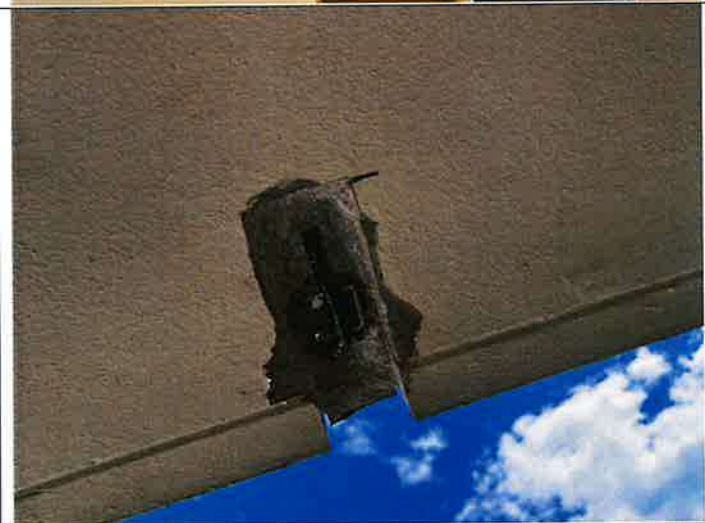
Photo No. 17

Location: Level 5 Walkway

The area was clean and able to be coated and patched.

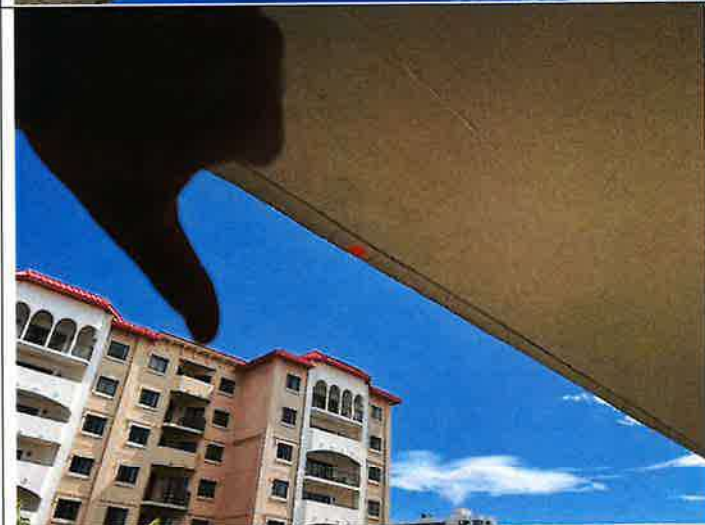
Photo No. 18

Location: Level 5 Walkway

New delaminated areas were observed and marked.
The contractor was directed to chip the stucco first
and sound the concrete once exposed.

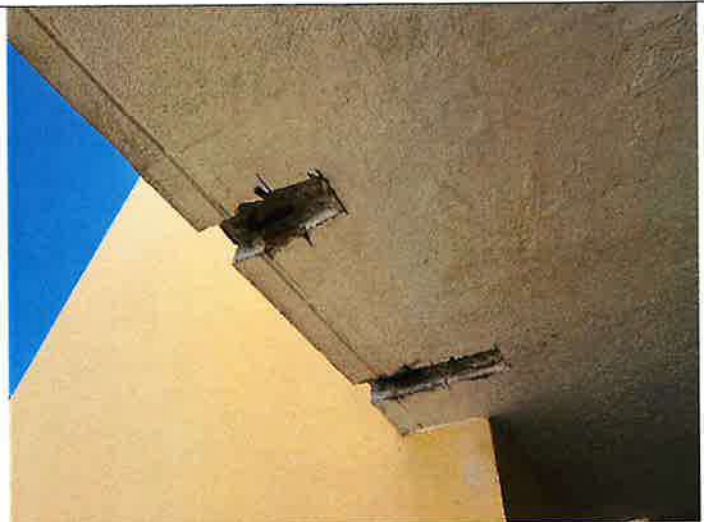
Photo No. 19

Location: Level 4 Walkway

The area was clean and able to be coated and patched.

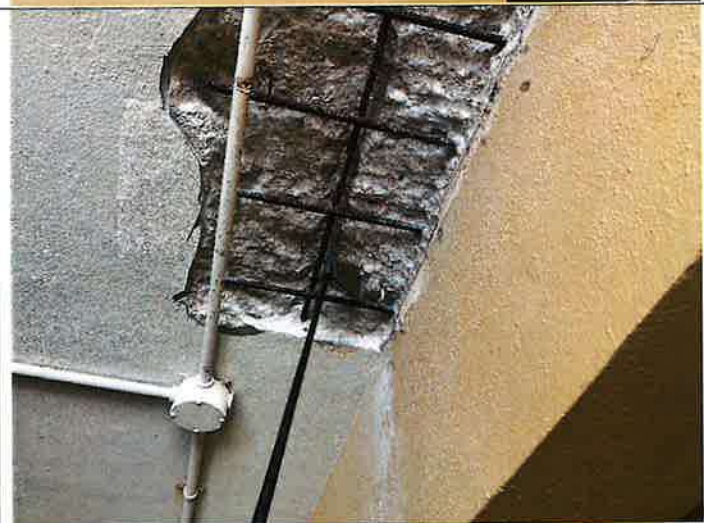
Photo No. 20

Location: Level 4 Walkway

The area was clean and able to be coated and patched.
The chairs were directed to be cut.

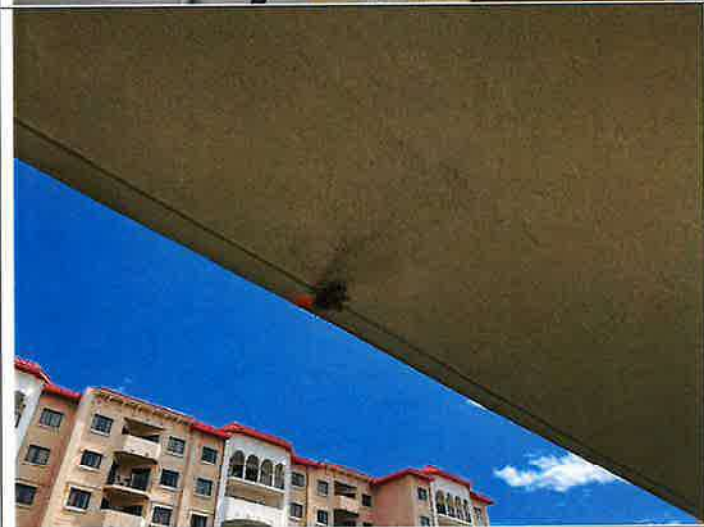
Photo No. 21

Location: Level 4 Walkway

New delaminated areas were observed and marked.
The contractor was directed to chip the stucco first
and sound the concrete once exposed.

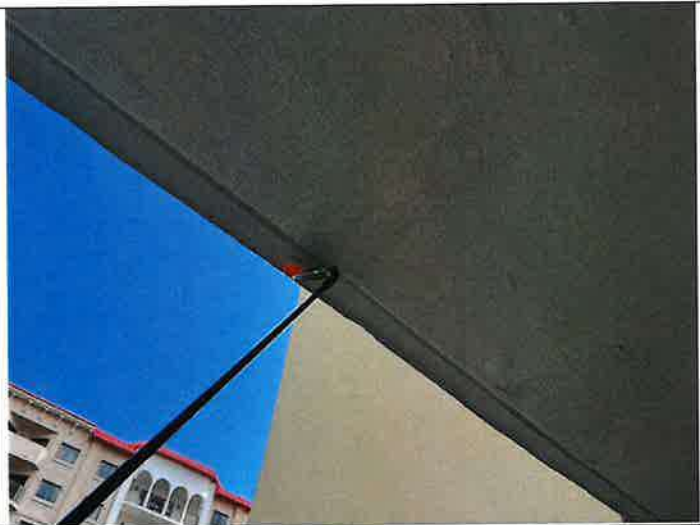
Photo No. 22

Location: Level 4 Walkway

New delaminated areas were observed and marked.
The contractor was directed to chip the stucco first
and sound the concrete once exposed.

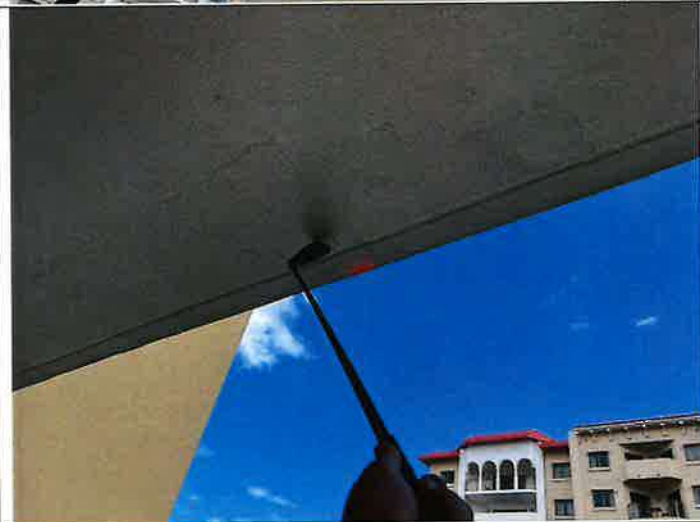
Photo No. 23

Location: Level 4 Walkway

New delaminated areas were observed and marked.
The contractor was directed to chip the stucco first
and sound the concrete once exposed.

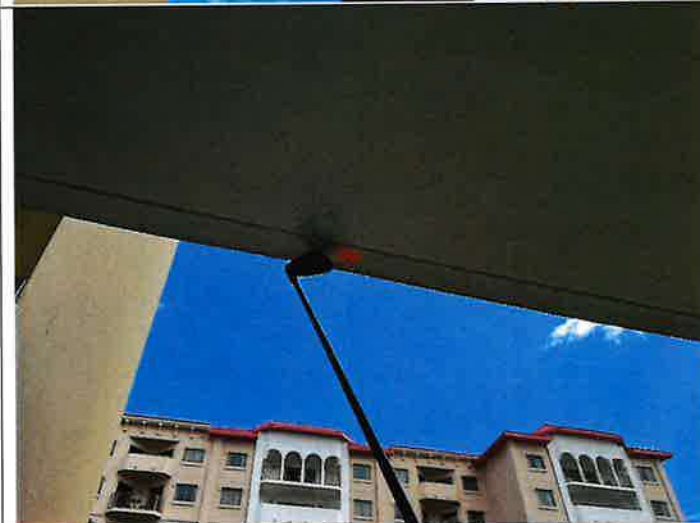
Photo No. 24

Location: Level 4 Walkway

New delaminated areas were observed and marked.
The contractor was directed to chip the stucco first
and sound the concrete once exposed.

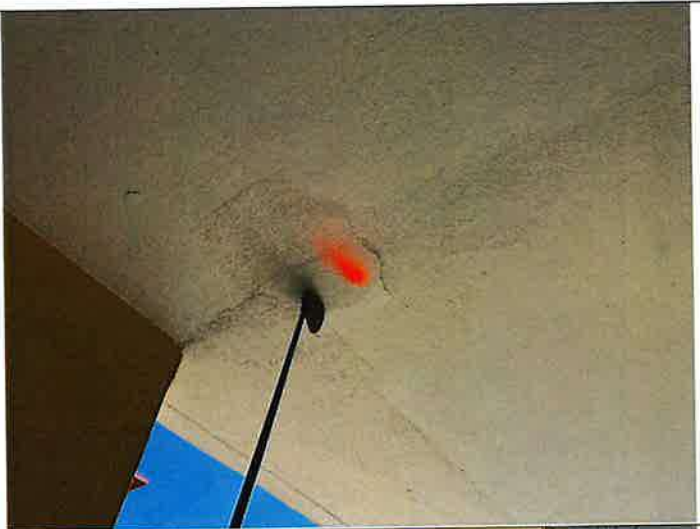
Photo No. 25

Location: Level 3 Walkway

New delaminated areas were observed and marked. The contractor was directed to chip the stucco first and sound the concrete once exposed.

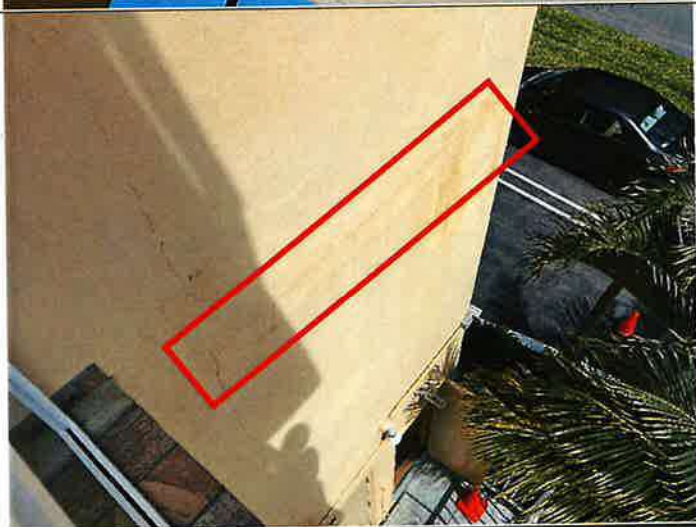
Photo No. 26

Location: Level 3 Walkway

The stucco crack at the south staircase exterior wall was inspected and sounded. The area was not delaminated and did not need to be sawcut and chipped.

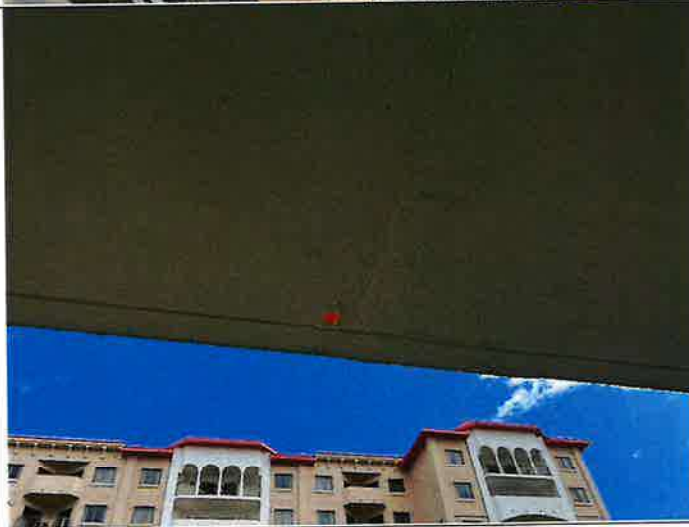
Photo No. 27

Location: Level 3 Walkway

New delaminated areas were observed and marked. The contractor was directed to chip the stucco first and sound the concrete once exposed.

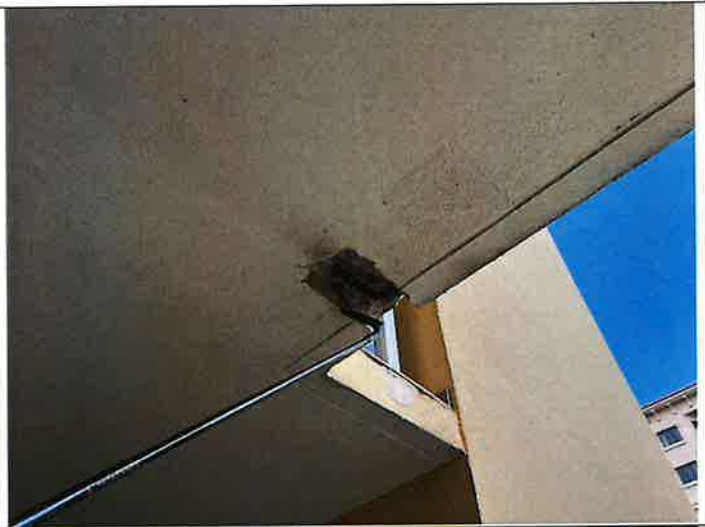
Photo No. 28

Location: Level 2 Walkway

The area was clean and able to be coated and patched.

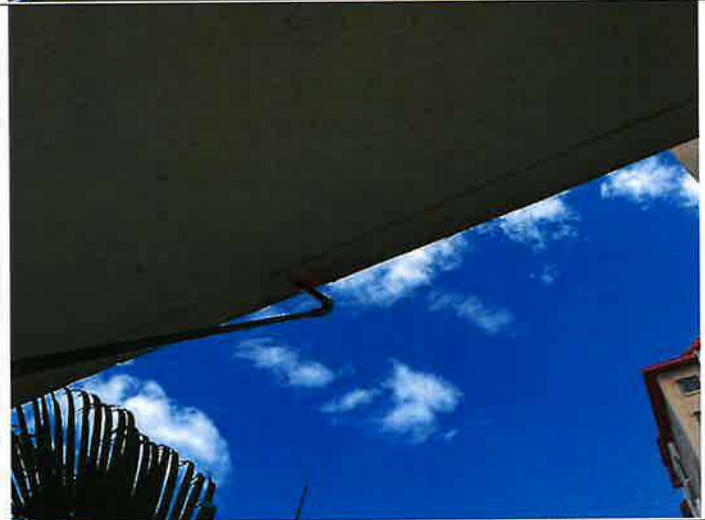
Photo No. 29

Location: Level 2 Walkway

New delaminated areas were observed and marked. The contractor was directed to chip the stucco first and sound the concrete once exposed.

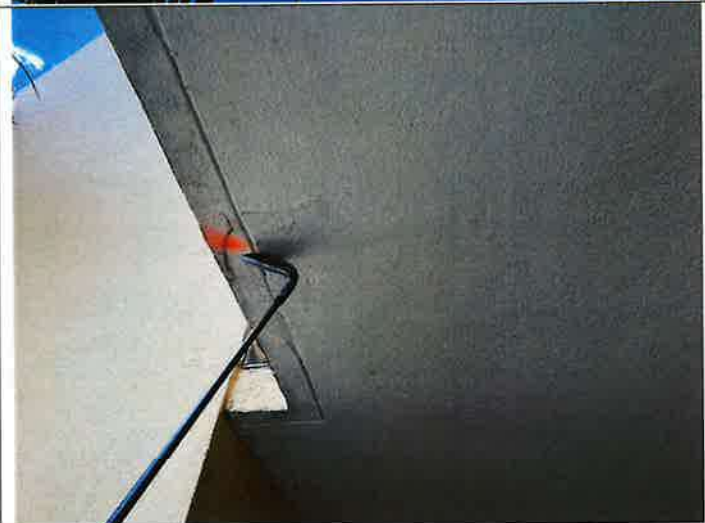
Photo No. 30

Location: Level 2 Walkway

New delaminated areas were observed and marked. The contractor was directed to chip the stucco first and sound the concrete once exposed.

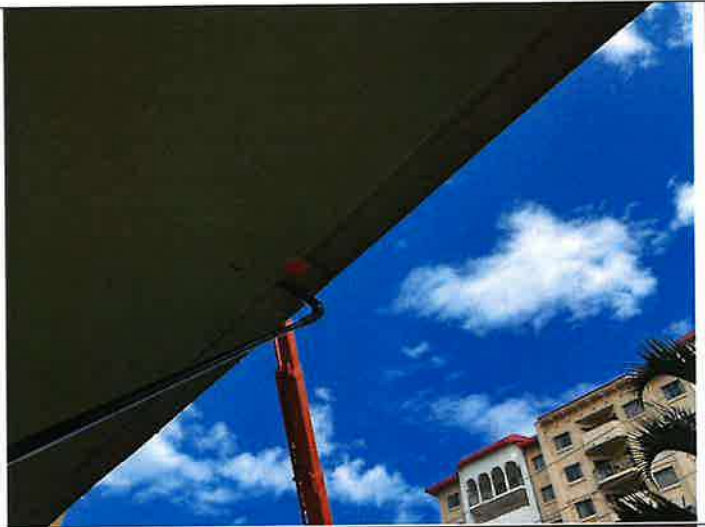
Photo No. 31

Location: Level 2 Walkway

New delaminated areas were observed and marked.
The contractor was directed to chip the stucco first
and sound the concrete once exposed.

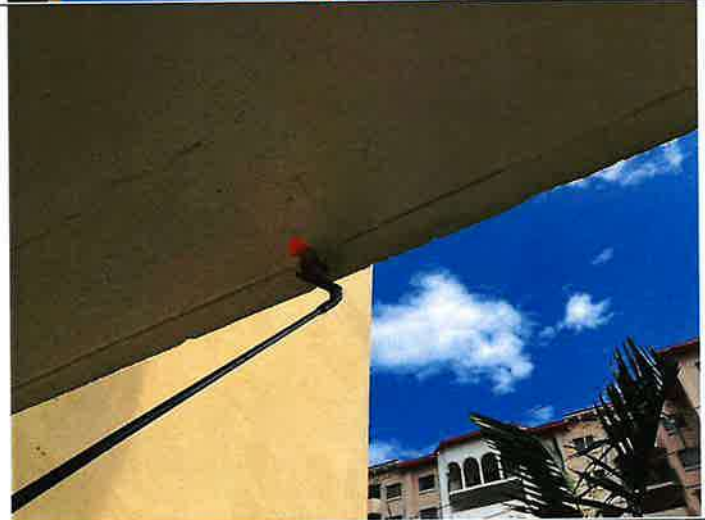
Photo No. 32

Location: Level 2 Walkway

New delaminated areas were observed and marked.
The contractor was directed to chip the stucco first
and sound the concrete once exposed.

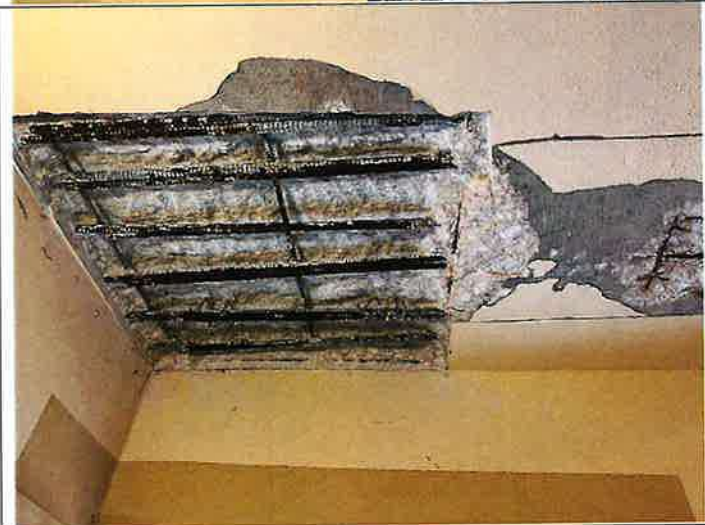
Photo No. 33

Location: Level 2 Walkway

This area was still in the process of being chipped out.
