Field Observation Report – Riverside Terrace Condominium

TRC Project No. 21FTL323

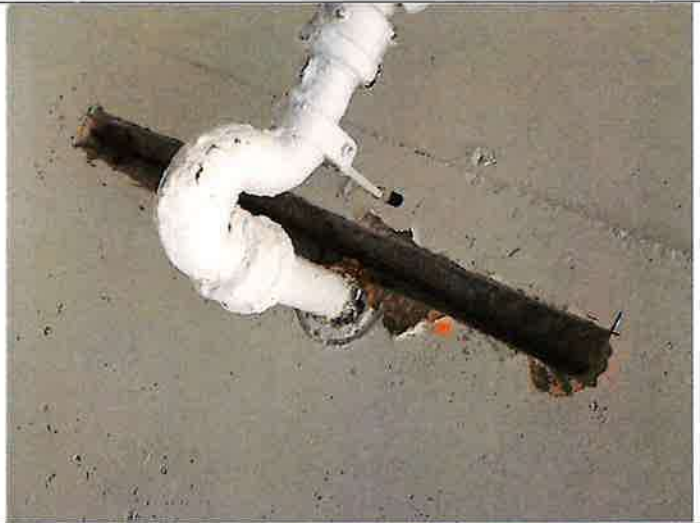
Photo No. 1

Location: Underside Parking Garage

The areas that the contractor was directed to chip out were done and ready to be coated and patched.

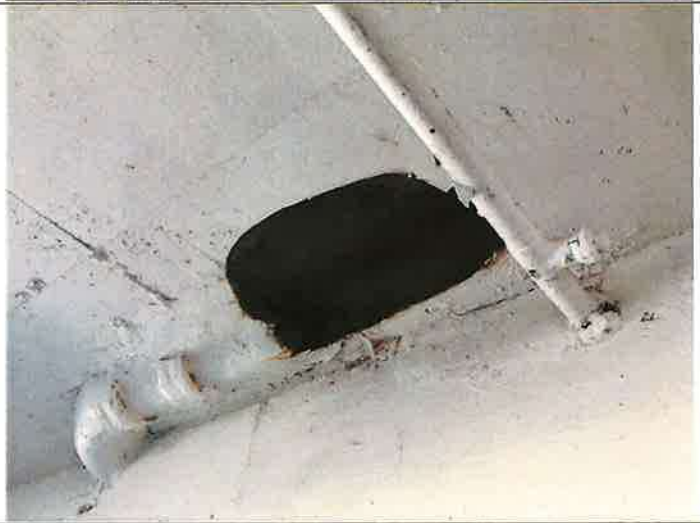
Photo No. 2

Location: Underside Parking Garage

The areas that were approved for patching were completed.

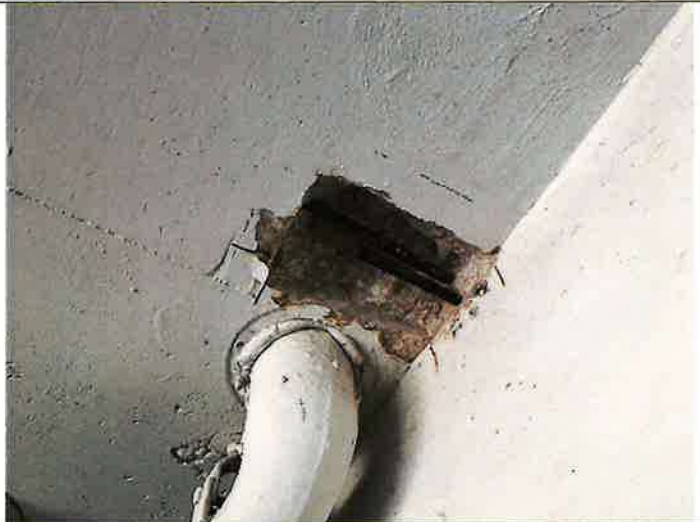
Photo No. 3

Location: Underside Parking Garage

The areas that the contractor was directed to chip out were done and ready to be coated and patched.

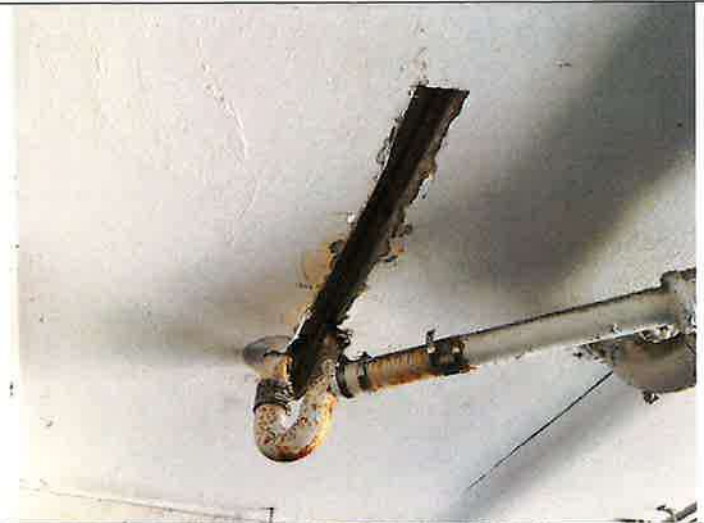
Photo No. 4

Location: Underside Parking Garage

The areas that the contractor was directed to chip out were done and ready to be coated and patched. The foam around the pipe was directed to be cut out.

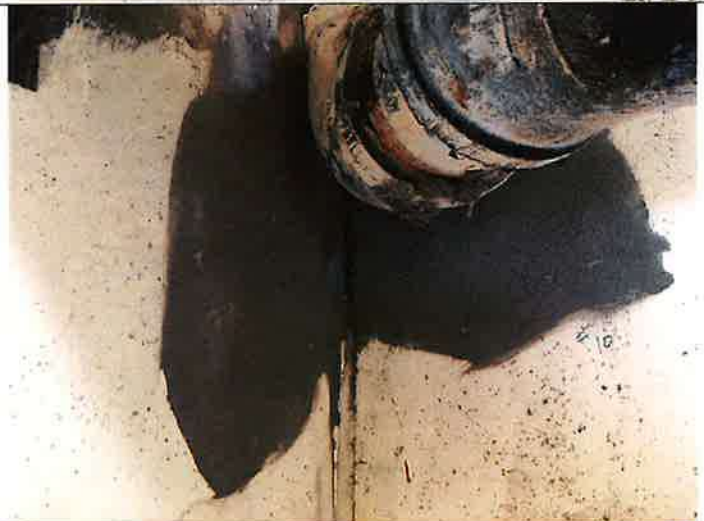
Photo No. 5

Location: Ground Floor South Staircase

The areas that were approved for patching from the previous inspection were completed.

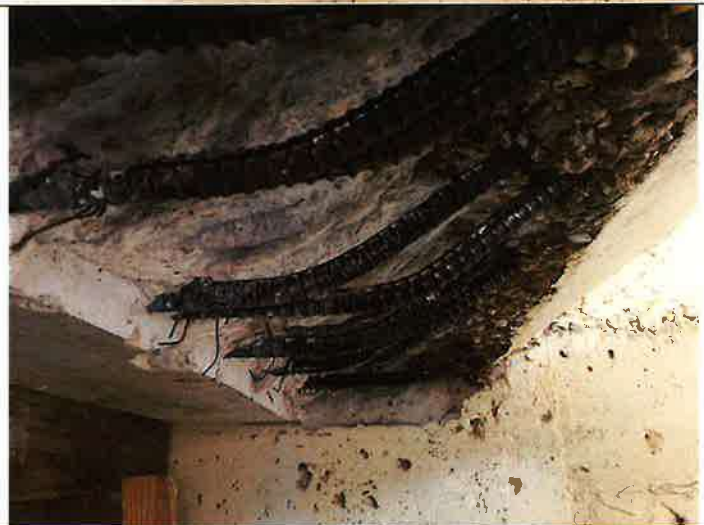
Photo No. 6

Location: Ground Floor South Staircase

The contractor chipped the stair landing and used 4x4 posts as shores. The contractor was directed to sawcut and chip per ICRI guidelines at both ends. The repair area should have square geometry and chipping should continue until solid concrete is reached.

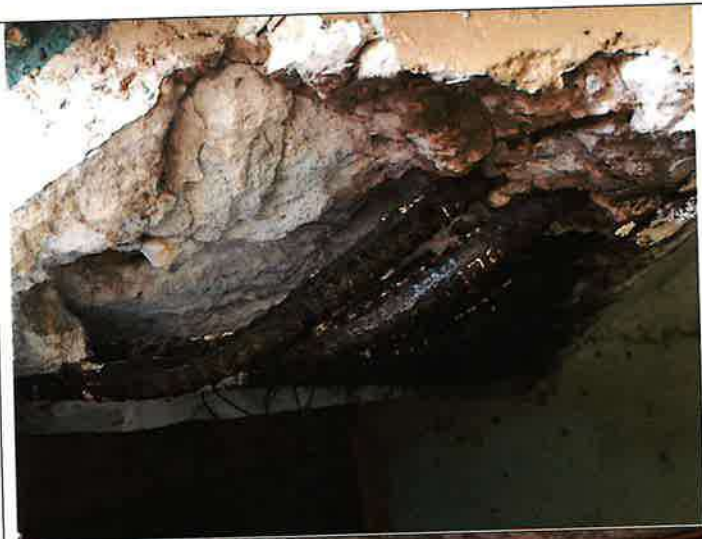
Photo No. 7

Location: Ground Floor South Staircase

The contractor chipped the stair landing and used 4x4 posts as shores. The contractor was directed to sawcut and chip per ICRI guidelines at both ends. The repair area should have square geometry and chipping should continue until solid concrete is reached.

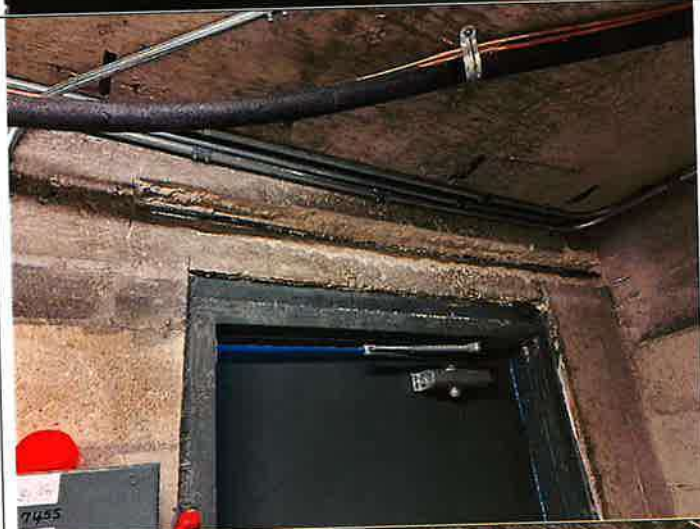
Photo No. 8

Location: Upper Roof Elevator Room

The areas that the contractor was directed to chip out were done and ready to be coated and patched.

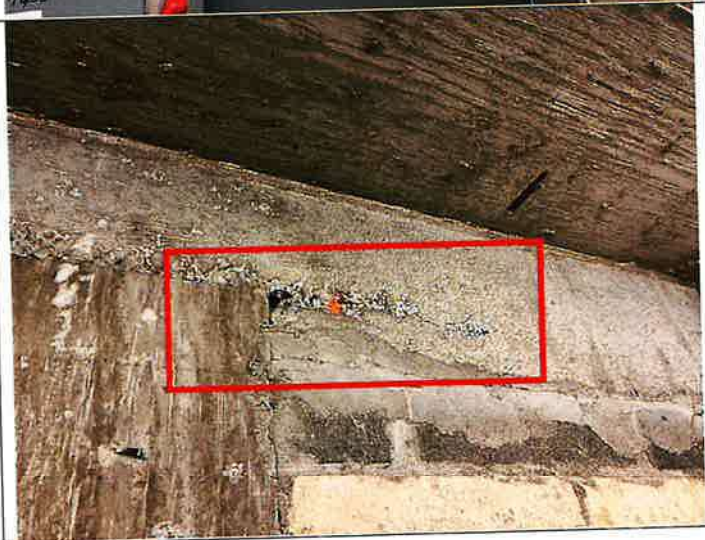
Photo No. 9

Location: Upper Roof Elevator Room

The squared location needs to be patched.

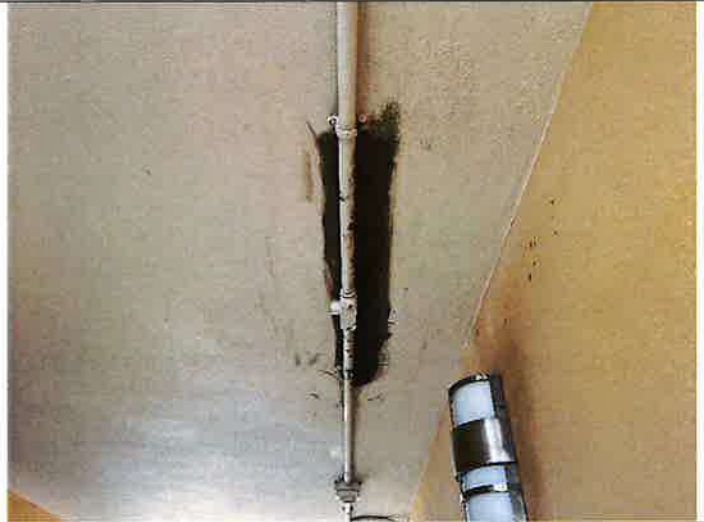
Photo No. 10

Location: Level 7 Walkway

The areas that were approved in the last inspection were completed.

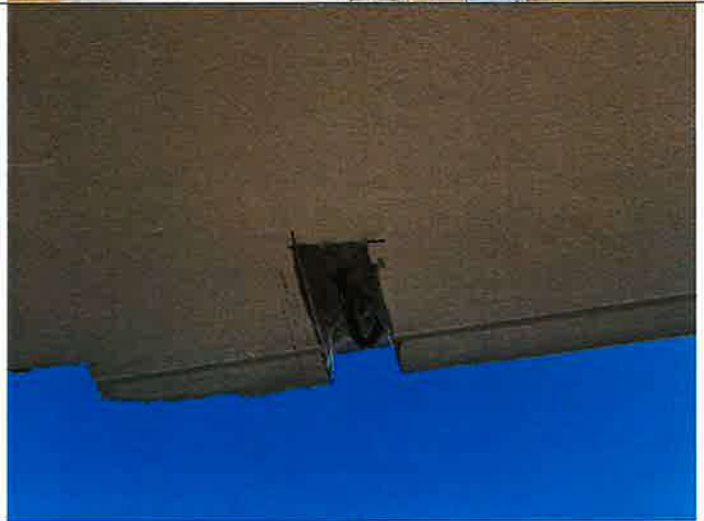
Photo No. 11

Location: Level 6 Walkway

This location needed to be cleaned further. Corrosion was still observed.

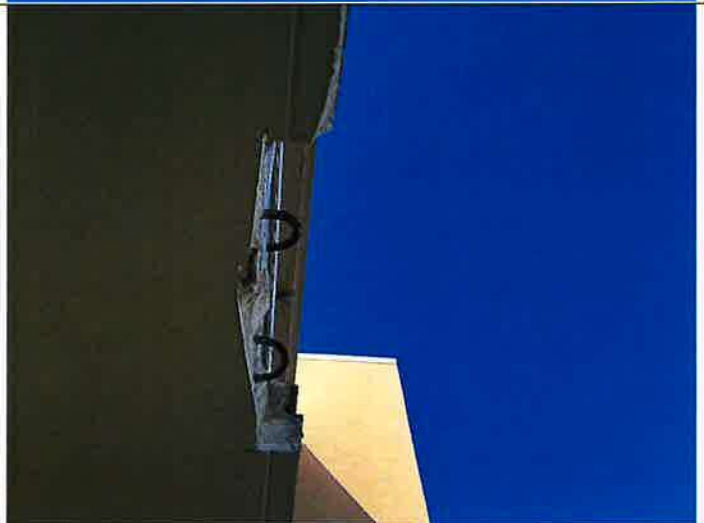
Photo No. 12

Location: Level 6 Walkway

The areas that the contractor was directed to chip out were done and ready to be coated and patched.

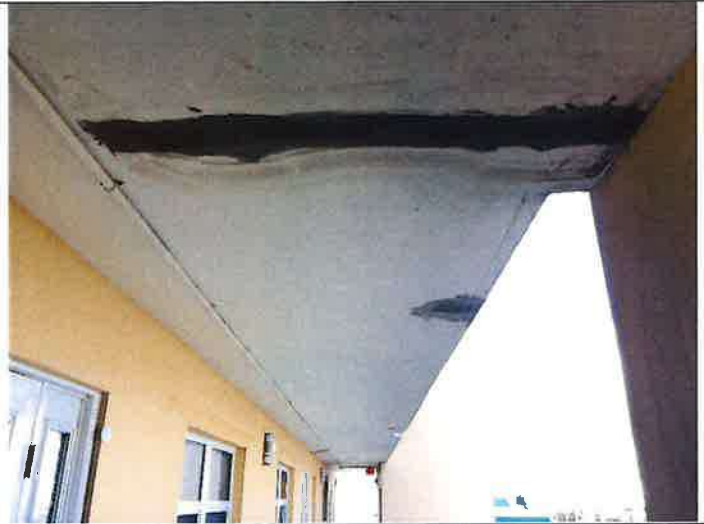
Photo No. 13

Location: Level 6 Walkway

The areas that were approved in the last inspection were completed.

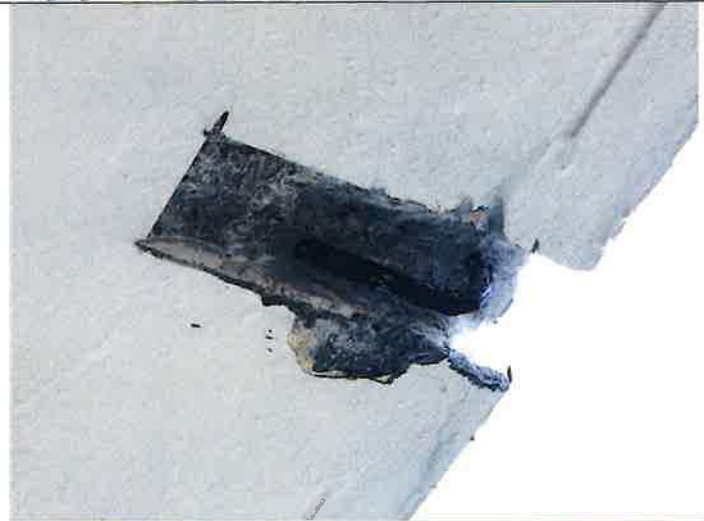
Photo No. 14

Location: Level 6 Walkway

This location needed to be cleaned further. Corrosion was still observed.

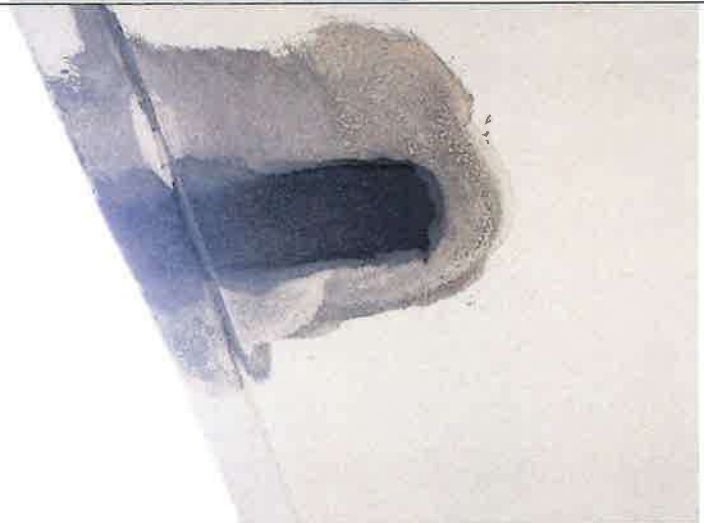
Photo No. 15

Location: Level 5 Walkway

The areas that were approved in the last inspection were completed.

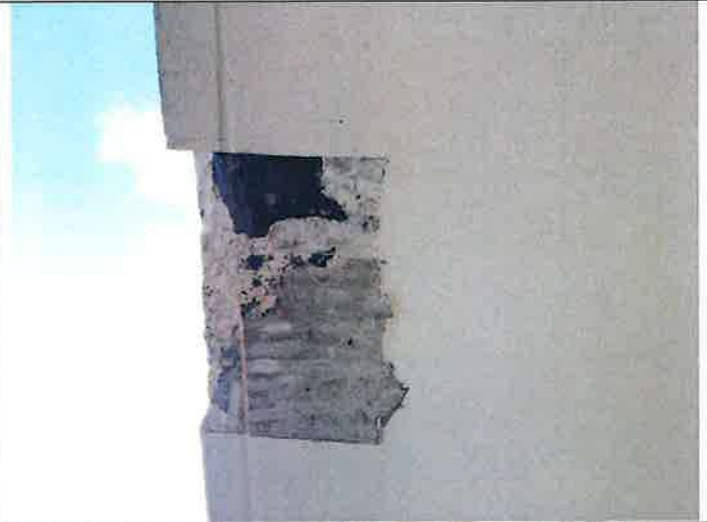
Photo No. 16

Location: Level 5 Walkway

This area was marked from the last inspection. It appeared to only have been a stucco issue. This area can be patched.

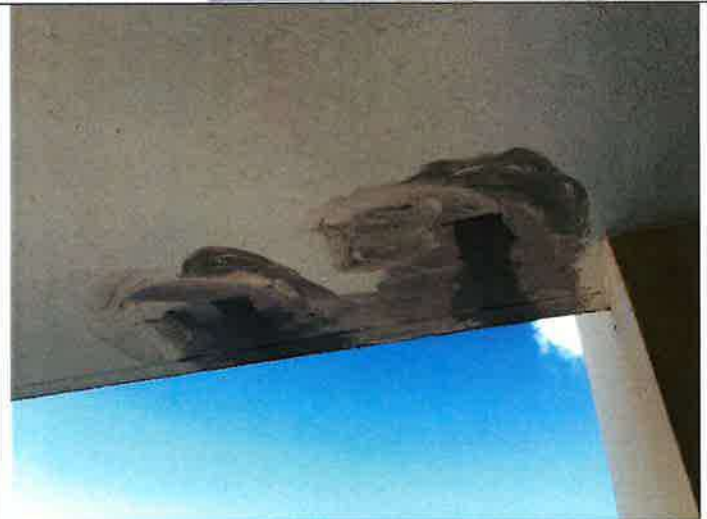
Photo No. 17

Location: Level 4 Walkway

The areas that were approved in the last inspection were completed.

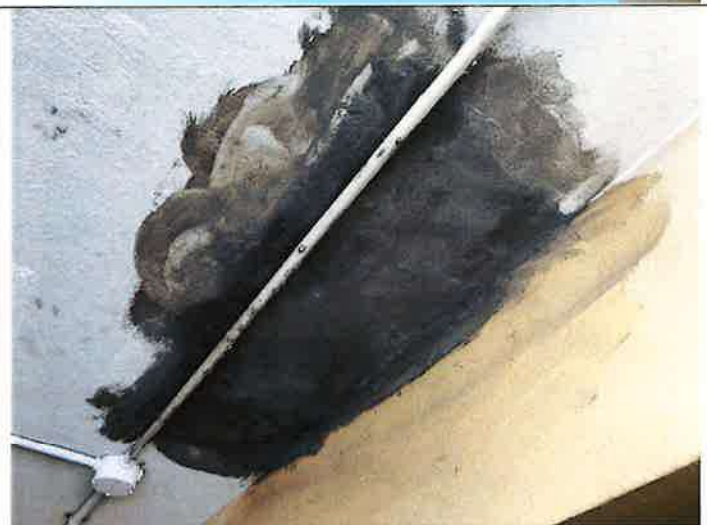
Photo No. 18

Location: Level 4 Walkway

The areas that were approved in the last inspection were completed.

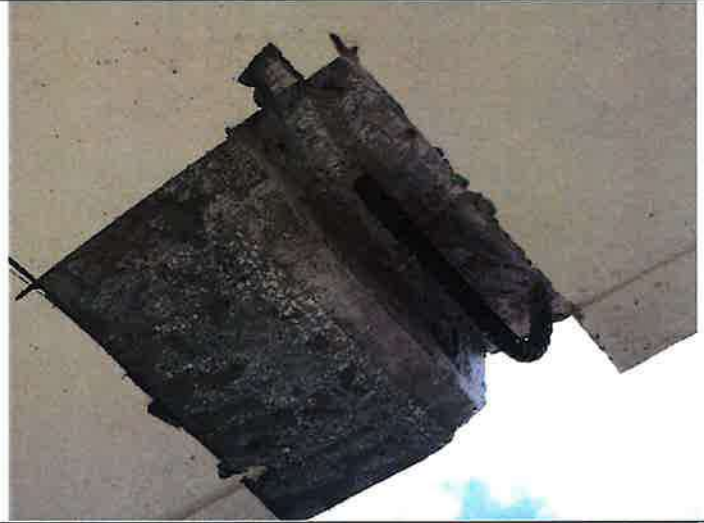
Photo No. 19

Location: Level 4 Walkway

The areas that the contractor was directed to chip out were done and ready to be coated and patched.

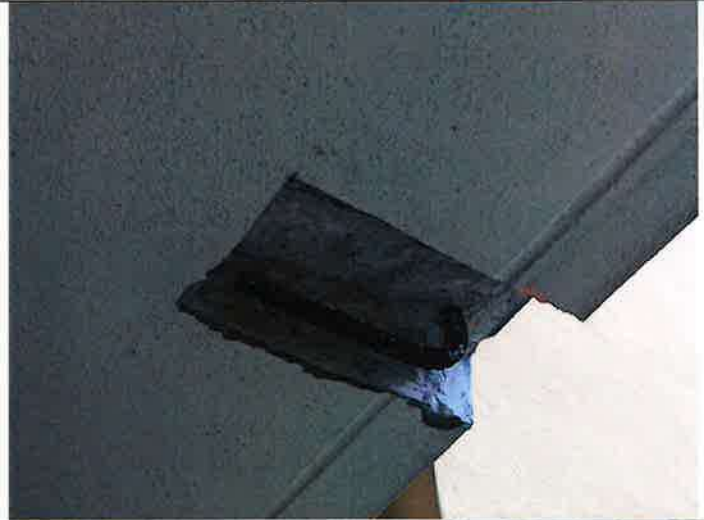
Photo No. 20

Location: Level 4 Walkway

The areas that the contractor was directed to chip out were done and ready to be coated and patched.

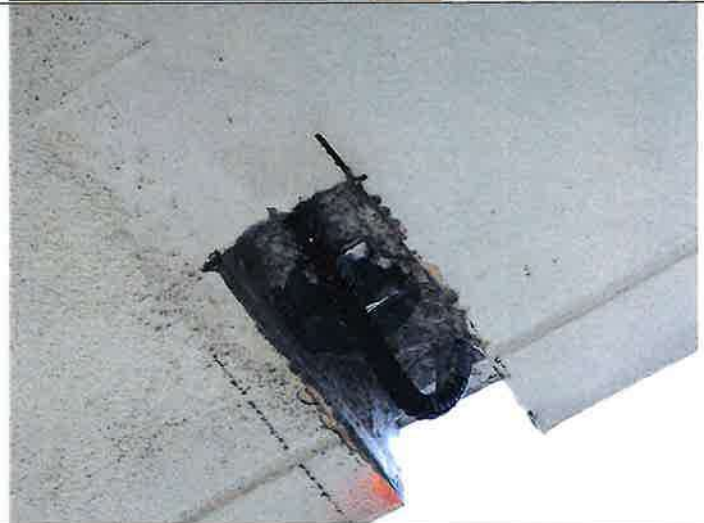
Photo No. 21

Location: Level 4 Walkway

The areas that the contractor was directed to chip out were done and ready to be coated and patched.

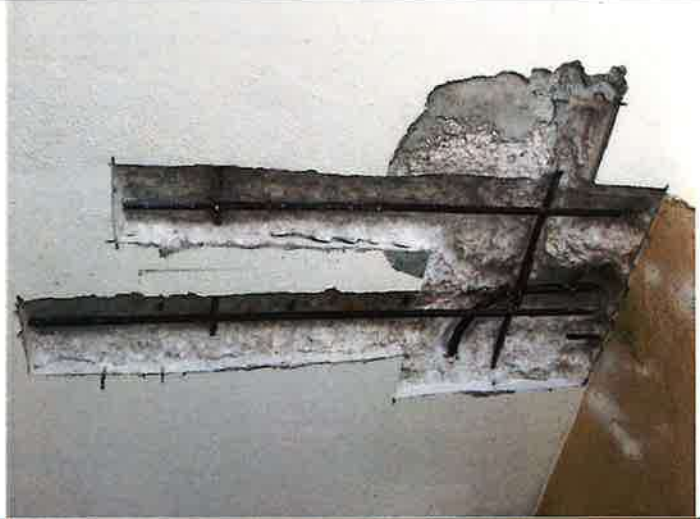
Photo No. 22

Location: Level 4 Walkway

This location needed to be cleaned further. Corrosion was still observed.

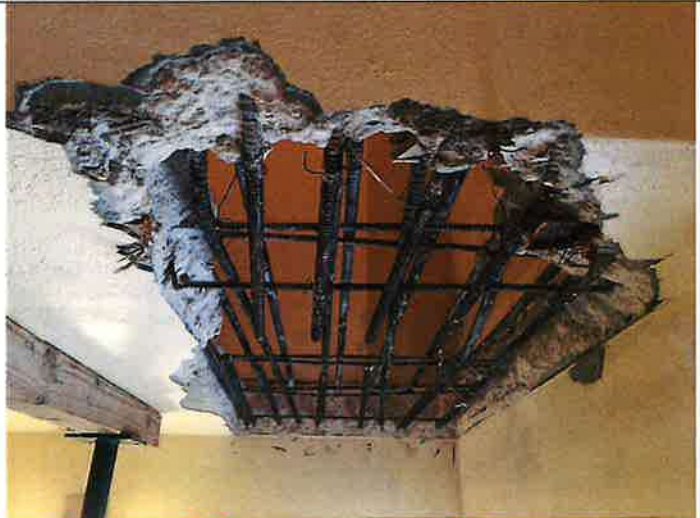
Photo No. 23

Location: Level 2 Walkway

This area was still in the process of being chipped out. The contractor was directed to square off the repair area.

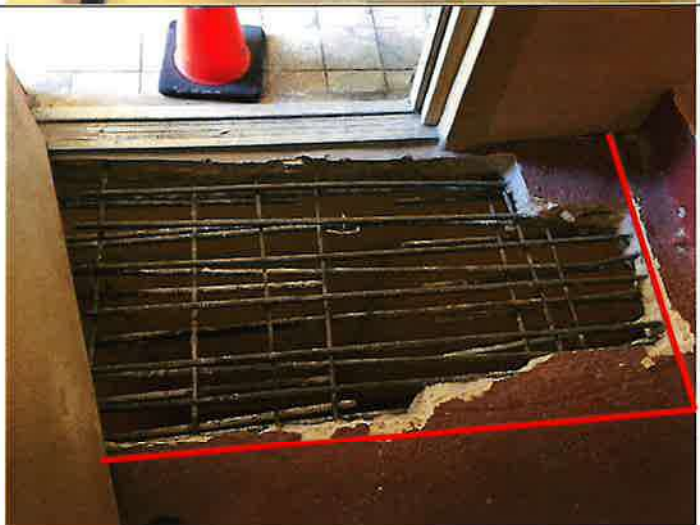
Photo No. 24

Location: Level 2 Walkway

This area was still in the process of being chipped out. The contractor was directed to square off the repair area.

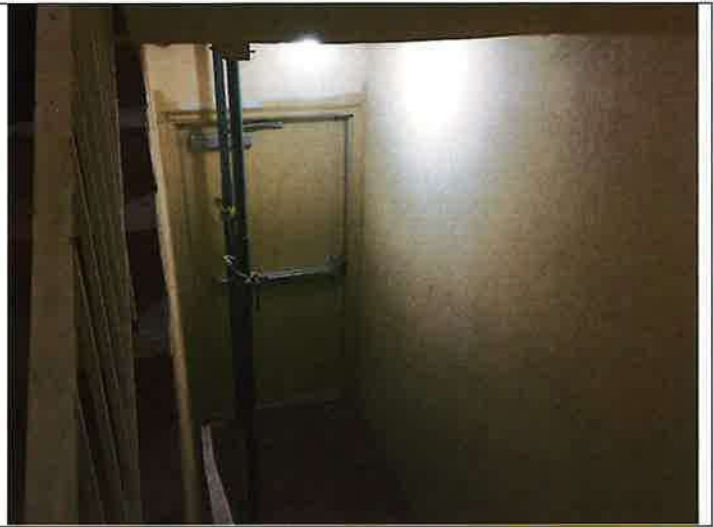
Photo No. 25

Location: Level 2 Walkway

Post shores were installed at the landing and the floor below it.
