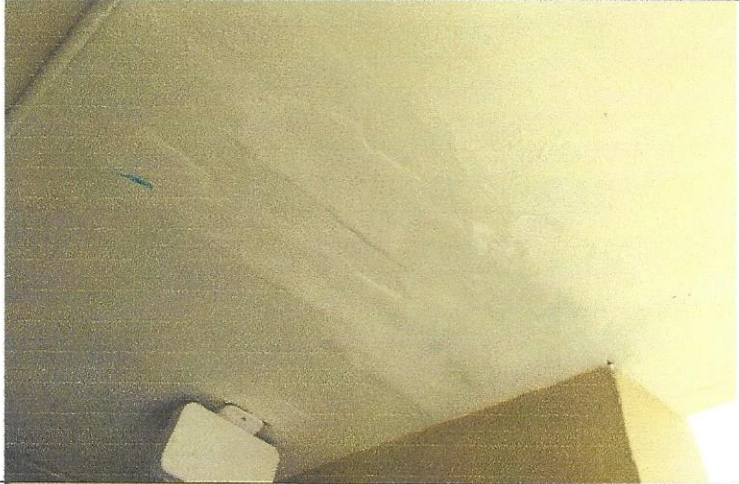
<p>Photo No. 13</p> <p>Location: Third Floor Walkway</p> <p>Comments:</p> <p>This repair area's finish was uneven and done poorly. This needs to be redone.</p> <p>Re-inspection required: <input checked="" type="checkbox"/> yes <input type="checkbox"/> no</p>

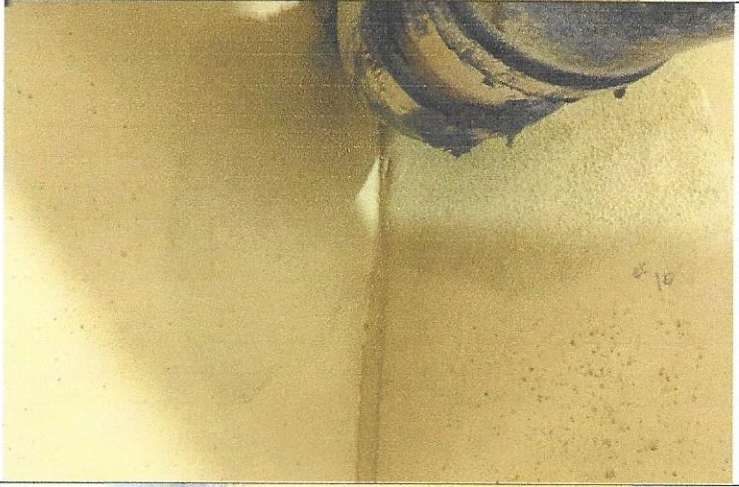
<p>Photo No. 14</p> <p>Location: Pump Room</p> <p>Comments:</p> <p>These areas were repaired and completed.</p> <p>Re-inspection required: <input type="checkbox"/> yes <input checked="" type="checkbox"/> no</p>

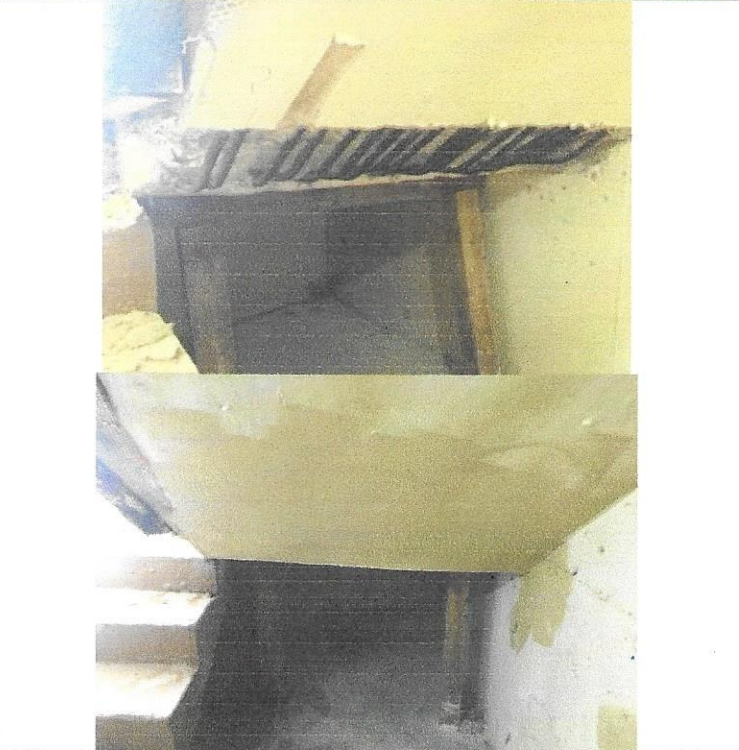
<p>Photo No. 15</p> <p>Location: Pump Room</p> <p>Comments:</p> <p>The contractor provided photos for the repair adjustments noted in the previous report. These areas were reviewed and approved.</p> <p>These areas were repaired and completed.</p> <p>Re-inspection required: <input type="checkbox"/> yes <input checked="" type="checkbox"/> no</p>

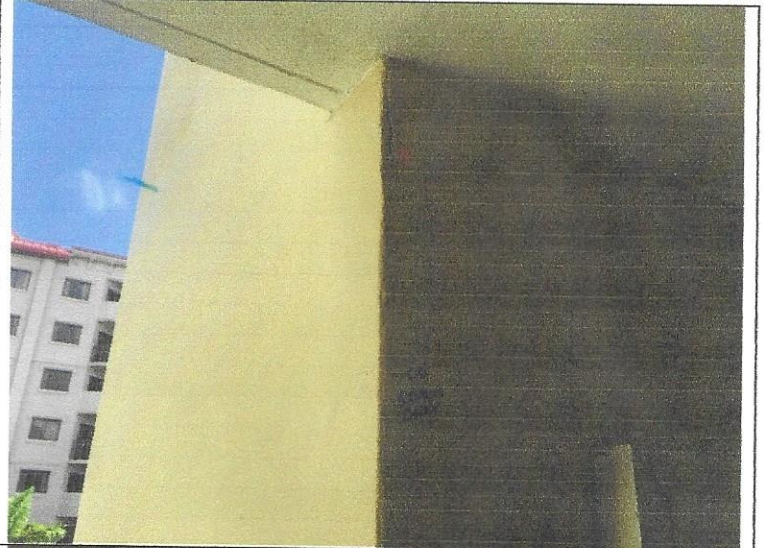
Photo No. 10

The sixth-floor repair area in front of unit 601 needs to still be repaired.

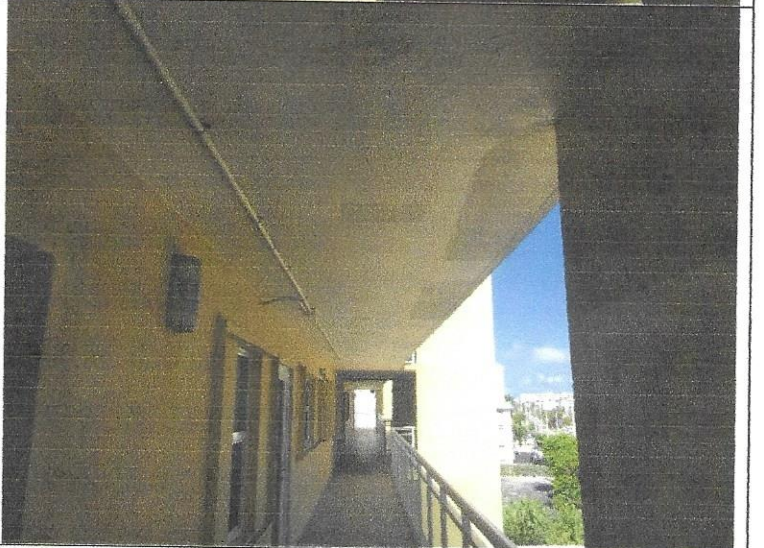
Photo No. 11

The fifth-floor repair areas were observed.

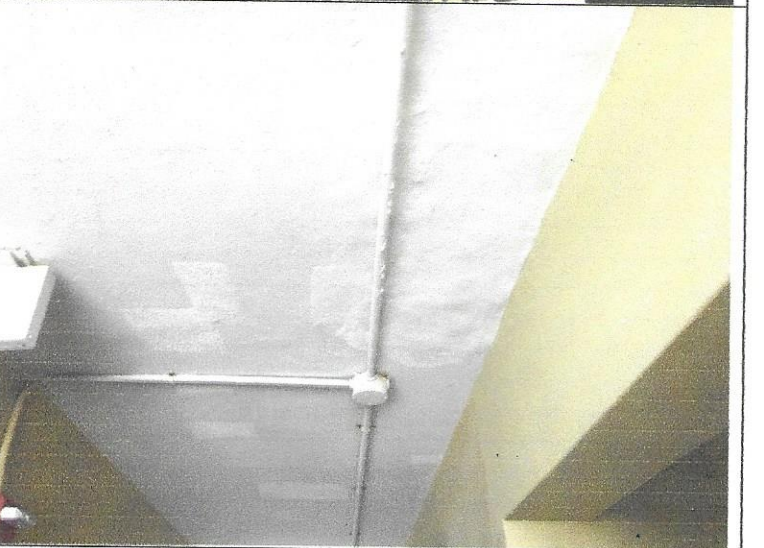
Photo No. 12

This repair area's finish was uneven and done poorly. This needs to be redone.

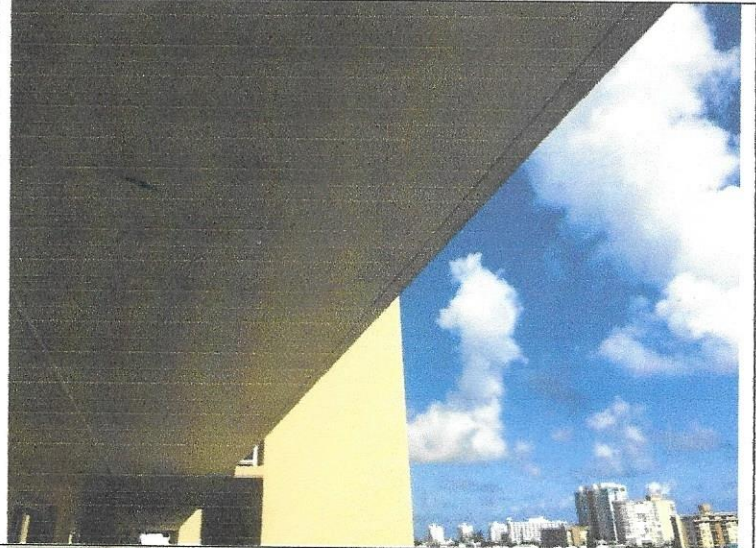
Photo No. 7

The seventh-floor repair areas were observed.

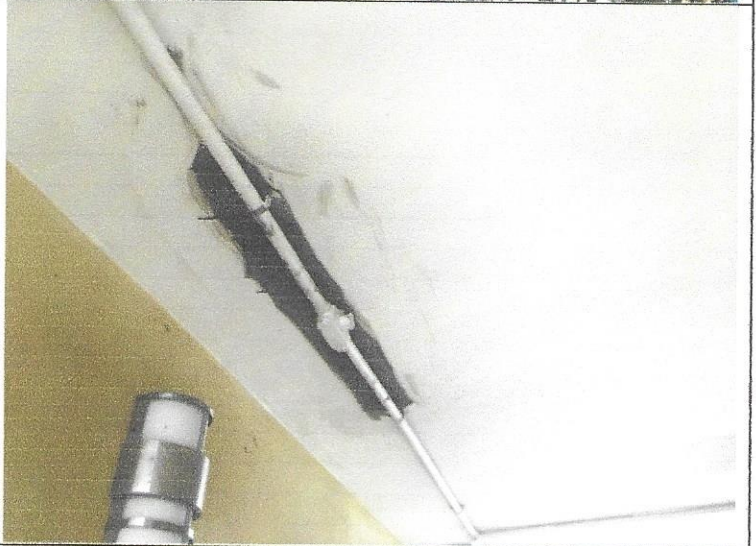
Photo No. 8

This location had not been painted.

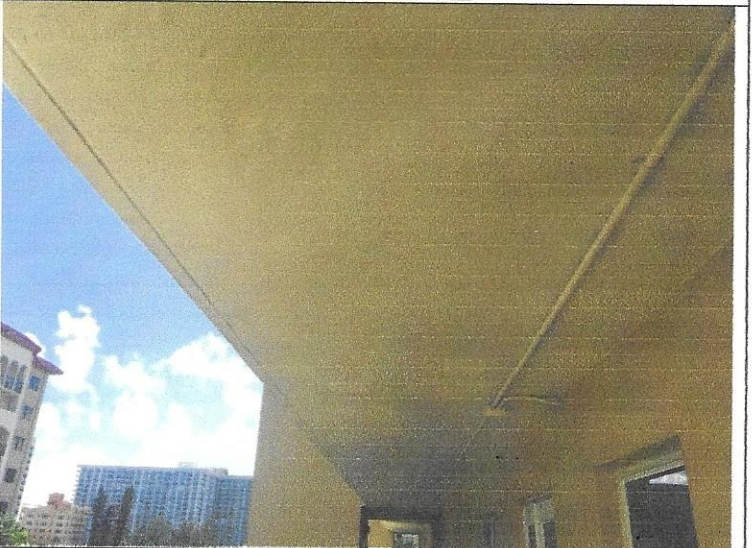
Photo No. 9

The sixth-floor repair areas were observed.

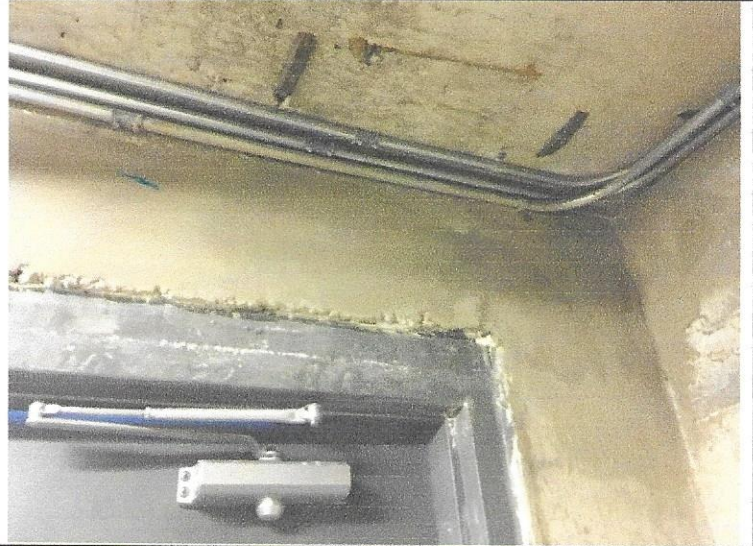
Photo No. 4

The tie-beam was repaired above the door opening.

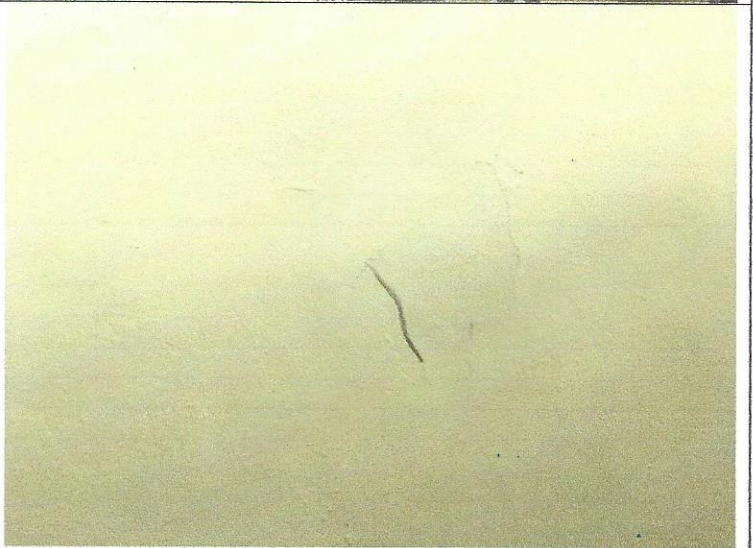
Photo No. 6

A sawcut was not patched at this ceiling location.

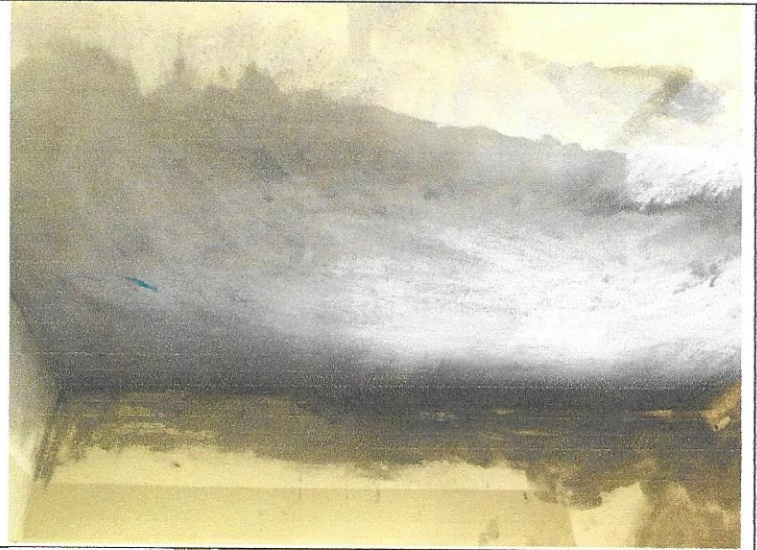
Photo No. 1

The contractor poured the landing and finished the underside of the repaired area with stucco that matched the surrounding finish. This location still needs to be painted.

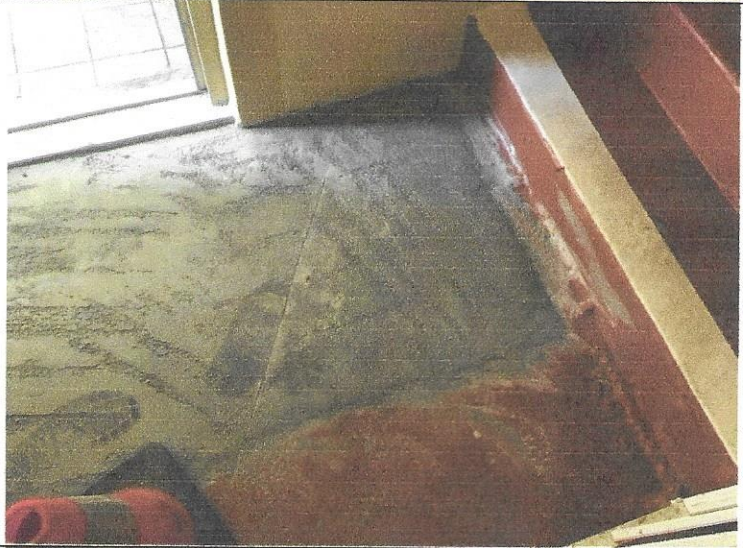
Photo No. 2

The areas that were approved for patching were completed. The contractor added texture to match the existing finish. This location still needs to be painted.

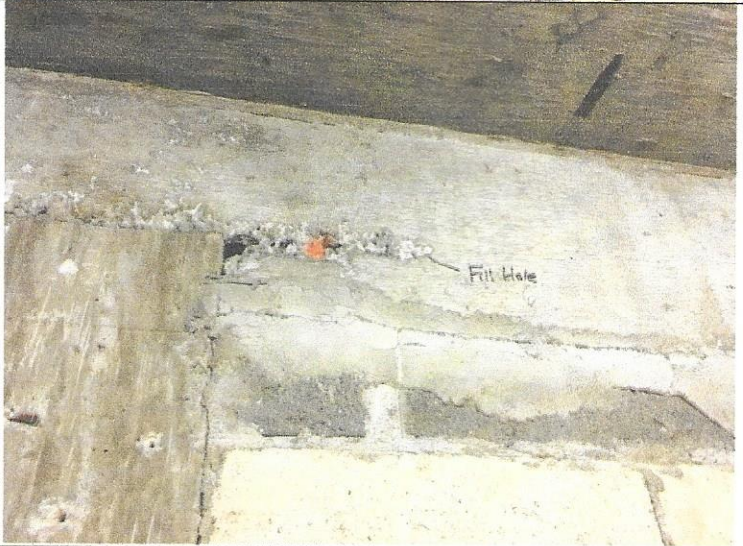
Photo No. 3

The contractor did not patch the marked tie-beam.
