December 2<sup>nd</sup>, 2024

Re: Riverside Terrace Condominium  
Structural Integrity Reserve Study (SIRS)  
615 North Riverside Drive  
Pompano Beach, Florida 33062  
UES Project No: 6011.2300167.0000

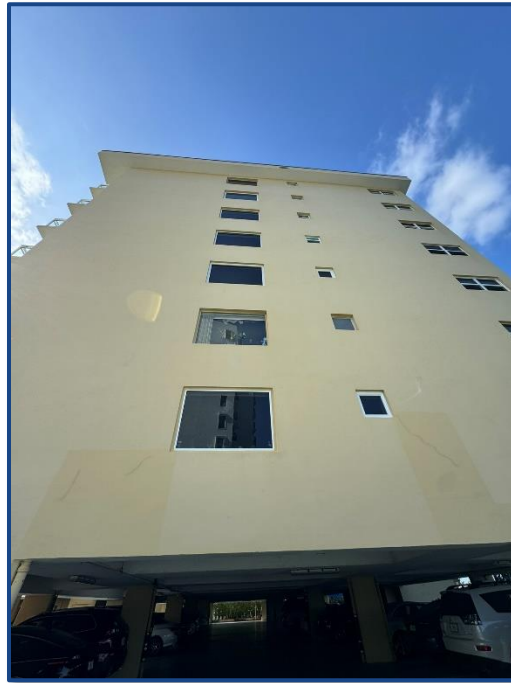
Photograph No. 1: Building North Elevation

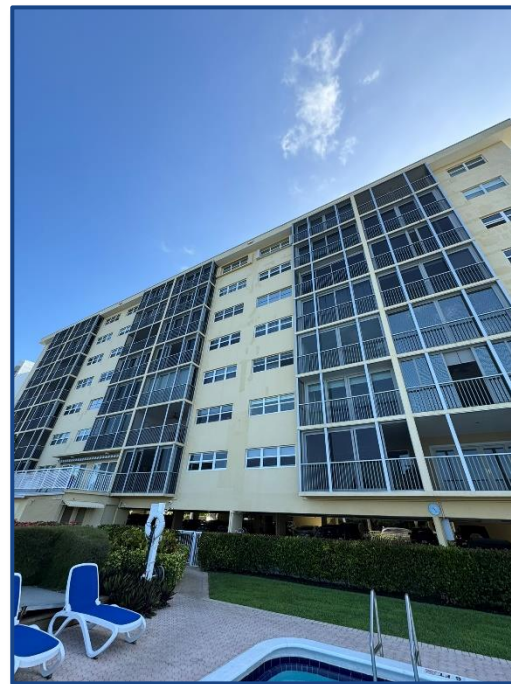
Photograph No. 2: Building West Elevation

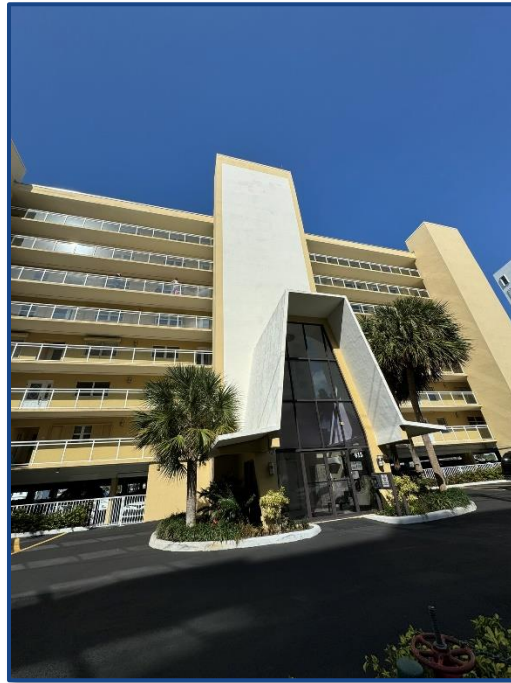
Photograph No. 3: Building East Elevation

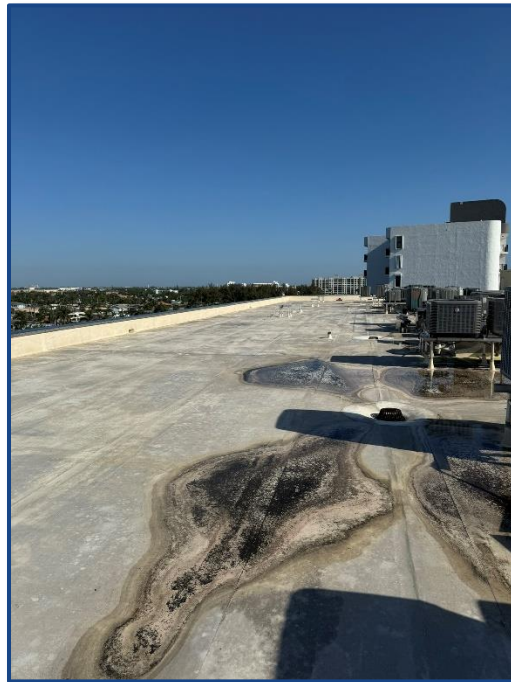
Photograph No. 6: Building Roof

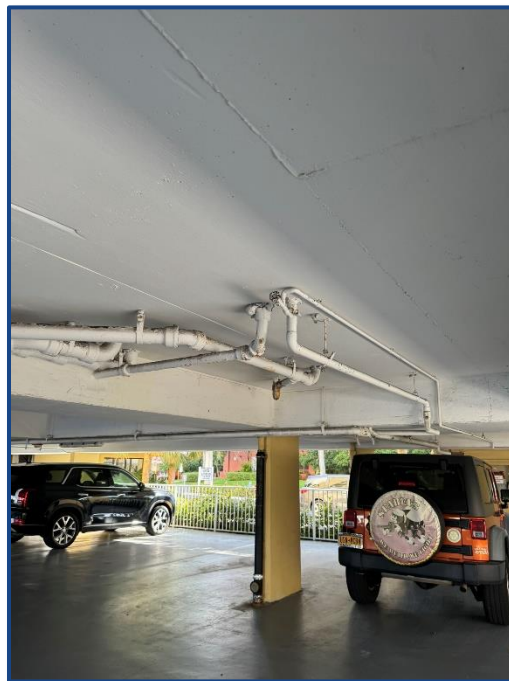
Photograph No. 10: Typical Building Parking Garage

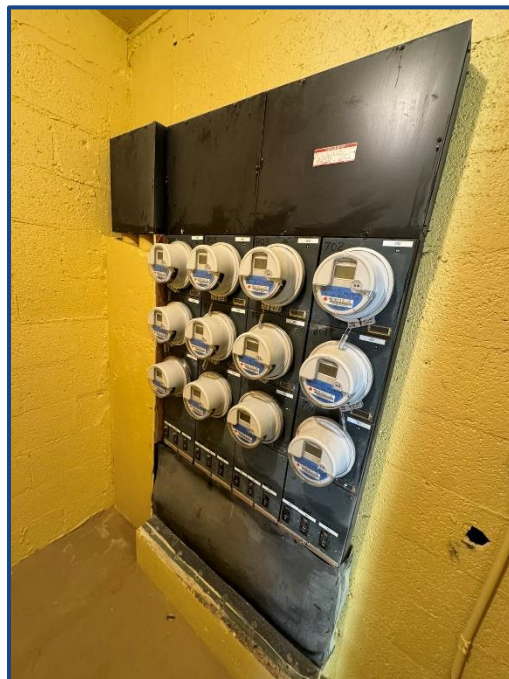
Photograph No. 12: Building 7<sup>th</sup> Floor Electrical Room

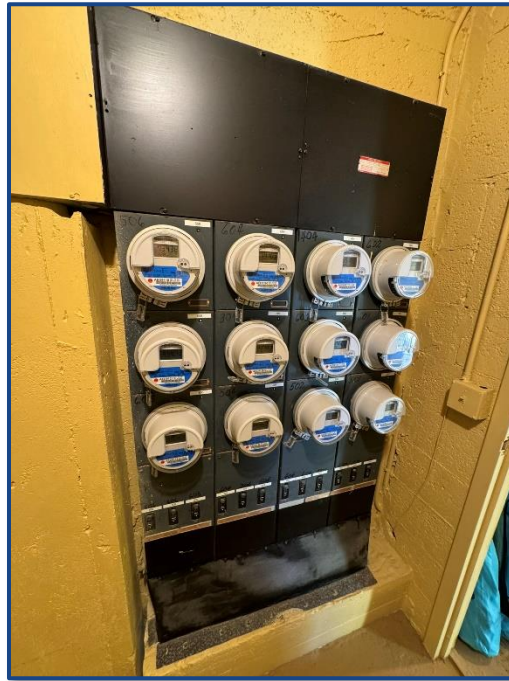
Photograph No. 13: Building 5<sup>th</sup> Floor Electrical Room

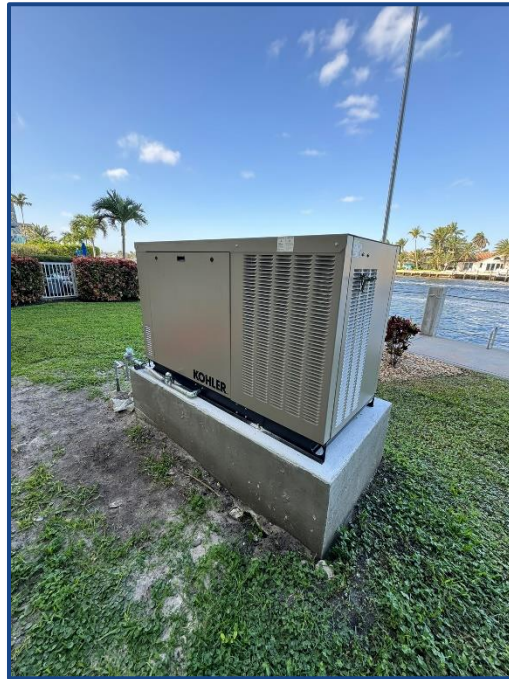
Photograph No. 15: Building Generator

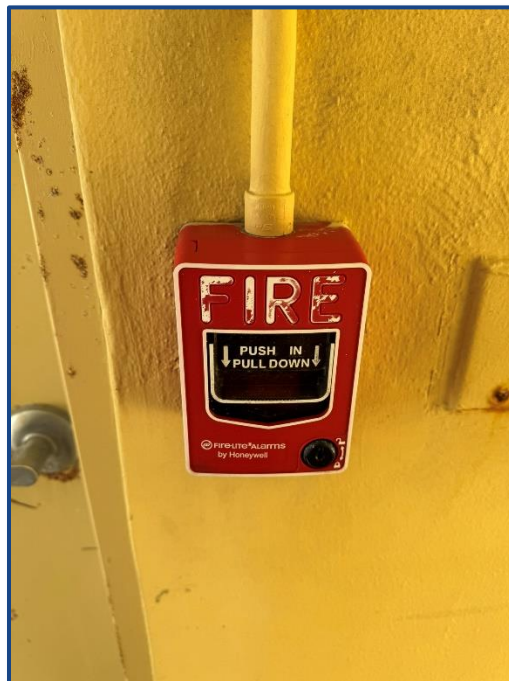
Photograph No. 16: Building Typical Fire Alarm Pull Station

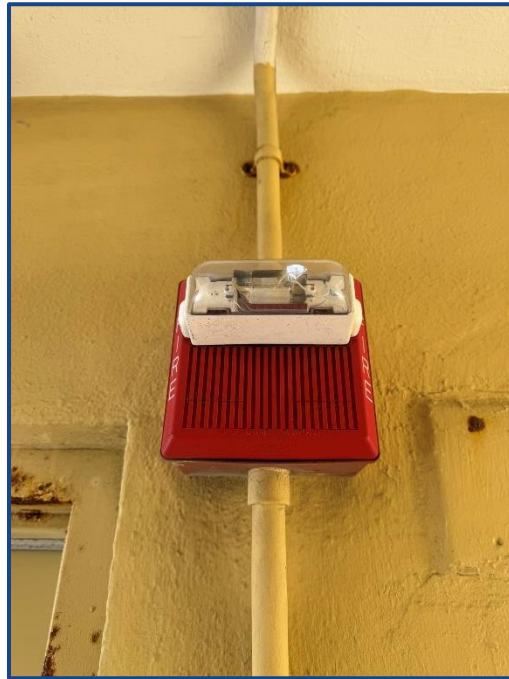
Photograph No. 17: Building Typical Fire Siren and Fire Emergency Light

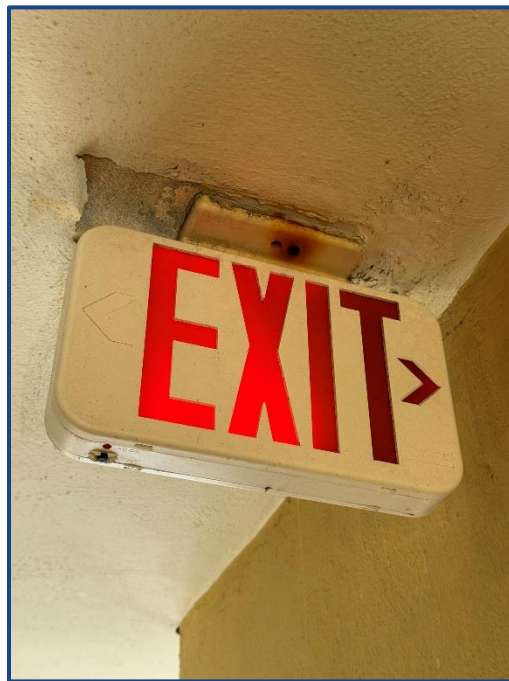
Photograph No. 18: Building Typical Fire Exit Sign

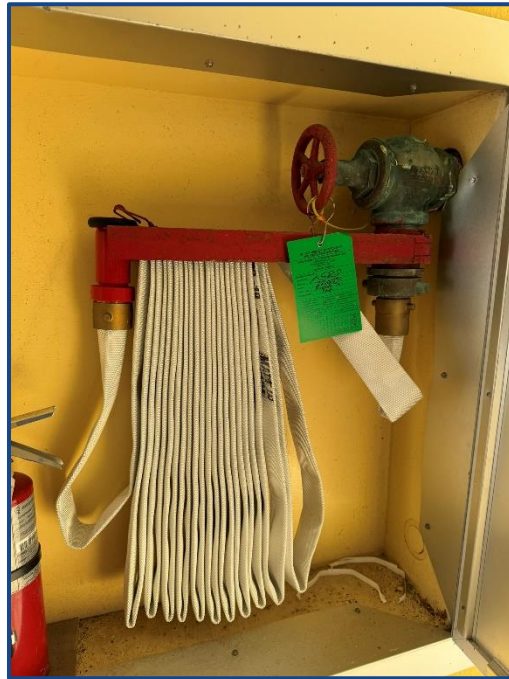
Photograph No. 19: Building Typical Fire Hose Station

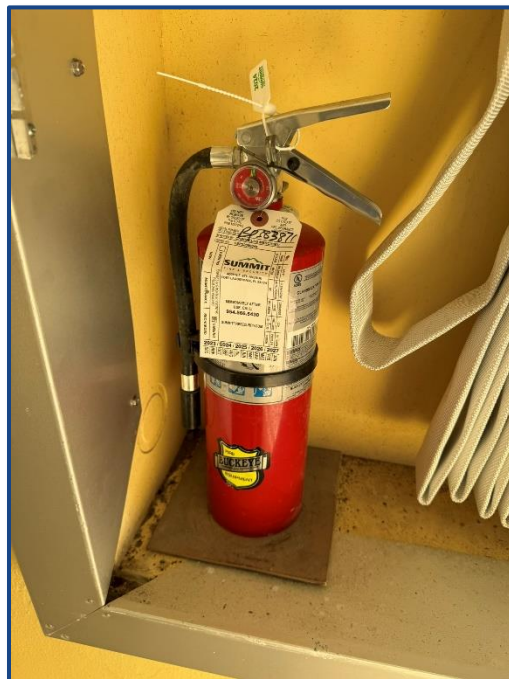
Photograph No. 20: Building Typical Fire Extinguisher

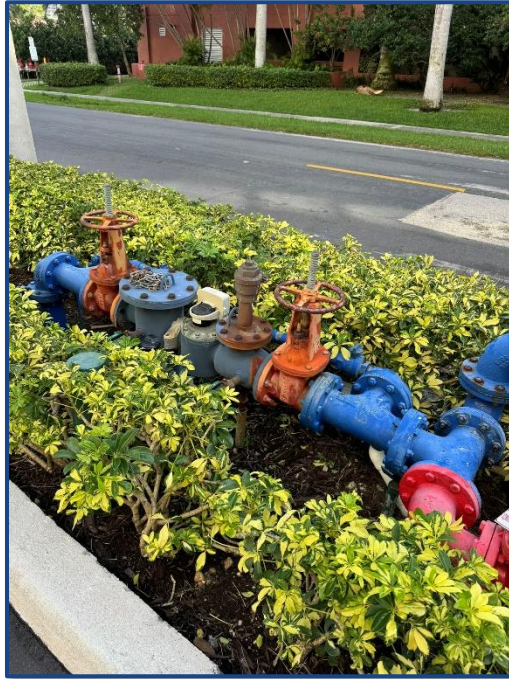
Photograph No. 21: Building Backflow Preventer & Double Detector Check Valve

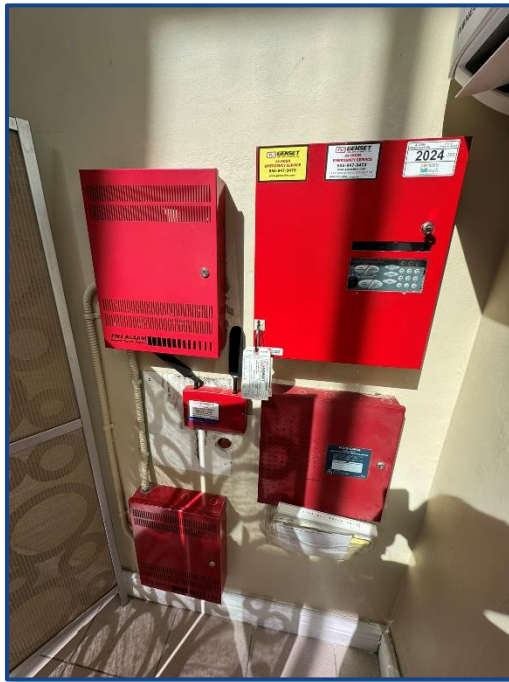
Photograph No. 22: Building Fire Alarm Panel
